PROBLEM SOLVER™ BULLETIN

BULLETIN: 25942

Damaged bolt and/or bushing

Honda Multi-Link Front Suspensions

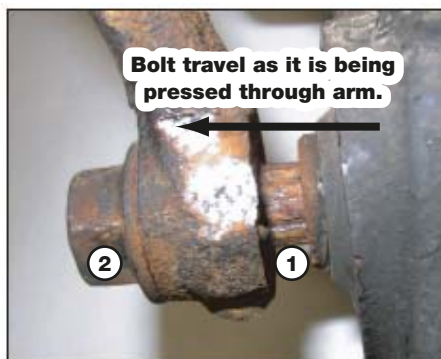
- When servicing struts or drive axles on Honda Multi-Link suspensions it is usually necessary to remove the wishbone from the lower control arm. It is very common for the pivot bolt to seize in the wishbone and/or bushing sleeve due to corrosion. Pressing the bolt out during removal can damage the wishbone and in most cases severely damages the bolt and bushing, prohibiting them from being reused.

1. Bolt breaking free from bushing sleeve.
2. Caution: If bolt is still frozen to wishbone, it may cause the fork to spread apart as pressure is being applied to bolt. This is clearly visible here by the gap between the bushing and wishbone.

- Only MOOG provides a complete service kit, containing a new bushing, zinc-plated serrated bolt and prevailing torque nut, to repair corroded wishbone pivots.
