TECHNICAL BULLETIN: TB15-03

Pro Series/Reese Select Series 5th Wheel: Service and Inspection Recommendation

Pro Series / Reese Select 5th Wheel

- 16K Pro Series
- 20K Pro Series
- 16K Reese Select

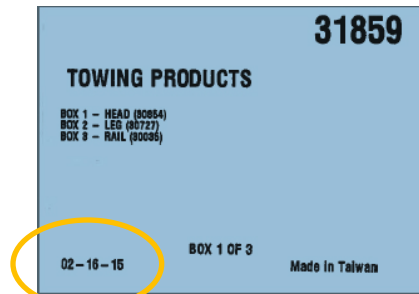
Date Code: Month-Date-Year
Example Feb 16, 2015

- Inspection from a new packaged unit in a box: Only units with package dates between January 1, 2012 to August 15, 2014 are suspect. If suspect units are found, please perform the inspection described on Page 3 and Page 4.

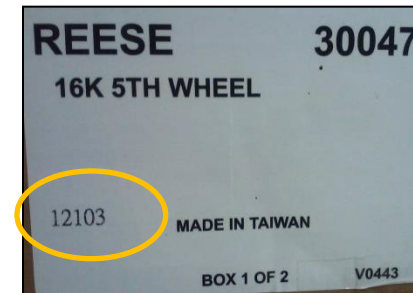
Date Code: YR/DDD
Example: 12103 = April 13, 2012

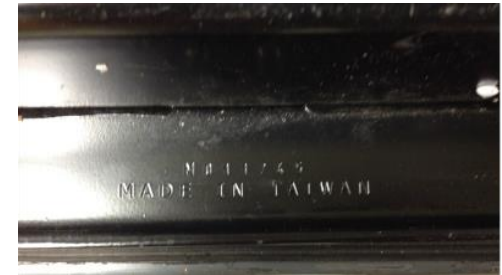
A. Units with MFG build date 2012 thru 2014 are suspect if they have:

- MFG Date Codes between M011201 – M011431
(Example 1201 is first week of Jan 2012)

- The C-clip design shown here

- A. Remove the 5th Wheel Hitch – Head
- B. Lay on workbench upside down
- C. Inspect C-Clip to see if it is installed correctly at the handle to linkage joint (see page 4). *If installed correctly: the C-Clip will be at the prescribed location and will rotate by hand or screw driver force.*
- D. If the C-Clip is missing or not installed correctly, contact Reese for service kit 58526. Disconnect handle as identified below and install replacement C-Clip. **Warning: do not use or sell prior to replacing C-Clip!**
- E. Service Kit: C-Clips will have colored paint dot on clips.

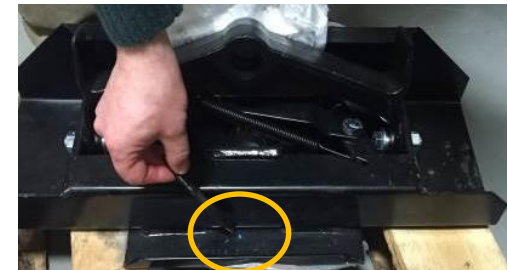
B. Units with MFG Date codes M011200 – M011431 are **OK** if they have either:

- A green dot or blue paint mark on the head assembly

- The updated C-clip design

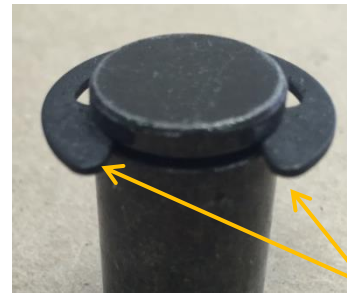
C-Clip Wings

A. C-Clip wings are in the groove

B. C-Clip base is in the groove

C-Clip Base

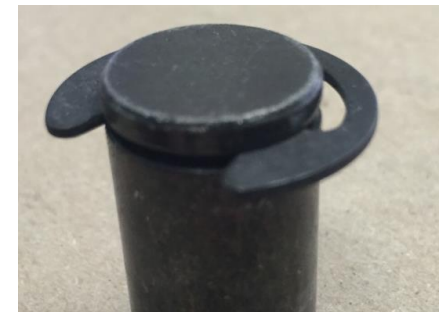
C. Secondary verification:

Confirm that C-Clip rotates by hand or screw driver force.
