2014-CURRENT RAM 2500 (REQUIRES 58522 BRACKET KIT)

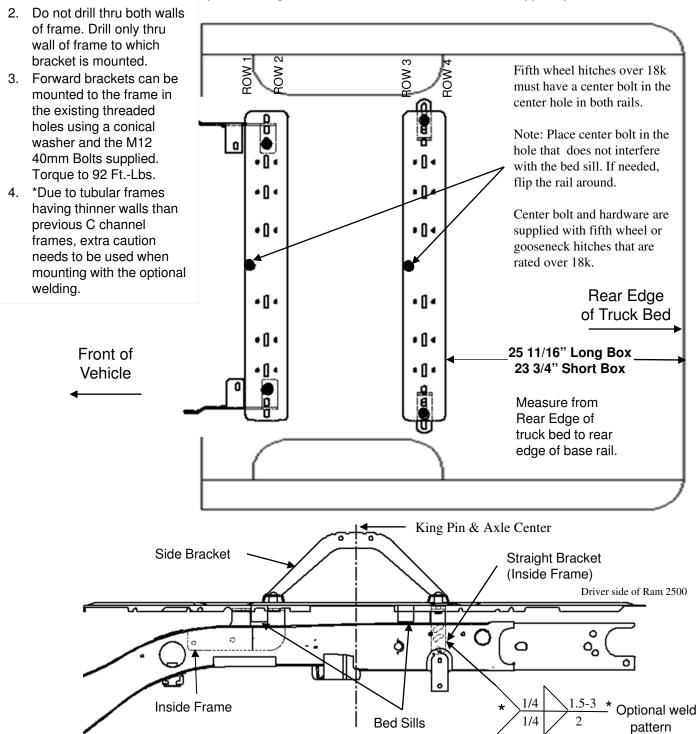
IMPORTANT NOTES FOR THIS INSTALLATION:

1. Rib neck bolts will need to be pulled through rearward access holes in frame with supplied pull wire.
