Axle-Back, 2005-2009 Mustang GT / 2007-2009 GT 500

INSTALLATION INSTRUCTIONS - #M31012/M31013/M31014

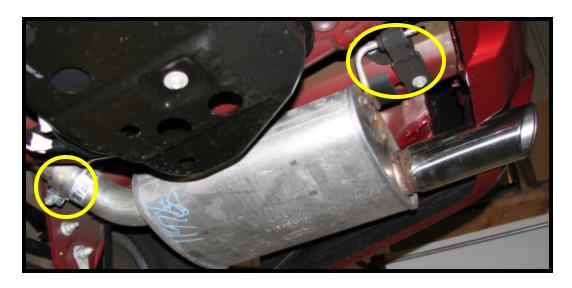
Photo 1: Passengers Side Factory Axle Back Muffler

1. Remove your stock "Axle-Back" system by removing the bolts that hold the rubber isolator brackets (two per side) to the chassis and then unbolting the Torca clamp on the over axle pipe.

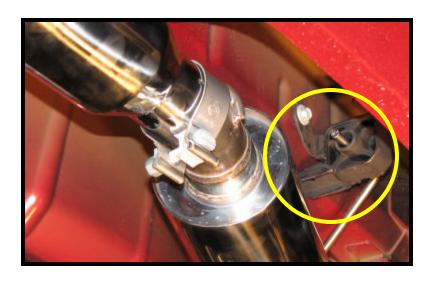
Photo 4: Passengers Side Front Isolator Bracket

3. Make sure that you install the hanger brackets back onto the vehicle the same way they came off. They can be installed incorrectly which results in poor and incorrect tip to rear valunce alignment. Please see the four photos below for clarification.

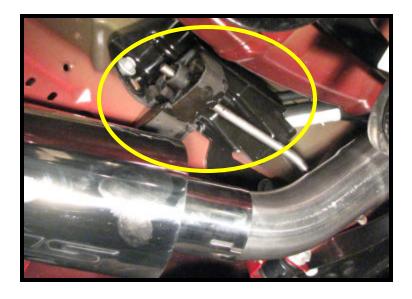
Photo 6: Drivers Side Front Isolator Bracket
