# CU2311 IMPROVEMENTS

# CU2311

## VALIDATION PROCESS

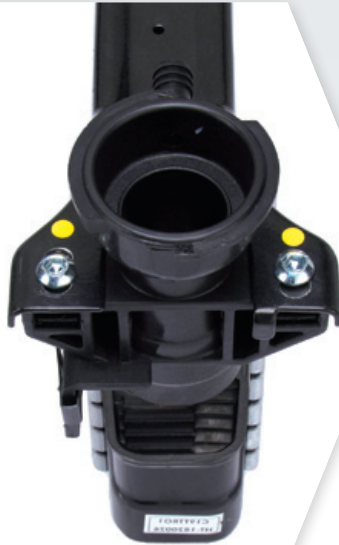
When the radiator reaches its maximum operating temperature the core expands, and when it cools down, it retracts. It is that very action that will cause the radiator tube to either tear or crack with time, causing leaks. These shoulder screws allow the aluminum core to expand and retract freely, causing less constraint on the radiator tubes.

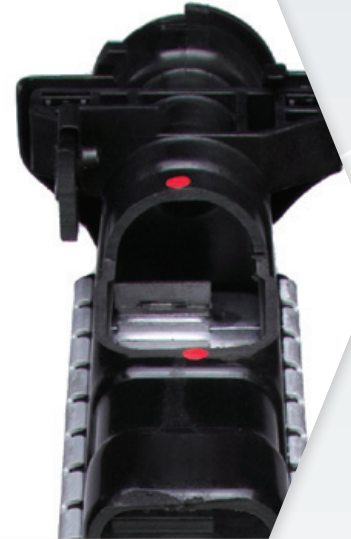
Tube inserts have been added to increase the strength of corner tubes therefore preventing tube tearing.

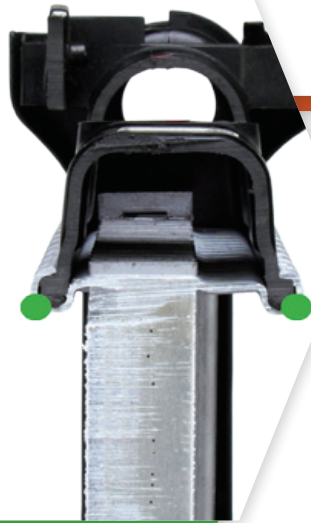
Oval-shaped gaskets have been implemented to optimize the sealing surface when gasket is compressed. Redesigned header groove and deeper tank lip cavity provides a stronger crimp and reduces tank flexing.

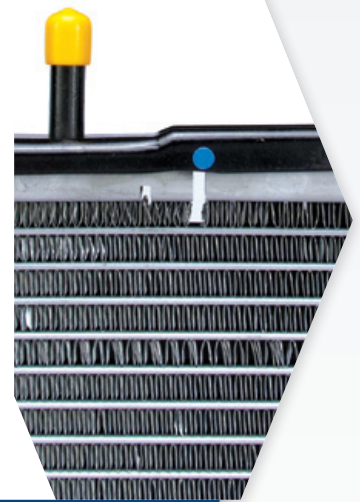
Thermal expansion affects the entire radiator core. However, not all components of this core expand and retract at the same speed or the same degree. For example, the side rails contain no coolant therefore are not as hot as the radiator tube itself. As a result of this, the radiator tube needs to expand a lot more than the side rail itself. Stress cuts were added to remove all stress on the radiator tubes.

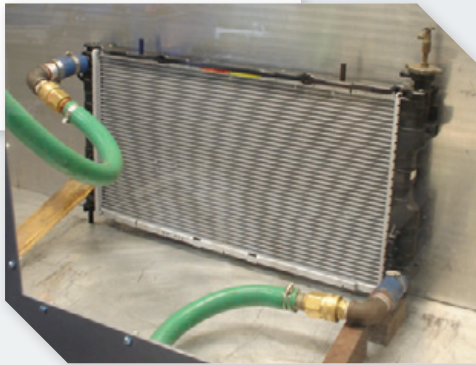
THERMAL  
CYCLE  
TESTER

- Hot coolant pressurized in radiator at 20 PSI FOR 1 min. AT 90°C
- Cooler coolant is pressurized in radiator at 20 psi for 1 min. AT 10°C
- This CYCLE is repeated 20,000 times

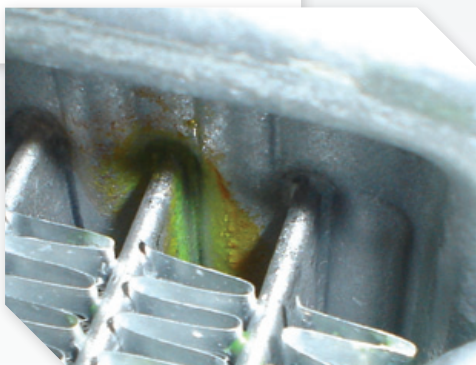
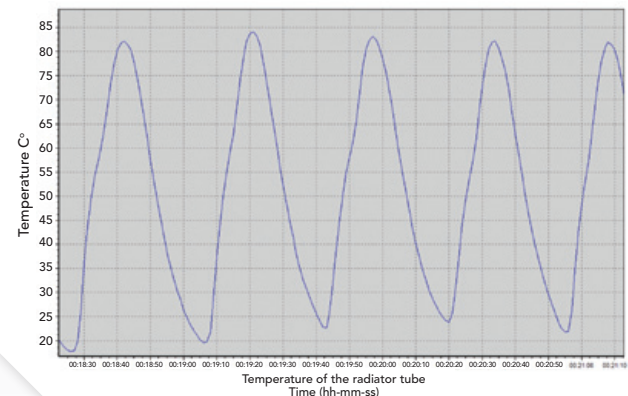
THERMAL  
TEST  
RESULT

Below is a graph showing the coolant temperature variations on the radiator tube that were monitored at the constant speed of 100 Km / hour. The graph shows that the thermostat was opening and closing continuously every 35 seconds. A properly calibrated thermostat will remain opened during normal engine operation. This continuous cycle of opening and closing from the thermostat is causing sudden temperature drops of 60 degrees or more which leads to severe thermal shock to the radiator. No radiator can withstand such thermal shock without premature failures and will lead to tube to header leaks as shown in the thermal test results.

- Spectra 20,093\* cycles
- OEM failed at 12,616 cycles

\*Testing was stopped at 20,093 without any failures
