# Rear Bumpsteer Adjustable Toe Arms Kit

## Installation Instructions

### SPL RTA 996

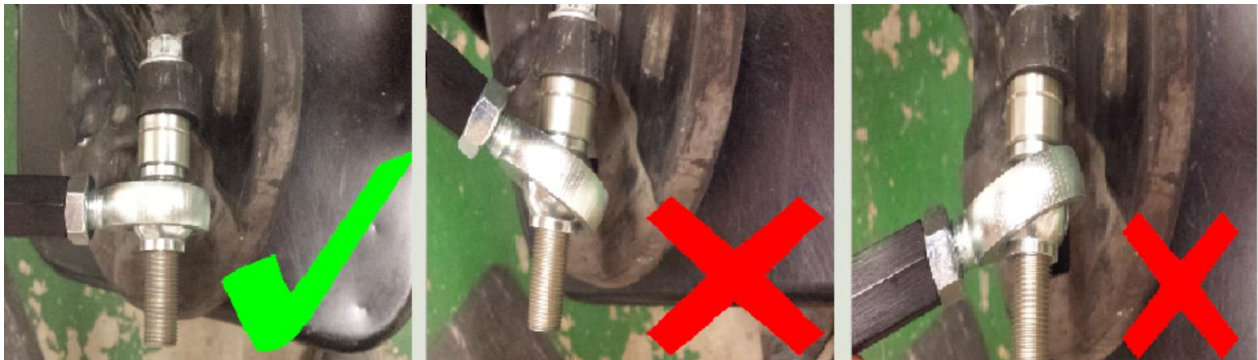
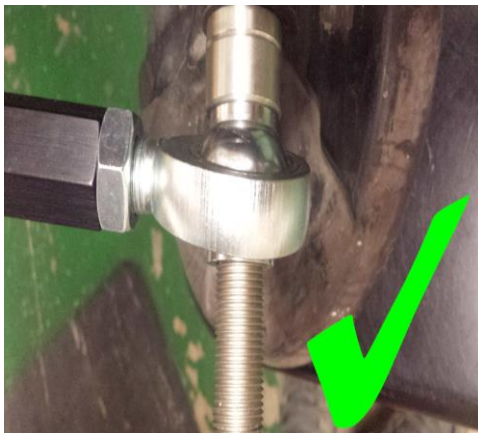
Check for binding or any problems by rotating steering wheel lock to lock. Check that the spherical bearing does not bind (the edge of the ball bearing hitting or close to hitting the housing) under any situation as shown in the pictures below. After installing, run the suspension and the steering rack from lock to lock through its travel to make sure there is no contact between the arms.

Note that the FK Rod End can rotate freely, so the picture on left is not binding even though the edge of the ball is touching the housing.

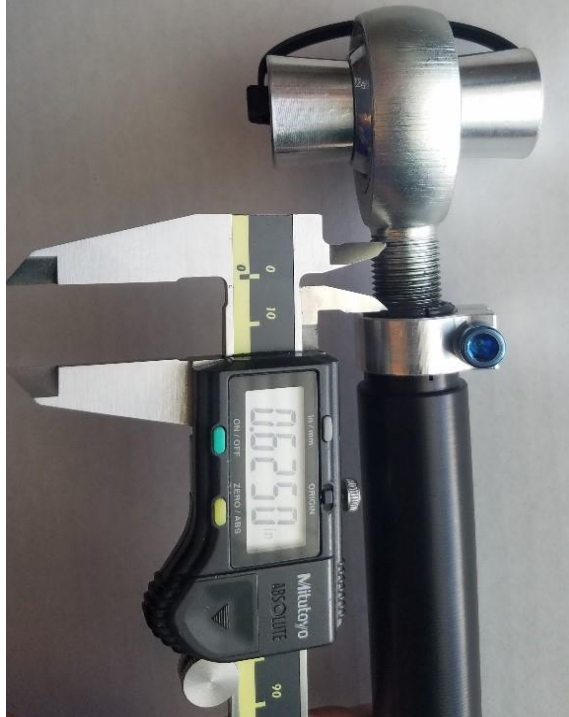
Loosen the Aluminum Clamps (6) on both ends of the Turnbuckle. Turn the Turnbuckle so as to thread in/out the FK Rod End (spherical bearing side). Threading in/out the FK Rod End will in turn thread out/in the Turnbuckle on the chassis side.

Once the FK Rod End is long/short enough, tighten down the Aluminum Clamps. Note that for safe thread engagement, the **maximum** amount of exposed thread on the Rod End should not exceed the measurement as pictured on the left.
