Steeda X5 Ball Joint Installation Instructions 555-8108

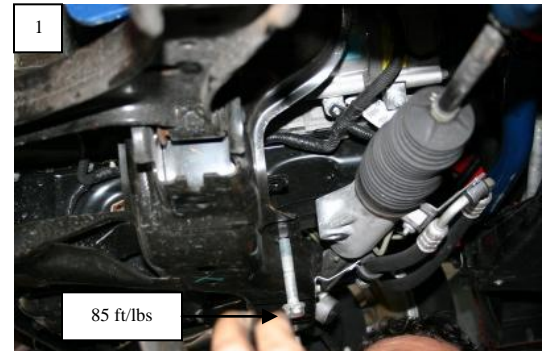
1. Raise the entire vehicle. If working from the floor, secure with jack stands. Remove the two front wheels.
2. Remove the two bolts holding the steering rack to the K-member. This will allow you to move the steering rack and gain access to the front control arm bushing. (Pic. 1)

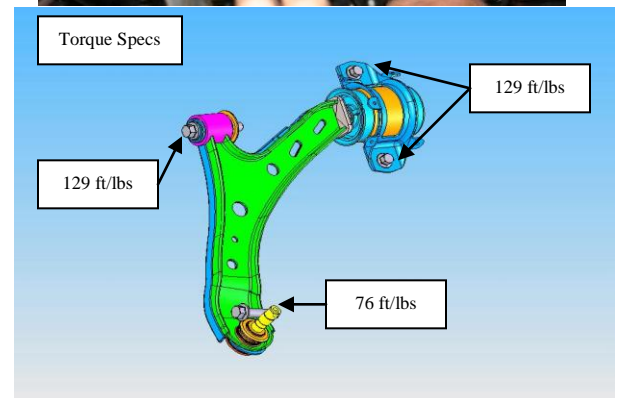
4. Once all bolts are removed, remove the front control arm. Note: It may be necessary to use a pry bar to release the ball joint stud from the clamp. (Pic. 2)

3. Remove one front control arm at a time. Each control arm is secured at three points. First, remove the two bolts at the rear of the control arm holding the hydra bushing. Next, remove the nut and bolt securing the front control arm bushing. Last remove the nut and bolt clamping the ball joint stud.
