Tech Bulletin

Top 5 Noise Symptoms Associated With A Worn CV Shaft

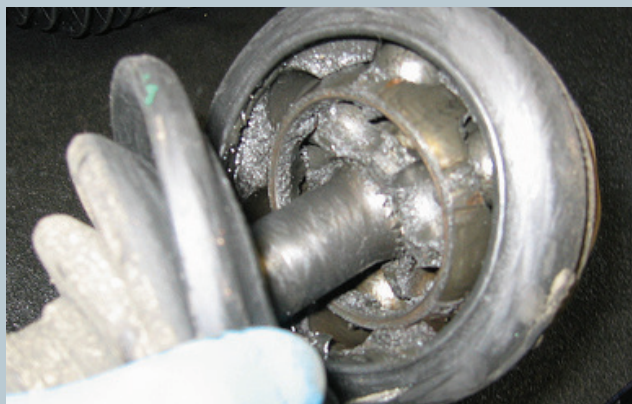
- 1. Popping or clicking noises when turning.** This indicates a worn or damaged outer CV joint. To verify this condition, place the vehicle in reverse, crank the steering wheel to one side and drive the vehicle backward in a circle (check the rearview mirror first!). If the noise gets louder, it confirms the diagnosis and the need for a new replacement CV shaft assembly.

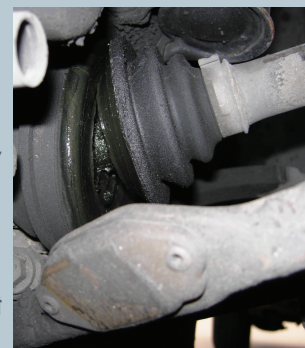
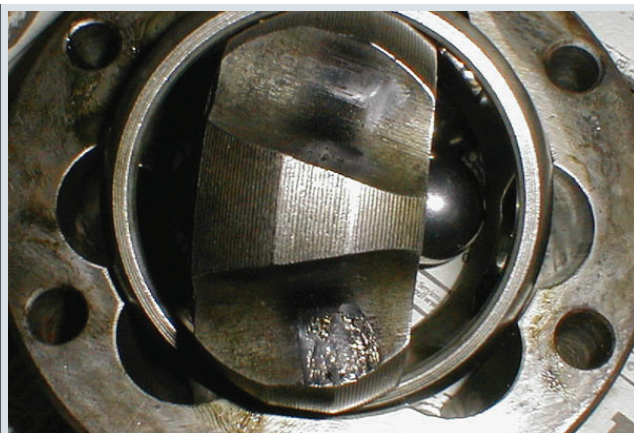
- 3. A humming or growling noise.** This can be due to inadequate lubrication in either the inner or outer CV joint caused by a damaged or split boot. However, this symptom is more often due to worn or damaged wheel bearings, a bad intermediate shaft bearing on equal length halfshaft transaxles, or worn shaft bearings within the transaxle.

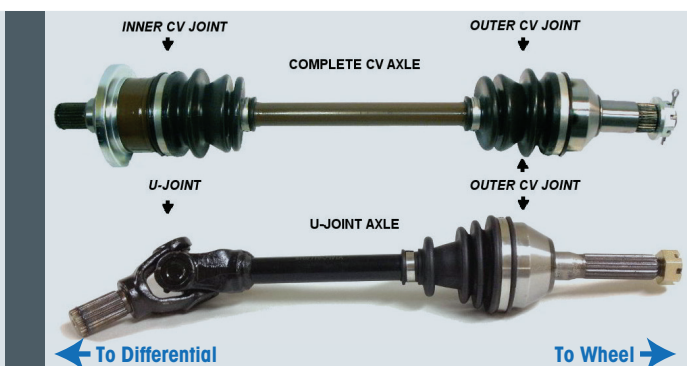
- 4. A shudder or vibration when accelerating.** This may be caused by play in the inboard or outboard joints, but the most likely cause is a worn inboard plunge joint. Similar vibrations can also be caused by a bad intermediate shaft bearing on transaxles with equal length halfshafts, or by bad motor mounts on FWD vehicles with transverse-mounted engines.
