5" Oval Bent End Nerf Bar

Part No. A7078S/B

Fits: 2007 - Current Toyota Tundra Crew Max Cab

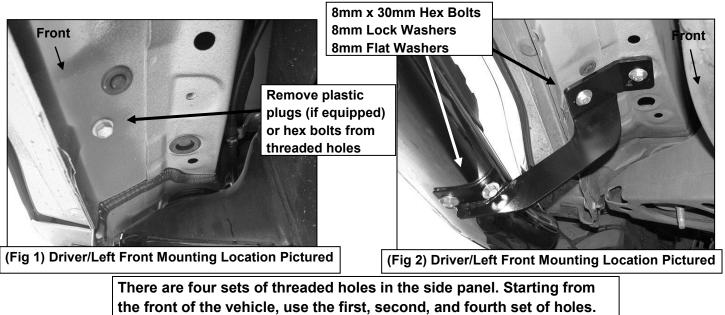
Starting on the driver side front of the vehicle, remove the existing (2) factory bolts, (or plastic plugs), on the side panel located by the front tire opening, (Figure 1). Bolt the front Mounting Bracket to the vehicle using the included (2) 8mm x 30mm Hex Bolts, (2) 8mm Lock Washers and (2) 8mm Flat Washers, (Figure 2). Do not tighten hardware at this time.

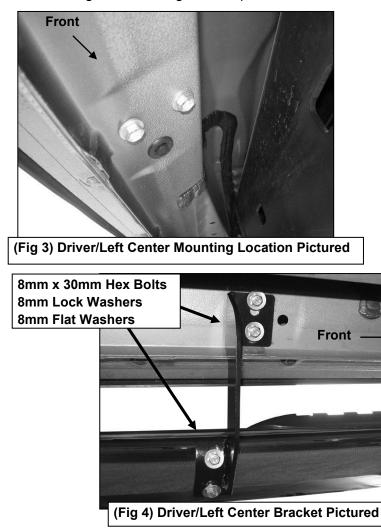
2. Repeat Step 2 to install the Center Bracket, (Figures 3 & 4), and Rear Bracket, (Figure 5). NOTE: The Center Bracket bolts to the mounting location closest to the front Bracket. The Rear Bracket bolts to the very last mounting location along the side panel toward the back of the cab. Do not tighten hardware at this time.

- Carefully place the Driver/Left Sidebar onto the (3) Brackets. Align the threaded holes in the bottom of the Sidebar with the holes on the Mounting Brackets. Attach the Sidebar to the Mounting Brackets with the included (6) 8mm x 30mm Hex Bolts, (6) 8mm Lock Washers and (6) 8mm Flat Washers, (Figures 2, 4 & 5). Do not tighten hardware at this time.
- 4. Level and adjust the Sidebar properly and tighten all hardware.
- 5. Repeat Steps 2 5 for passenger Sidebar installation.

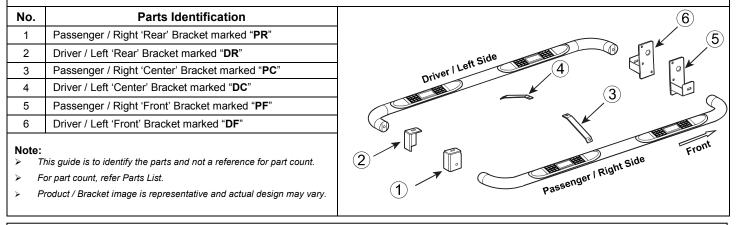
PARTS IDENTIFICATION GUIDE

Driver Side tube packed using "Green" color foam sheet. Passenger Side tube packed using "White" color foam sheet

In some cases Illustration images shown in Installation manual may not be the exactly same as per actual vehicle images ,also if Driver / Passenger side mounting brackets are very identical in the design, suggest referring Parts Identification guide to avoid fitment issue.

Side bar may be interchanged or mounting brackets are not installed at the correct position in the vehicle. Refer Parts identification guide.
