TrailFX Drop Down Step Part No. DHS005B / DHS006B

Fits: 2019 Chevrolet/GMC - Silverado/Sierra 1500 Crew Cab / **Double Cab**

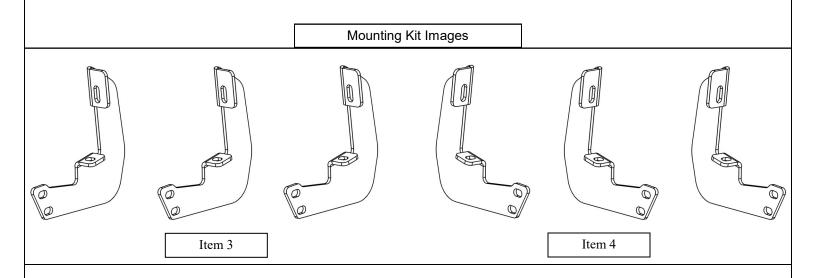
PARTS LIST:			
Item	Qty	Part Description	Tools Needed
1	1	Step Bar Driver Side	13 MM SOCKET & WRENCH
2	1	Step Bar Passenger Side	14 MM SOCKET & WRENCH
3	3	Mounting Bracket Driver Side	15 MM SOCKET & WRENCH
4	3	Mounting Bracket Passenger Side	RATCHET
5	12	M8 Bolt	TORQUE WRENCH
6	12	M8 Lock Washer	
7	12	M8 Flat Washer	
8	12	M10 Flange Bolt	
9	12	M10 Flange Nut

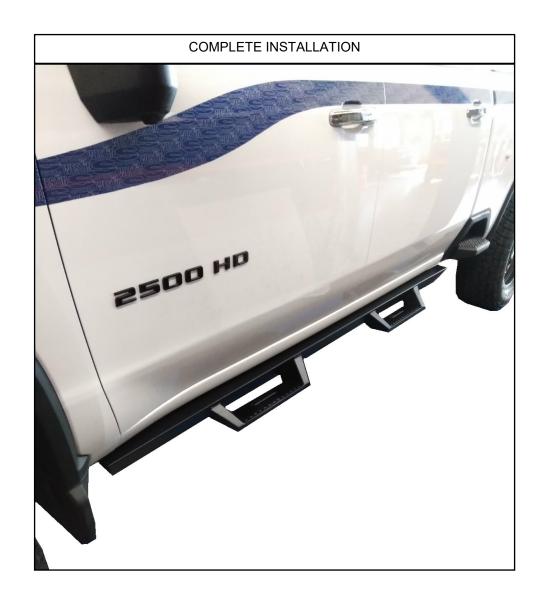
- 4. Grab Driver Side Bar and install to mount brackets with (6) M10 Flange bolts and (6) Serrated Flange Nuts. Assemble loosely to be able to adjust step bar as needed. See **Figure 2**. See **Figure 3** for reference.
- 5. Repeat for passenger side.
- 6. Align and adjust the step bar as desired. Tighten all hardware and torque all M8 fasteners to 15 ft.-lbs. and all M10 fasteners to 30 ft.-lbs.
