Replacement Bumper

Part No. FX1003

Fits: 2003 - 2007

Chevrolet / GMC HD

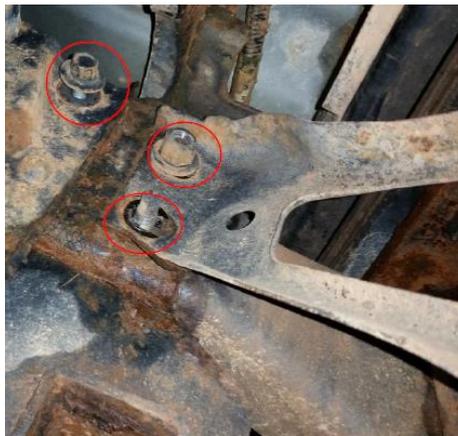
Figure 1A

1. Remove license plate and OEM license plate lights. Disconnect trailer receptacle. If equipped unplug back-up sensor harness.
2. Remove the two fasteners connecting the hitch to the stock bumper located on either side of the receiver with an 18mm socket.
3. Remove the fasteners connecting the bumper mounts to the frame. This requires removing one bolt from the bottom of the frame (22mm) and three bolts from the side of the frame (18mm and 15mm). Save hardware for reuse.
4. Remove OEM bumper by pulling it rearward away from the truck.
5. Remove OEM spare tire access cover and trailer plug from the OEM bumper. Set aside for reinstallation.

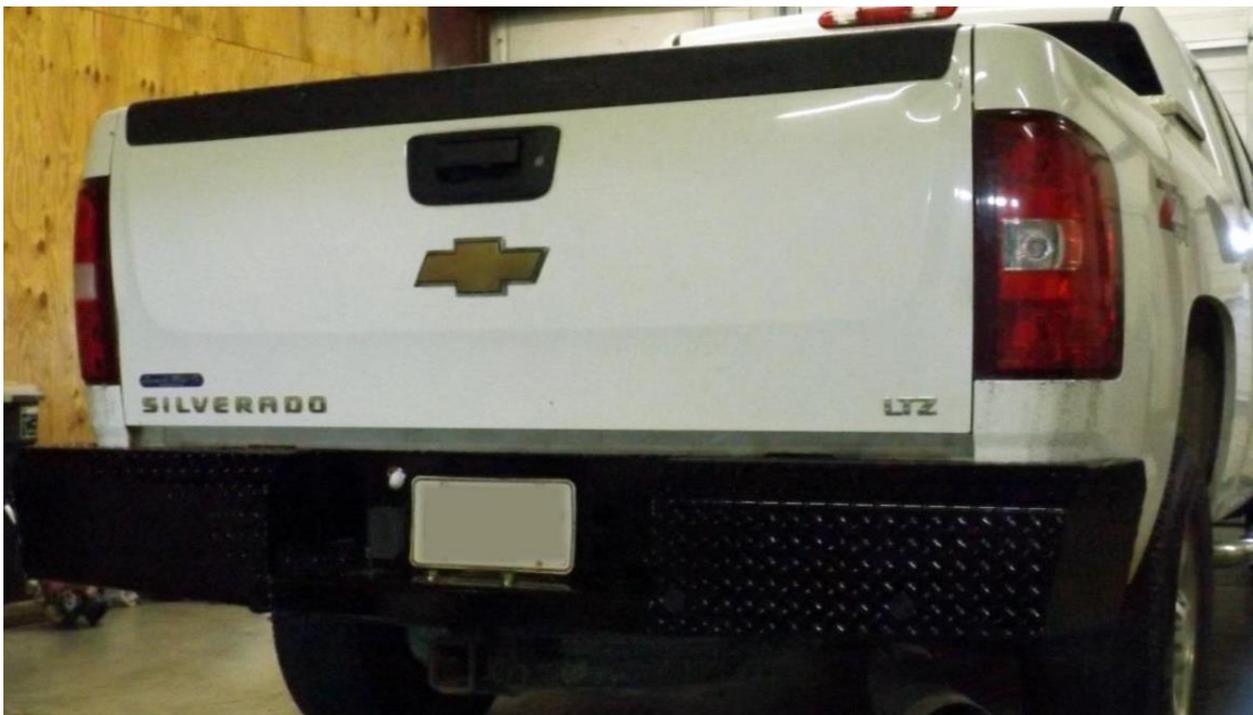
1. Replace OEM bumper with the Trail FX rear bumper assembly. Use the OEM 14mm screws with 14mm nuts provided in the T2150-HW kit to fasten the bumper to the frame rail in the OEM mounting locations. Do not fully tighten.

2. Use the provided spacers to offset the bottom of the bumper from the hitch mounting flange. Fasten with the provided 9/16" screws, washers, lock washers, and nuts. Do not fully tighten.

3. Level and align the bumper in relation to the truck bed. Fully tighten all fasteners.
4. Reinstall OEM 14mm screws connecting the hitch to the bottom of the frame with the remaining 14mm nuts and washers in the T2150 fasteners kit.
