Product Name: Kompact Mazda/Subaru PB BOV
 Product Description: Model-Specific Kompact BOV
 Product Number: TS-0203-1209

Suitable for: Mazda MPS (Mazdaspeed) 3, 6, CX7
 Subaru Legacy/Liberty GT, WRX MY08 (not STi) – Current, Forester XT MY08 - Current

HOW TO INSTALL YOUR BOV

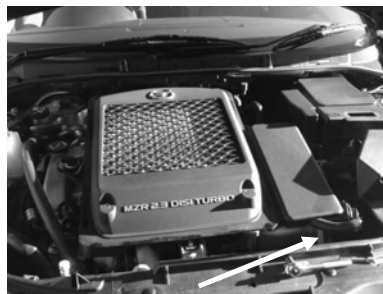
- 1) Remove the engine cover by removing the two securing screws/plugs.

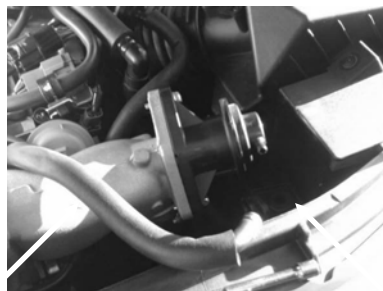
- 2) Locate the standard BOV. Remove the vacuum/pressure source from the standard BOV.

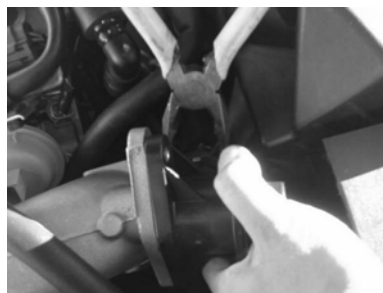
- 3) Remove the bolts securing the standard BOV and then remove the plumb back hose by removing the spring clamp.

- 4) Push the plumb back hose onto the plumb back fitting on the new BOV. Use the factory bolts to fit the new BOV onto the intercooler pipe. Remember to install the supplied gasket in between the BOV flange and the intercooler flange. Reinstall the vacuum/pressure source to the nipple. Refit the engine cover. Start the engine and check for leaks.

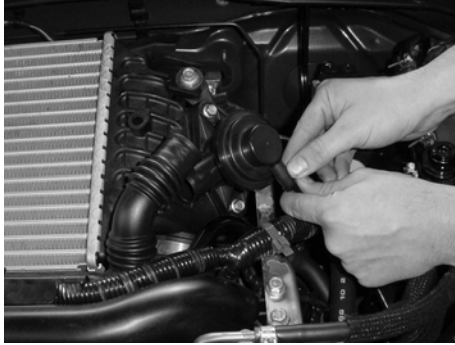
- 1) Locate the standard BOV and remove the vacuum/pressure source tube and the plumb back hose.

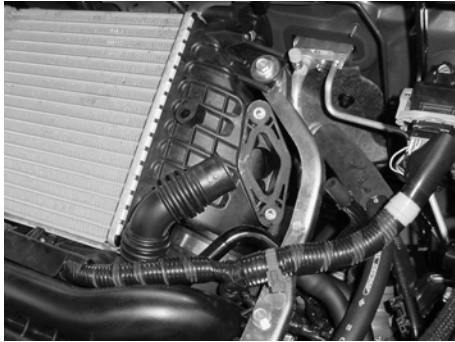
- 2) Remove the securing bolts and remove the standard BOV

- 3) Use the factory bolts to fit the new BOV onto the intercooler pipe. Remember to install the supplied gasket in between the BOV flange and the intercooler flange. Reinstall the vacuum/pressure source to the nipple and plumb back pipe to the plumb back fitting and clamp using the factory clamp. Start the engine and check for leaks.

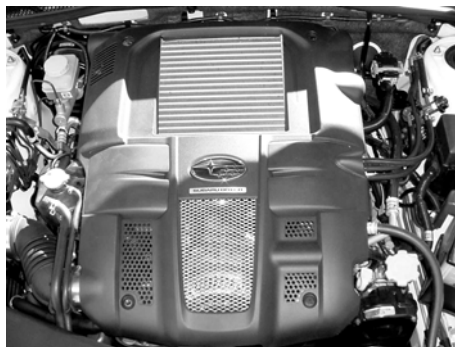
- 1) Remove engine cover by removing the 4 securing screws.

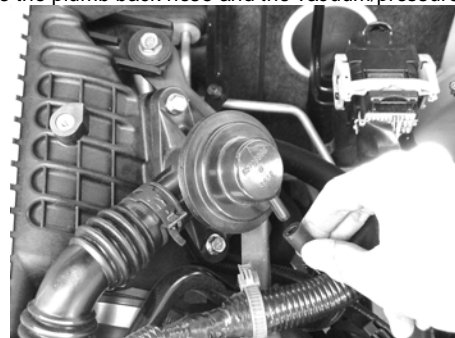
- 2) Locate standard BOV and remove the plumb back hose and the vacuum/pressure source line.

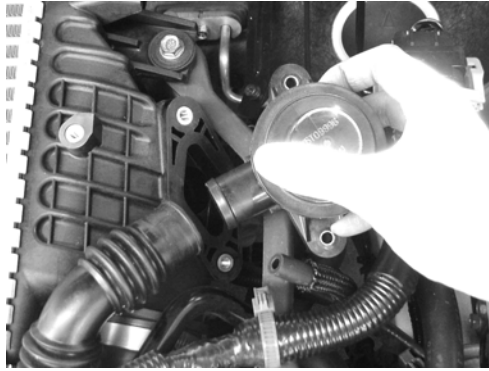
- 3) Remove standard BOV.

- 4) Use the factory bolts to fit the new BOV onto the intercooler pipe. Remember to install the supplied gasket in between the BOV flange and the intercooler flange. Reinstall the vacuum/pressure source to the nipple and the plumb back hose. Reinstall the engine cover. Start the engine and check for leaks.
