AIR DITCHER

AIR TO COIL CONVERSION KIT

94-96 Cadillac DeVille • 91-96 Cadillac El Dorado • 94-97 Cadillac Seville

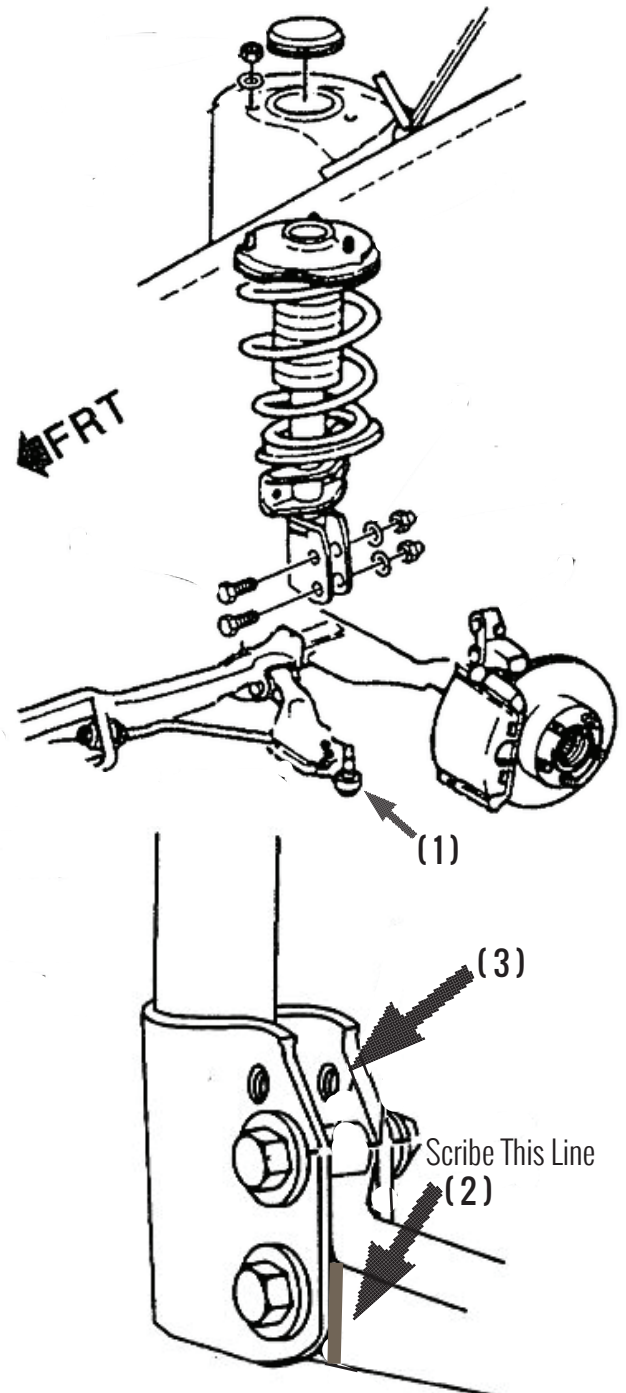
1. Remove nuts attaching top of strut assembly to body.
2. Raise vehicle and support frame with jackstands.
3. Remove Tire and wheel assembly.
4. Remove road sensing suspension position sensor from lower control arm. (1)

5. Scribe knuckle and strut. (2)

Using a grease pencil trace the left line of the strut mounting tab onto the steering knuckle. This line will be used to align the new strut in the same position as the old. Failure to install the new strut correctly will result in failure aligning the new strut.

6. Remove Brake line bracket from strut. (3)
7. Remove Stabilizer link from strut.
8. Remove Strut electrical connector.
9. Remove Strut-to-knuckle bolts and support knuckle with wire. (4)
10. Remove Strut.

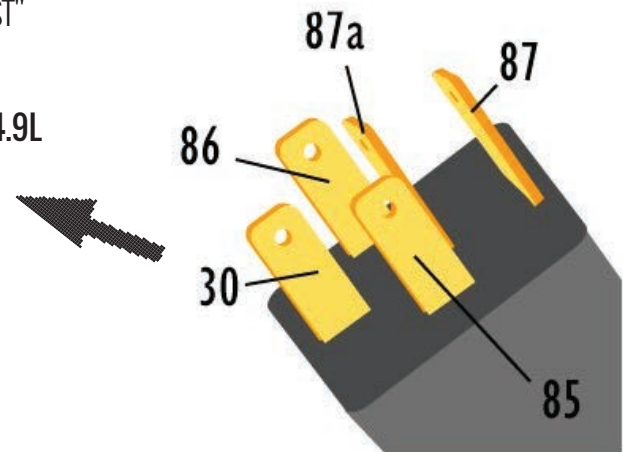
1993 Eldorado + Seville with Speed Sensitive Suspension and 4.9L Engine Only

Cut circuit 1020 (PINK).

Attach the IPC side of circuit 1020 to relay pin 87A.

Attach the module side of circuit 1020 to relay pin 86.

Run a ground wire to relay pin 30.

Run a wire from a switched ignition (hot in Run) source to relay pin 85.
