## Porsche Cayenne / VW Touareg Driveshaft Support Bearing Kit Installation Tips

The following is a guideline for installation of this kit and illustrates the basic steps. A trained technician following the factory workshop manual and repair procedures is necessary to properly complete this repair.

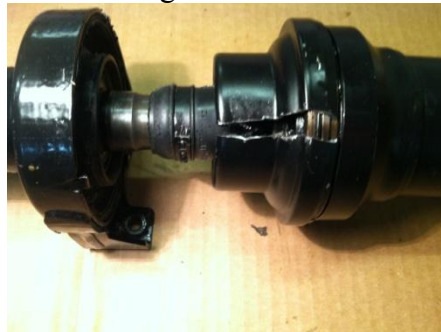
- With shaft securely located on a bench carefully cut the outer metal jacket and rubber CV boot located near the center support bearing. Remove the boot assembly and discard.

**Note:** Make sure to not to get metal shavings or debris into the CV joint assembly.

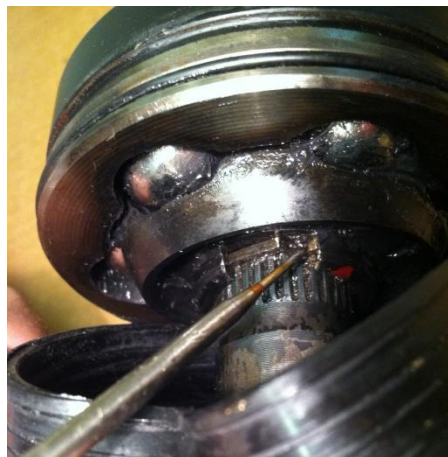
- A careful examination where the splined shaft enters the joint will reveal the retaining key way.

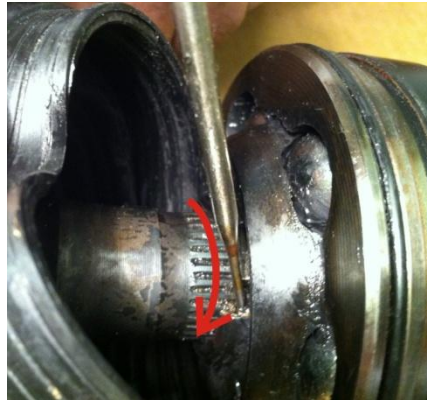
- Using a fine pointed punch or drift begin tapping the exposed end of the metal key radially.

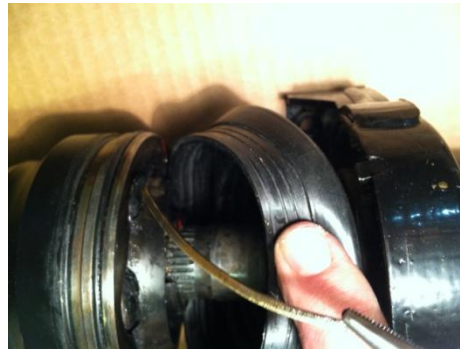
- Once a sufficient amount of the metal retainer key is exposed the remainder can be withdrawn with a pair of pliers.

**Note:** Removal of this retaining key is the only way the splined sections of the shaft can be separated to allow servicing of the support bearing.

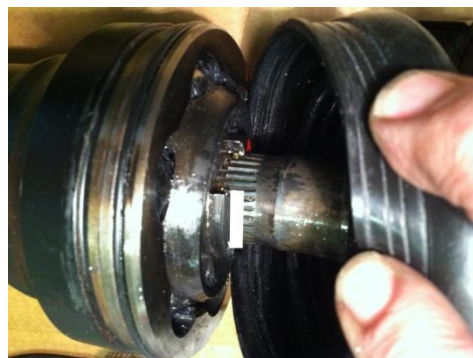
- Clean the exposed splines of grease and index with a paint mark the point where the shaft enters the inner CV joint race.

**Note:** This is critical to proper reassembly later.

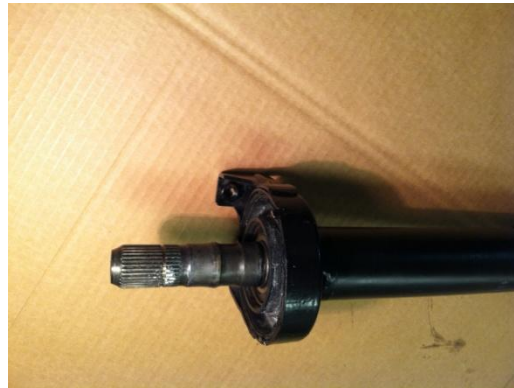
- Using a suitable press or puller separate the splined section of the shaft from the CV joint taking great care not to damage the CV joint.

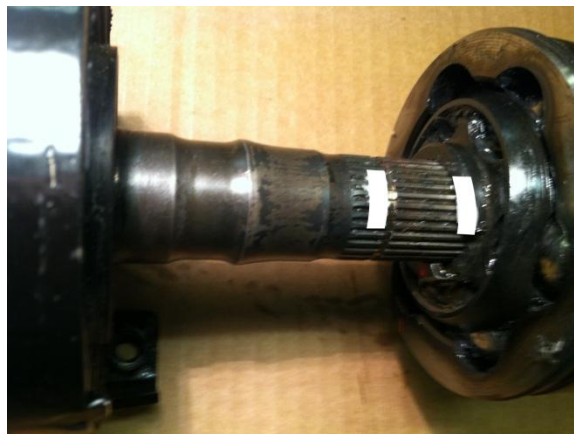
- Slip the newly supplied rubber CV boot onto the short splined shaft and fold forward toward the support bearing assembly to provide clearance for the next step.
- Offer up the short section of the shaft to the CV joint and carefully make sure the previously made paint markings are perfectly aligned.

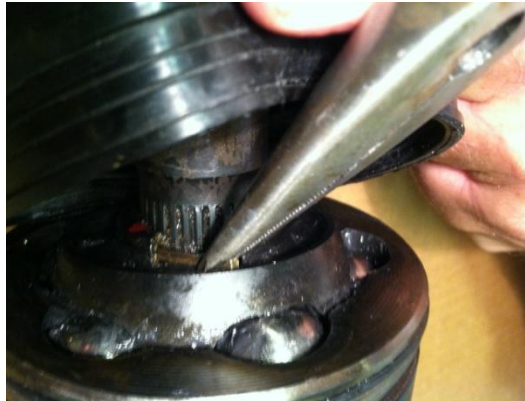
- Take new locking key provided and begin feeding it into the exposed slot working it in slowly and carefully with pair of pliers. Hold the key at the very base to avoid kinking the key as it is fed into the slot.

**Note:** Once the key is sufficiently located into the slot it may be possible to carefully tap the end of it with a suitable drift to push the remainder home.

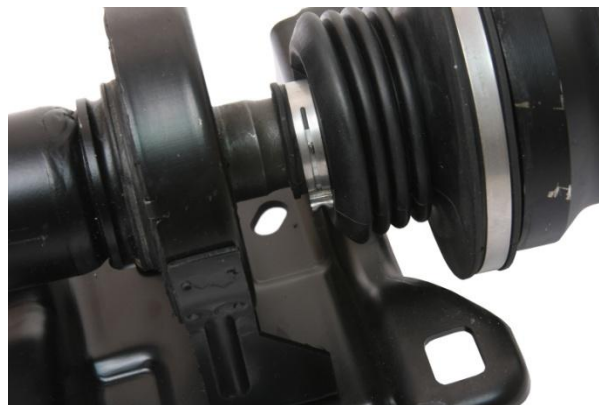
- If CV joint appears dry or has lost grease it is advisable to repack it with suitable CV grease before fitting the boot.
- Fit the large end of the new boot carefully to the outer CV race and secure both sides with the supplied clamps.

**NOTE:** Small end of boot should be slid rearward (toward joint) as far as possible before clamping into place.
