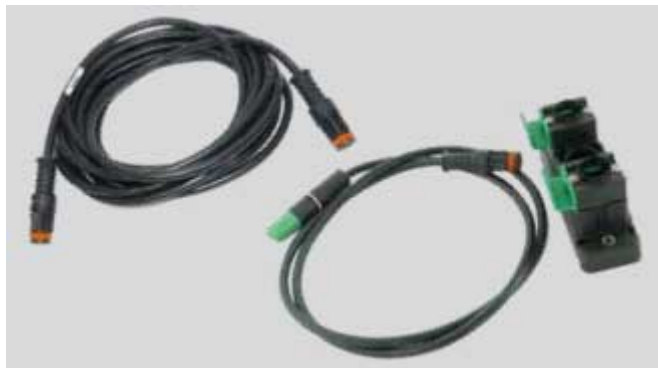
I need to replace an EB+ Gen2 with an EB+ Gen3 but I can't connect the Info Centre because the green plug is missing on the EB+ Gen3. What now?

EB+ Gen3 has two new DIAGN connectors for additional CAN

functions. A kit is available for connecting Info Centre 1 to EB+ Gen3 (part no. 950800913). To connect Info Centre 2, the diagnostic cable must be replaced (part no. 814037001).

A service bulletin with detailed information and part numbers is included in all EB+ Gen3 spare part kits.

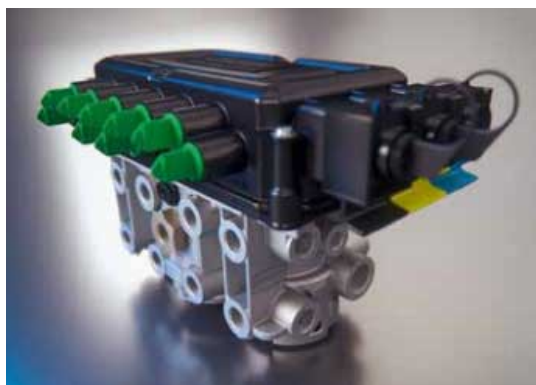
Can I use the EB+ AUX channel in order to guarantee sufficient power supply for the trailer tracking system?

The battery is usually powered via the lighting system, but especially during the summer when a truck may be driven for a long time without its lights on, this power supply can be insufficient. Thus, tracking systems can fail due to inadequate power. But if the battery is connected to the EB+ ECU, it receives a constant supply of power as long as the trailer and tractor are coupled.

supplying the trailer tracking system battery through the AUX connection in EB+ Gen3.
