THE PROBLEM SOLVER®

Corrosion freezes the camber bolt in place

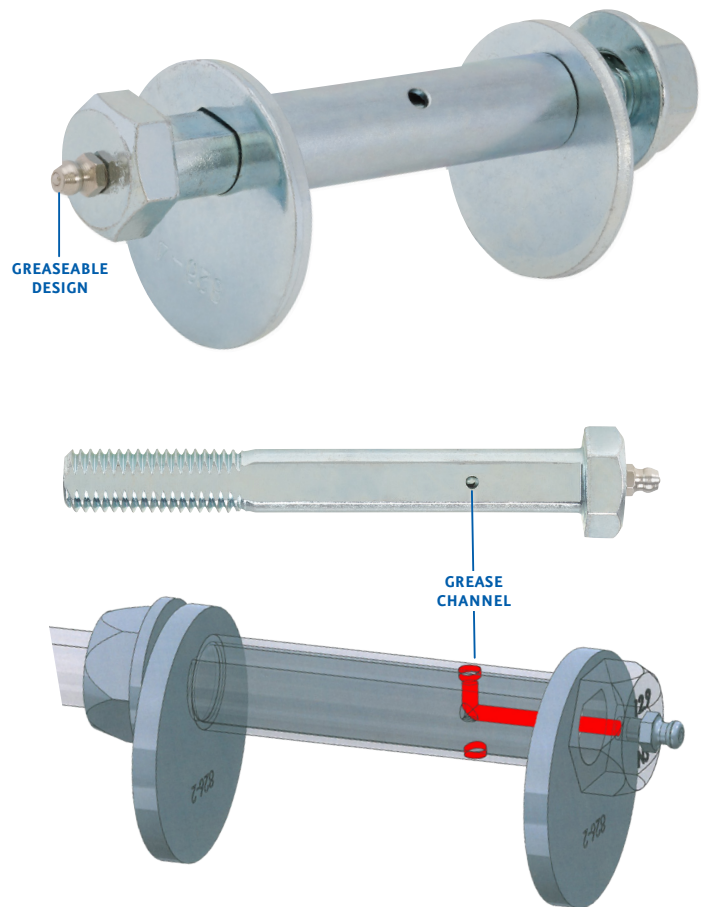
MOOG® Problem Solver® greaseable camber adjustment bolt

The MOOG® Problem Solver® camber adjustment bolt features a fully greaseable design that prevents corrosion. A grease fitting on one end of the bolt allows grease flow inside. An engineered grease channel in the bolt lets grease flow out and along the interior and exterior of the sleeve to keep the bolt and sleeve lubricated. With these features enabling regular maintenance, the MOOG camber adjustment bolt will remain adjustable even after many miles of service in harsh conditions.
