TERAFLEX

Technical Service Bulletin JK HD Ball Joint Kit 2013+ JK Stub Shaft Modification

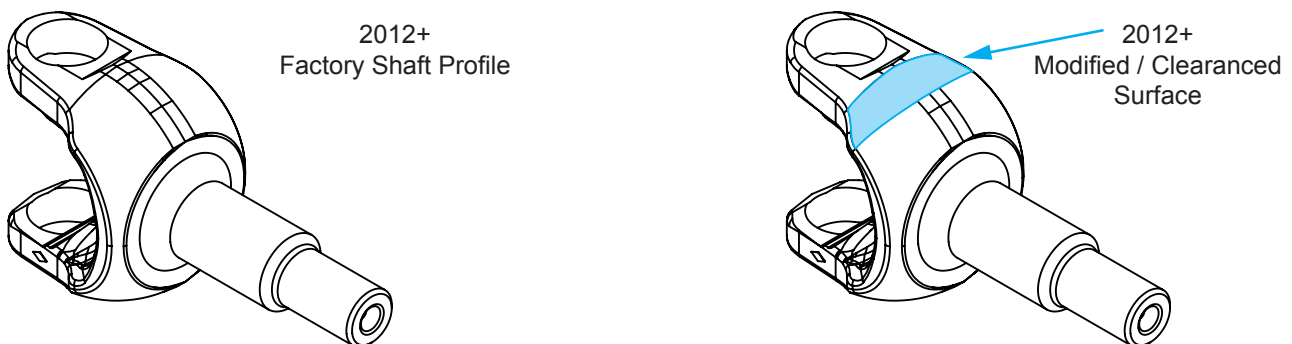
2012 and newer front Dana 30 & Dana 44 equipped JK Wranglers utilize a larger diameter outer stub shaft. This causes interference issues when used with TeraFlex HD Ball Joints (lower ball joint only).

Note: By avoiding any modification to the critical strength area, shown above, the outer stub shaft's performance and strength will not be affected by this slight modification.

A DIY solution to fix this issue involves minor clearing of a non-critical area of the outer stub shaft to allow proper lower ball joint clearance. As seen in the diagram above, removal of approximately 0.125" from each side of the outside diameter of the outer stub shaft shoulder is required.
