## PRODUCT UPDATE BULLETIN

15-0004

## PREVENT DAMAGE WHEN INSTALLING TRANSIT BULKHEADS

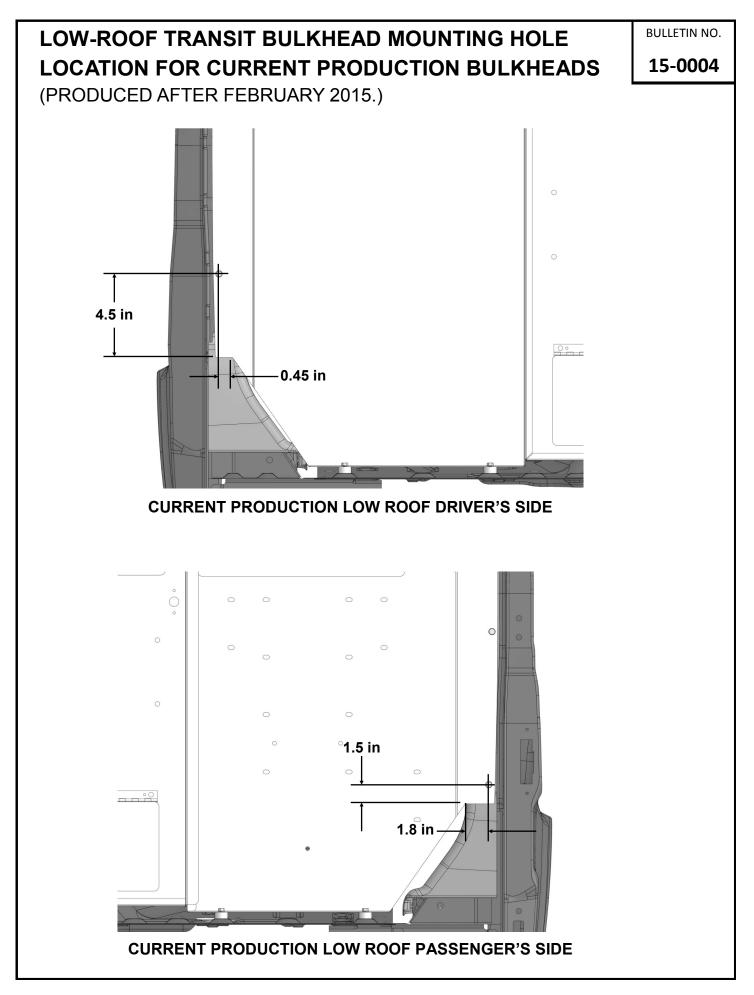
LOW ROOF PASSENGER'S SIDE

Ford Motor Company has stated that they will no longer cover damage to the seatbelt retractor body or the PIA sensor on the retractor if there is a hole through the B-pillar trim and into the mechanism.

Check the hole location of low-roof Transit bulkheads. If they are not the same as current production, drill new lower mounting holes as shown on page 2 of this bulletin.
