THE AUTOMOTIVE LIGHTING BENCHMARK

INSTALL GUIDE

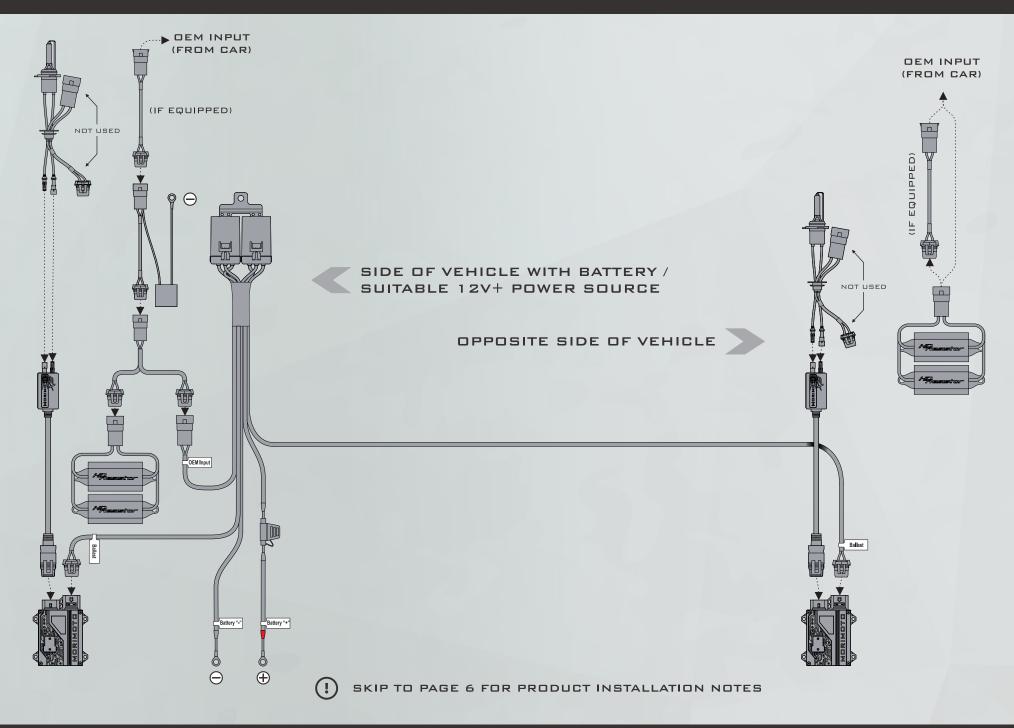
EXTERNALLY-WIRED HEADLIGHT DIAGRAM

The blue anodized HD Load Resistors are required to combat the finicky wiring on these vehicles. These resistors get hot enough to melt plastic, so be sure to mount them to metal and not a plastic inner fender liner, radiator shroud, etc.
