## AGA Door Lever Repair Kit

### 2008-2015 C-Class (W204 Chassis)

Part #: AGA-MB-DLK-204

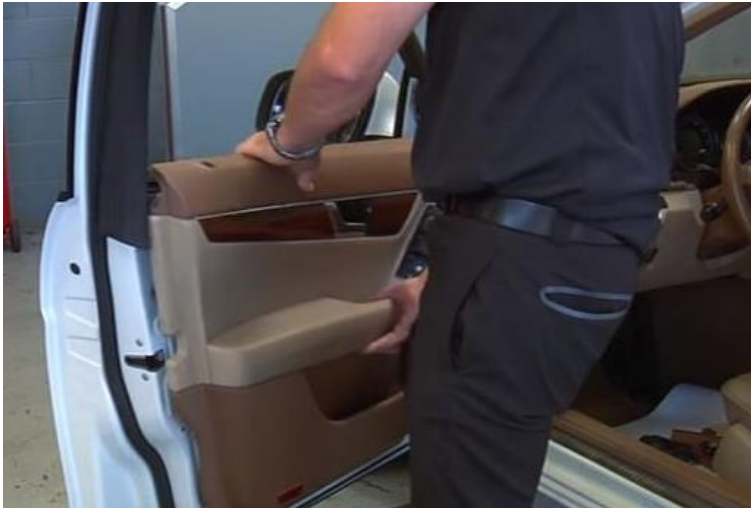
1: Remove door panel. This can vary from vehicle year and model. Refer to M/B manual, All Data, or a similar information source for details on the exact removal procedure. Be careful not to pull hard when removing the panel to avoid damaging any wire connections.

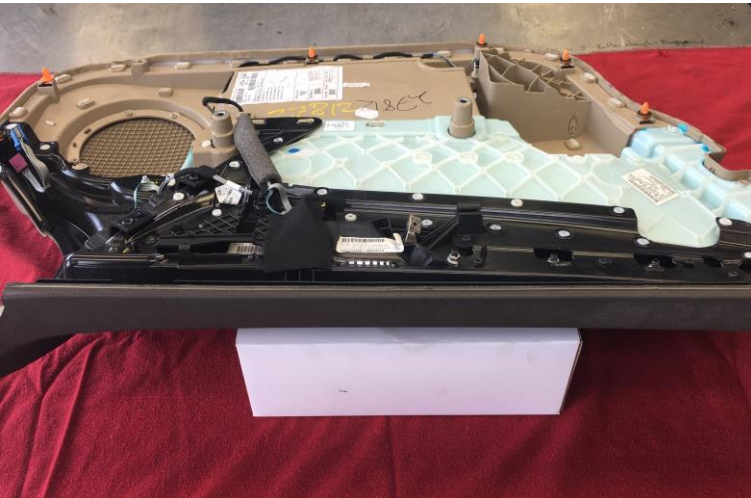
2: We recommend placing the removed door panel on a clean surface with the inside facing up and the top of the panel toward yourself. Place a clean support such as a box beneath the lever. This will ensure that the lever will be in a closed/retracted position while doing the repair.

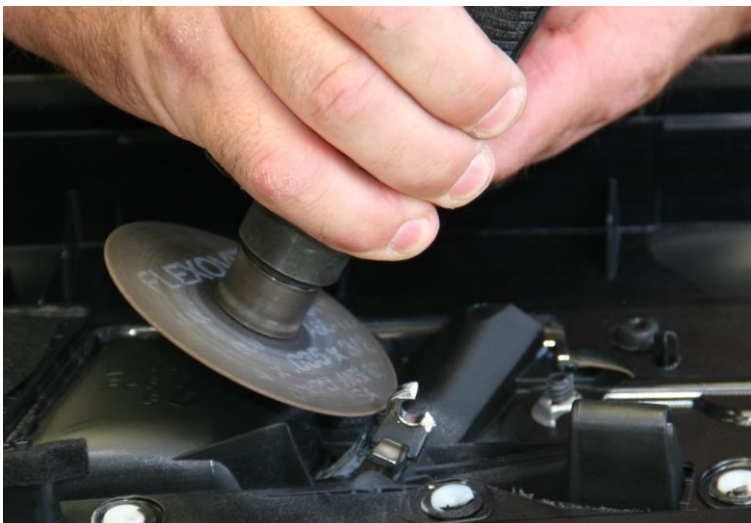
3: Cut off remaining broken tab with a cut-off wheel or similar device.

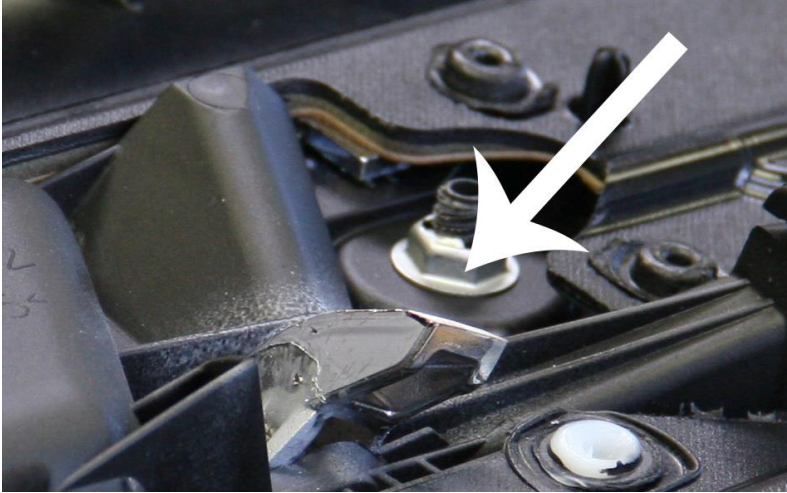
4: Grind or sand tab until it looks like this.

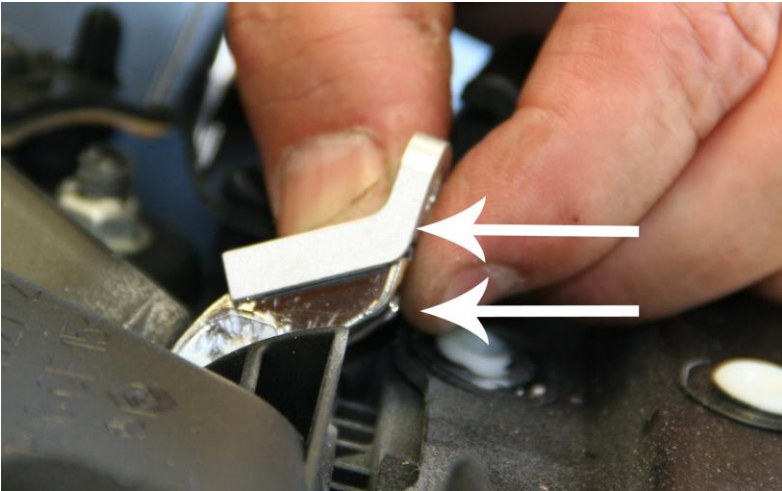
5: Place new aluminum bracket on lever. Make sure the bottom of the new aluminum bracket and the cut plastic lever is aligned. **(see arrows in picture)**

6: Use the aluminum bracket as shown in the previous picture as a drill guide. Drill a hole in the plastic lever using the supplied #28 drill.

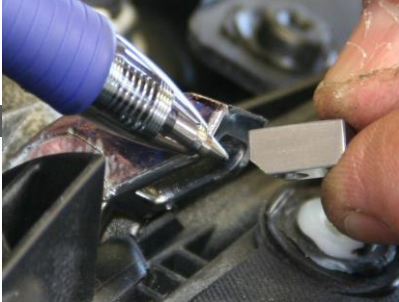
**Picture A**

7: As shown in Picture A, the hole must be installed toward the top of the door panel (closest to you) and the chamfered corner away from the lever. As show in Picture B, place the threaded block in the bottom groove of the plastic lever.

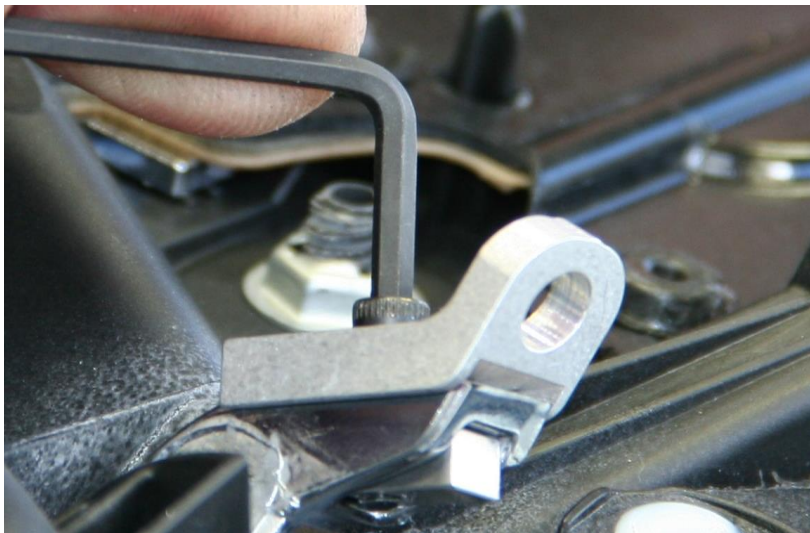
8: Install the aluminum bracket on top of the plastic lever. Install the supplied 8-32" socket cap head screw with the provided 7/64" Allen wrench and tighten bolt.

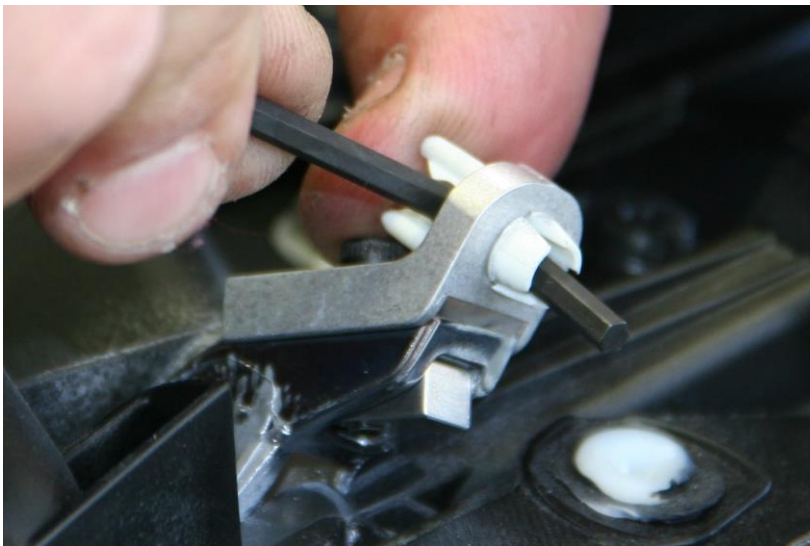
9: Install the new OEM Mercedes clip that is supplied. If needed us the 7/64" allen wrench for leverage as shown in picture. Then reinstall the door panel.
