| Part# | GR03LEA84S/K | Application | For 2015-2018 Chevy Silverado 2500 /3500 | | | | | |

Install Notes: Overlay Replacement Drill Cut

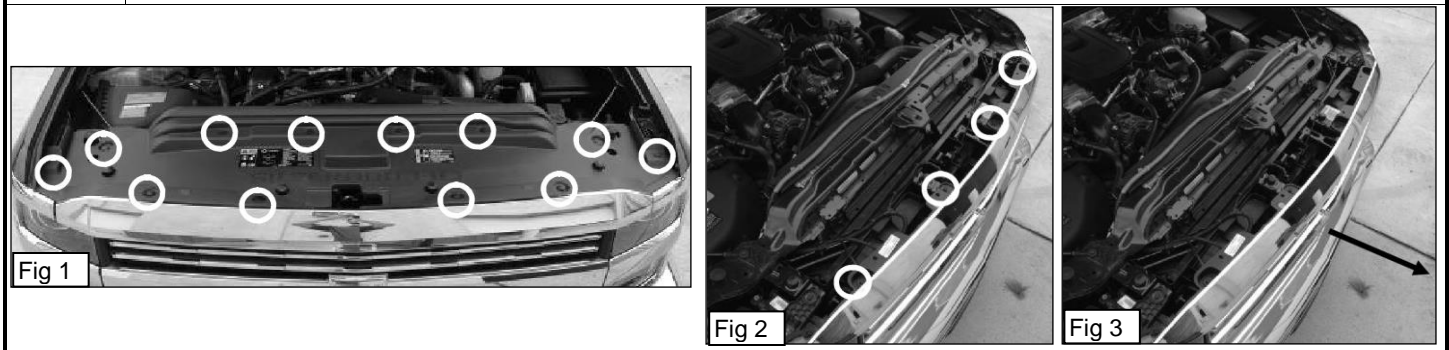
| Step | Description | Illustration |
|---|---|--|
| 2 | Pop hood, remove plastic cover by removing 12 retaining clips with flat head screw driver. (Fig 1) | |
| 3 | Once cover is removed, remove the top 4 grille screws with 10mm wrench. (Fig 2) | |
| 4 | Remove upper OEM grille by pulling grille forward away from the truck. (Fig 3). This will allow access to the rear of the lower grille shell. | |

| 5 | Position grille in lower grille shell and mark holes for drilling. Removed grille and drill (6) holes in locations marked. |
| 6 | Reinsert grille into lower grille shell and secure grille using (6) flat washers and (6) hex flange nuts from the back side of the lower grille shell. |
