# ATD-5217 *MADE IN MEXICO* FOR 120 LB. DRUMS

## OWNERS MANUAL

### AIR OPERATED CHASSIS PUMP

# PORTABLE LUBRIGUN 120 LB DRUM SIZE 50:1 RATIO PUMP

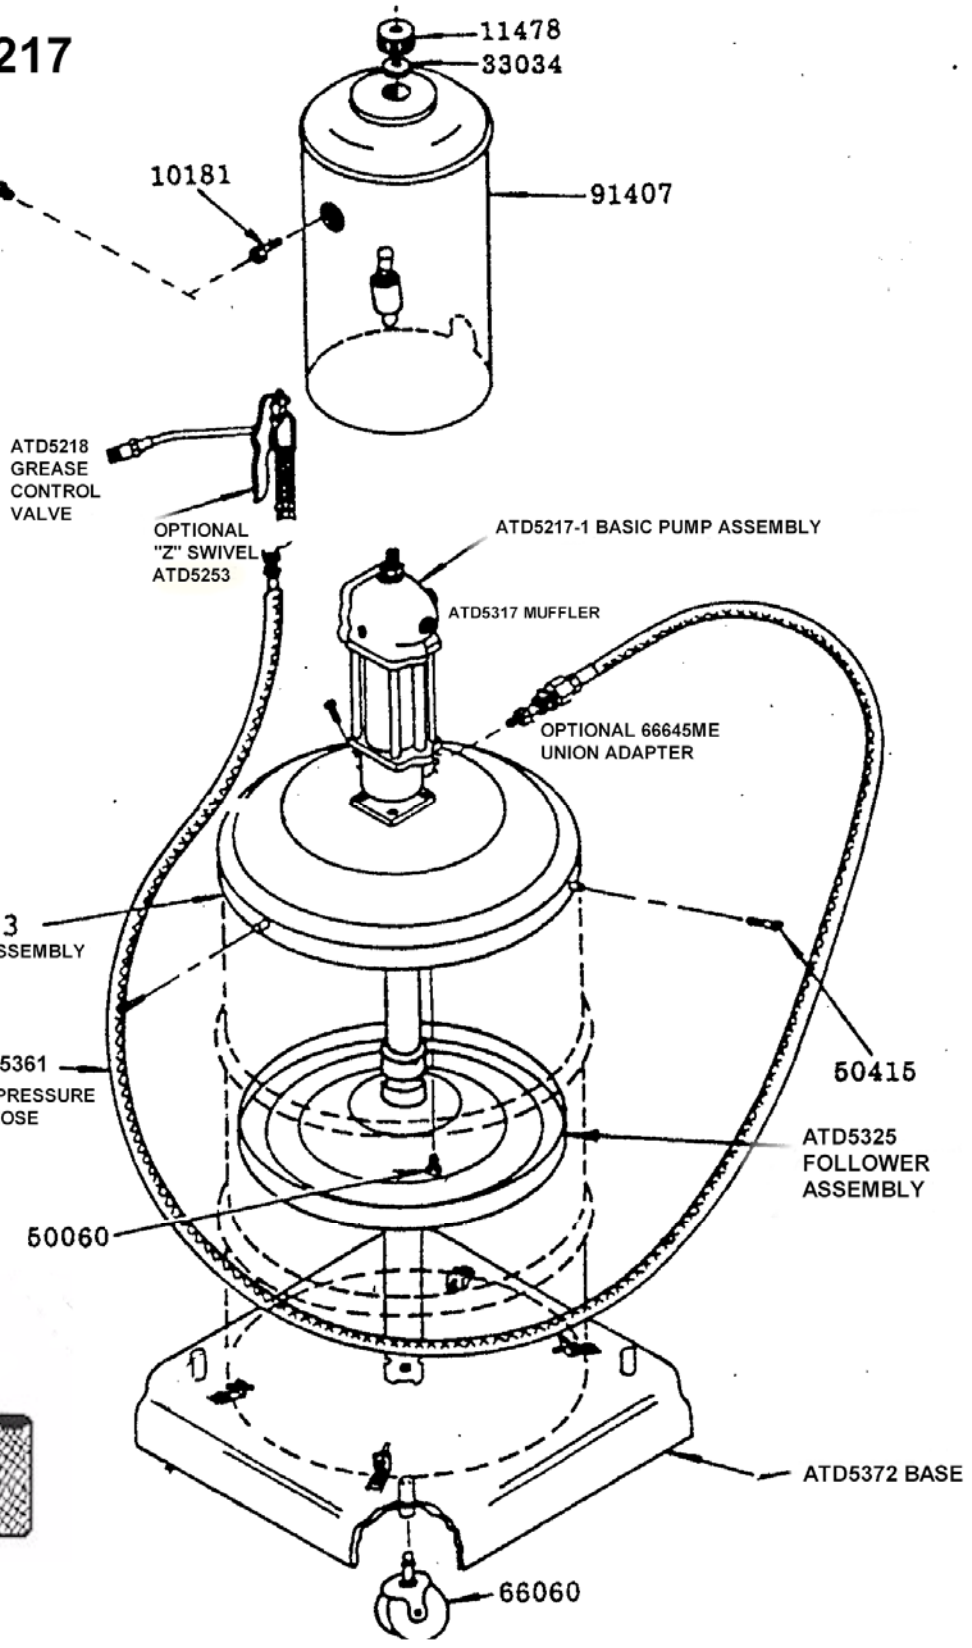
## MODEL ATD5217

ATD5218  
GREASE  
CONTROL  
VALVE

ATD5217-1 BASIC PUMP ASSEMBLY

45733  
DRUM COVER ASSEMBLY

ATD5361  
6FT HIGH PRESSURE  
GREASE HOSE

ATD5325  
FOLLOWER  
ASSEMBLY

ATD5372 BASE

| <b>Instruction for Assembly of ATD-5217 Lubrigun</b> | | |
|--|--|--|
| <b>Assemble Drum Cover to Pump</b> | Insert end of pump tube (ATD-5217-1) through hole in the drum cover (45733). Line up holes in drum cover (45733) with the pump outlet body (ATD-5217-1). Place the screws (50060) in their respective holes in the drum cover (45733) and tighten drum cover (45733) to the bottom of the pump body (ATD-5217-1) | |
| <b>Insert</b> follower plate (ATD-5325) onto the bottom of the pump tube (ATD-5217-1) and slide the follower plate (ATD-5325) up the pump tube. | | |
| <b>Lower</b> pump tube into lubricant until drum cover (45733) rests on top bead of drum. | | |
| <b>Insert</b> the three (3) adjusting screws (50415) into the drum cover (45733) and tighten securely to hold the pump (ATD-5217-1) to the drum. | | |
| <b>Install</b> the muffler (ATD-5317)(not shown) in the exhaust port of the air motor head. Locate the muffler (ATD-5317) on the schematic. Ensure that the muffler (ATD-5317) is inserted in the correct orifice. | | |
| Assemble the lubricant hose (ATD-5361) to the pump outlet body. If the union adapter (66645ME) was purchased, thread the union adapter into the lube opening followed by the hose (ATD-5361) into the union adapter. The connections must be <b>leakproof</b> . <b>Do not connect the ATD-5218 Control Valve Yet. You want to prime the system and purge contaminants out of the Grease Hose.</b> | | |

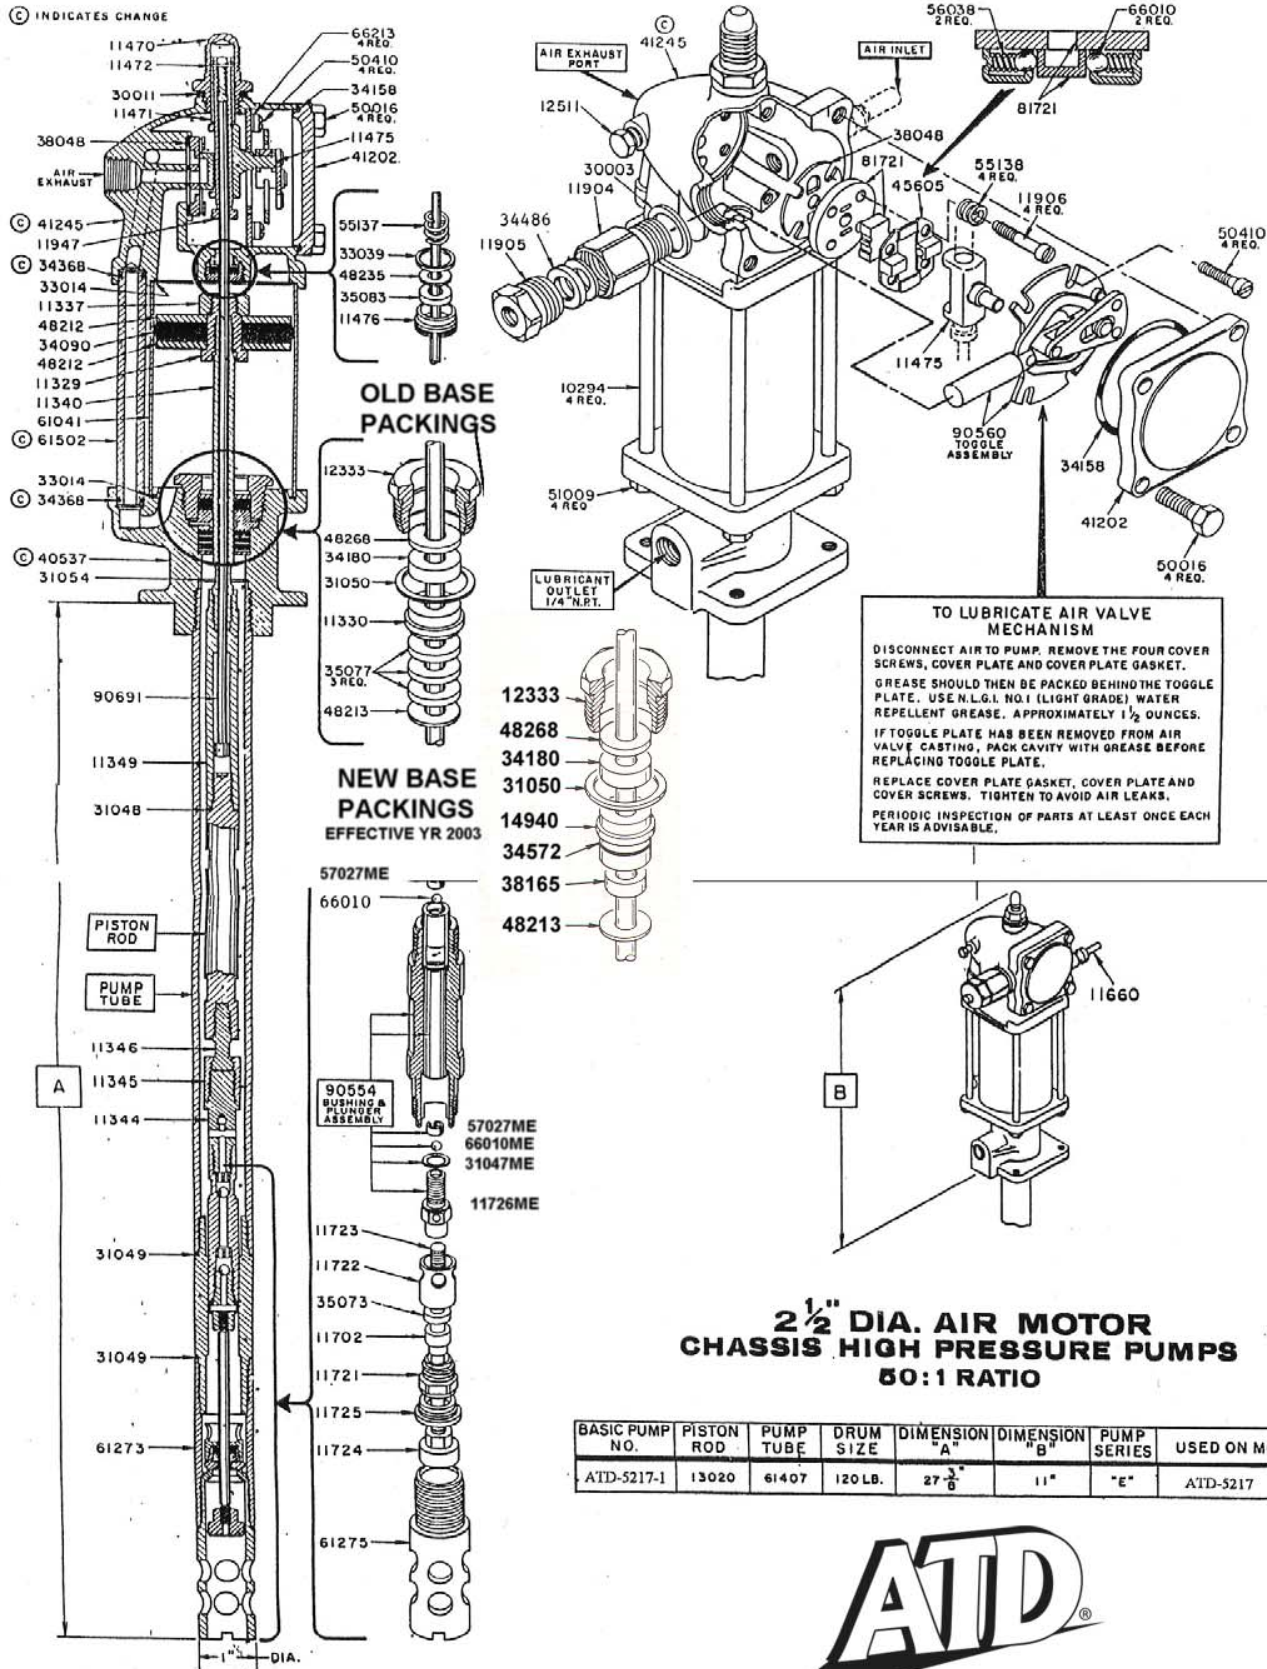
# PUMP ASSEMBLY ATD-5217-1

**TO LUBRICATE AIR VALVE MECHANISM**

DISCONNECT AIR TO PUMP. REMOVE THE FOUR COVER SCREWS, COVER PLATE AND COVER PLATE GASKET. GREASE SHOULD THEN BE PACKED BEHIND THE TOGGLE PLATE. USE N.L.G.I. NO.1 (LIGHT GRADE) WATER REPELLENT GREASE. APPROXIMATELY 1 1/2 OUNCES. IF TOGGLE PLATE HAS BEEN REMOVED FROM AIR VALVE CASTING, PACK CAVITY WITH GREASE BEFORE REPLACING TOGGLE PLATE. REPLACE COVER PLATE GASKET, COVER PLATE AND COVER SCREWS. TIGHTEN TO AVOID AIR LEAKS. PERIODIC INSPECTION OF PARTS AT LEAST ONCE EACH YEAR IS ADVISABLE.

**2 1/2" DIA. AIR MOTOR  
CHASSIS HIGH PRESSURE PUMPS  
50:1 RATIO**

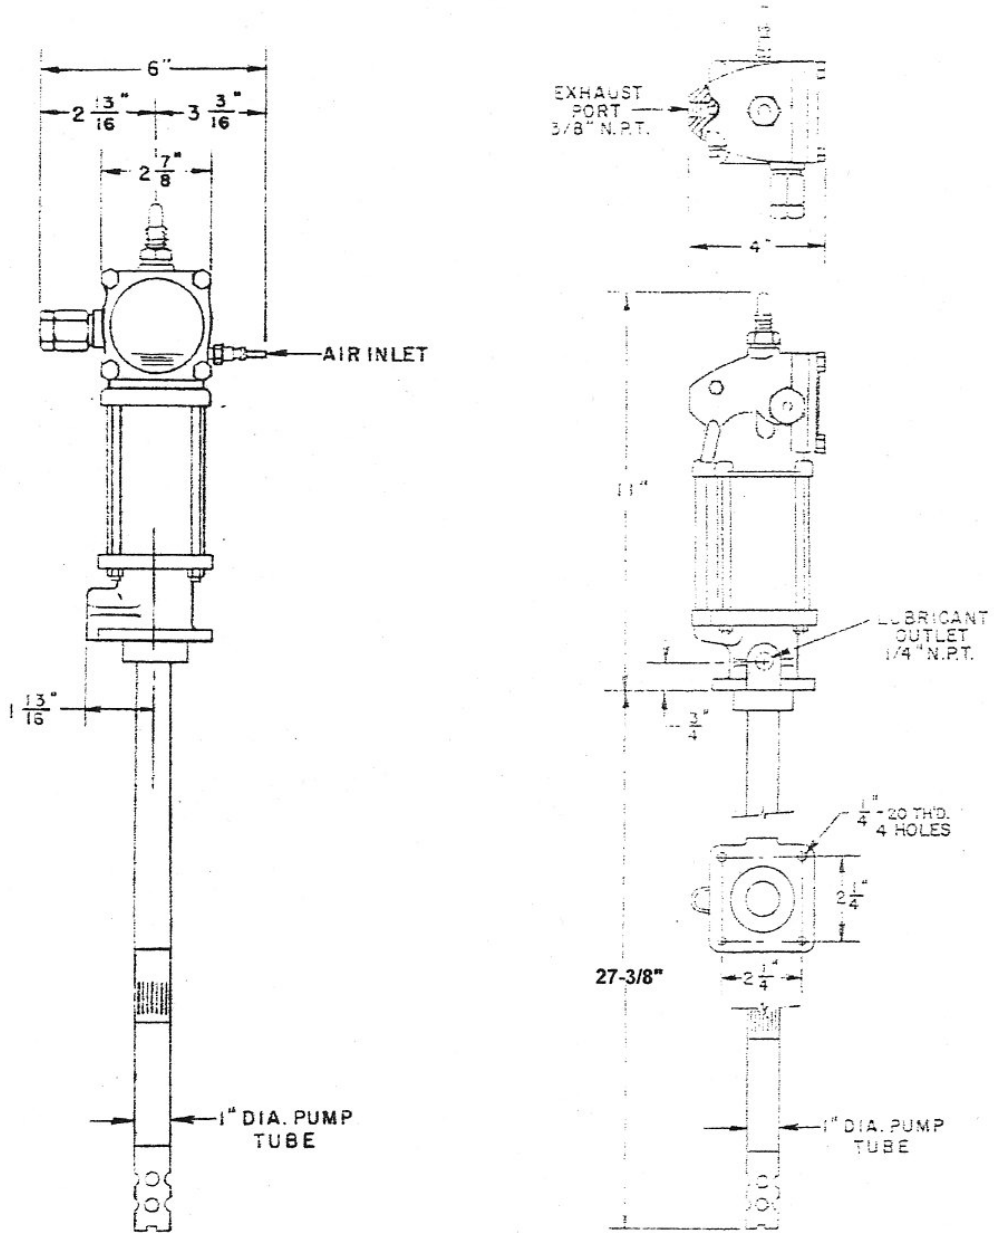
**2-1/2" AIR MOTOR OPERATED PUMPS**  
**MODEL ATD5217 Pump Assembly (ATD5217-1-Pump)**  
**(CHASSIS --- 50:1 RATIO)**

**ATD-5217-1**

Service Instructions for ATD-5217 Pump Assembly (ATD-5217-1)

**Lubricate Air Valve Once Each Week with SAE 30 Common Motor Oil (only)**

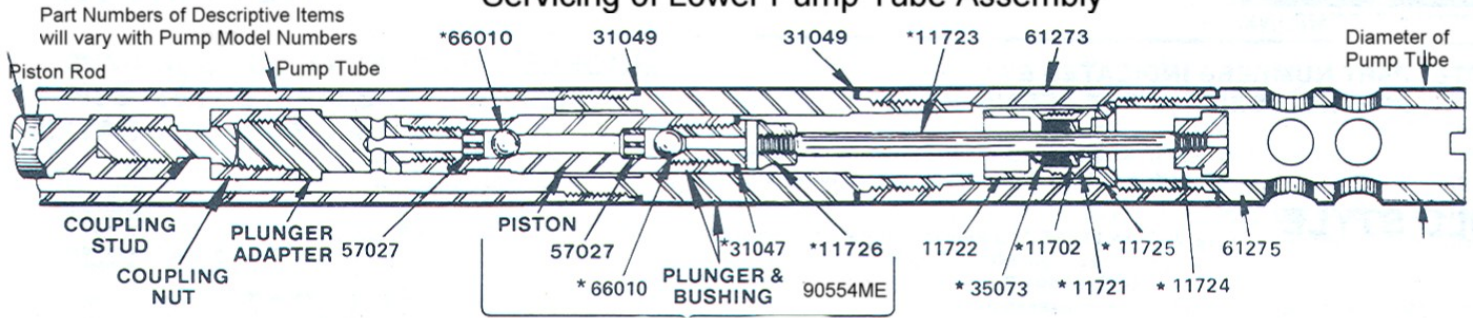
**Servicing of Lower Pump Tube Assembly**

Loss of pressure, volume or continuous operation of pump when not in normal use indicates:

A. Foreign material lodged under Piston Ball Checks or between Upper and Lower Inlet Checks.

To correct this condition the Piston Ball Checks and Inlet Checks should be removed, thoroughly. If sealing surfaces between Upper and Lower Inlet Checks are rough or pitted, replace or resurface if damage is slight.

B. Shovel Rod Packing worn or damaged. Before installing new Packing, inspect surface of Shovel Rod and replace if rough or pitted. Do not grip Shovel Rod when disassembling lower pump tube assembly.

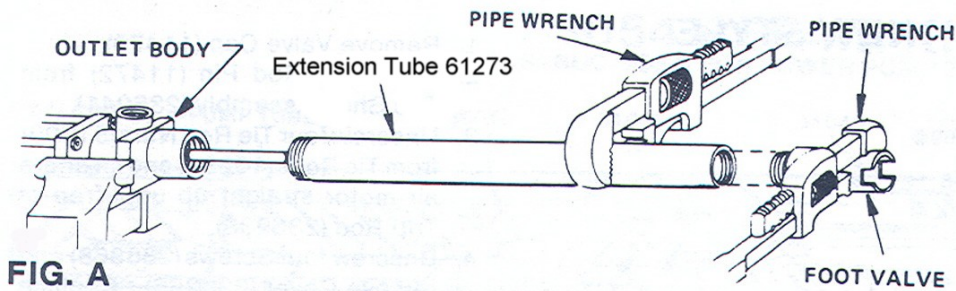
FIG. A

**Cleaning:** Use Mineral Spirits and a Brush to Thoroughly Clean all Debris out of the Foot Valve 61275 and Extension Tube 61273; Thoroughly inspect all parts for wear or damage; Clean all Parts

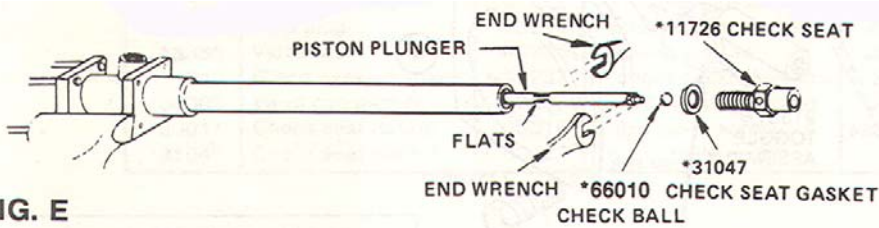
FIG. E

**Fig E.** Grip two flats at top of piston plunger with an end wrench and remove Check Seat (11726).

**Note #1:** Check Ball (66010) may remain in plunger after Check Seat (11726) is removed. To remove check ball tilt pump in vise and gently tap top of plunger at location of two flats.

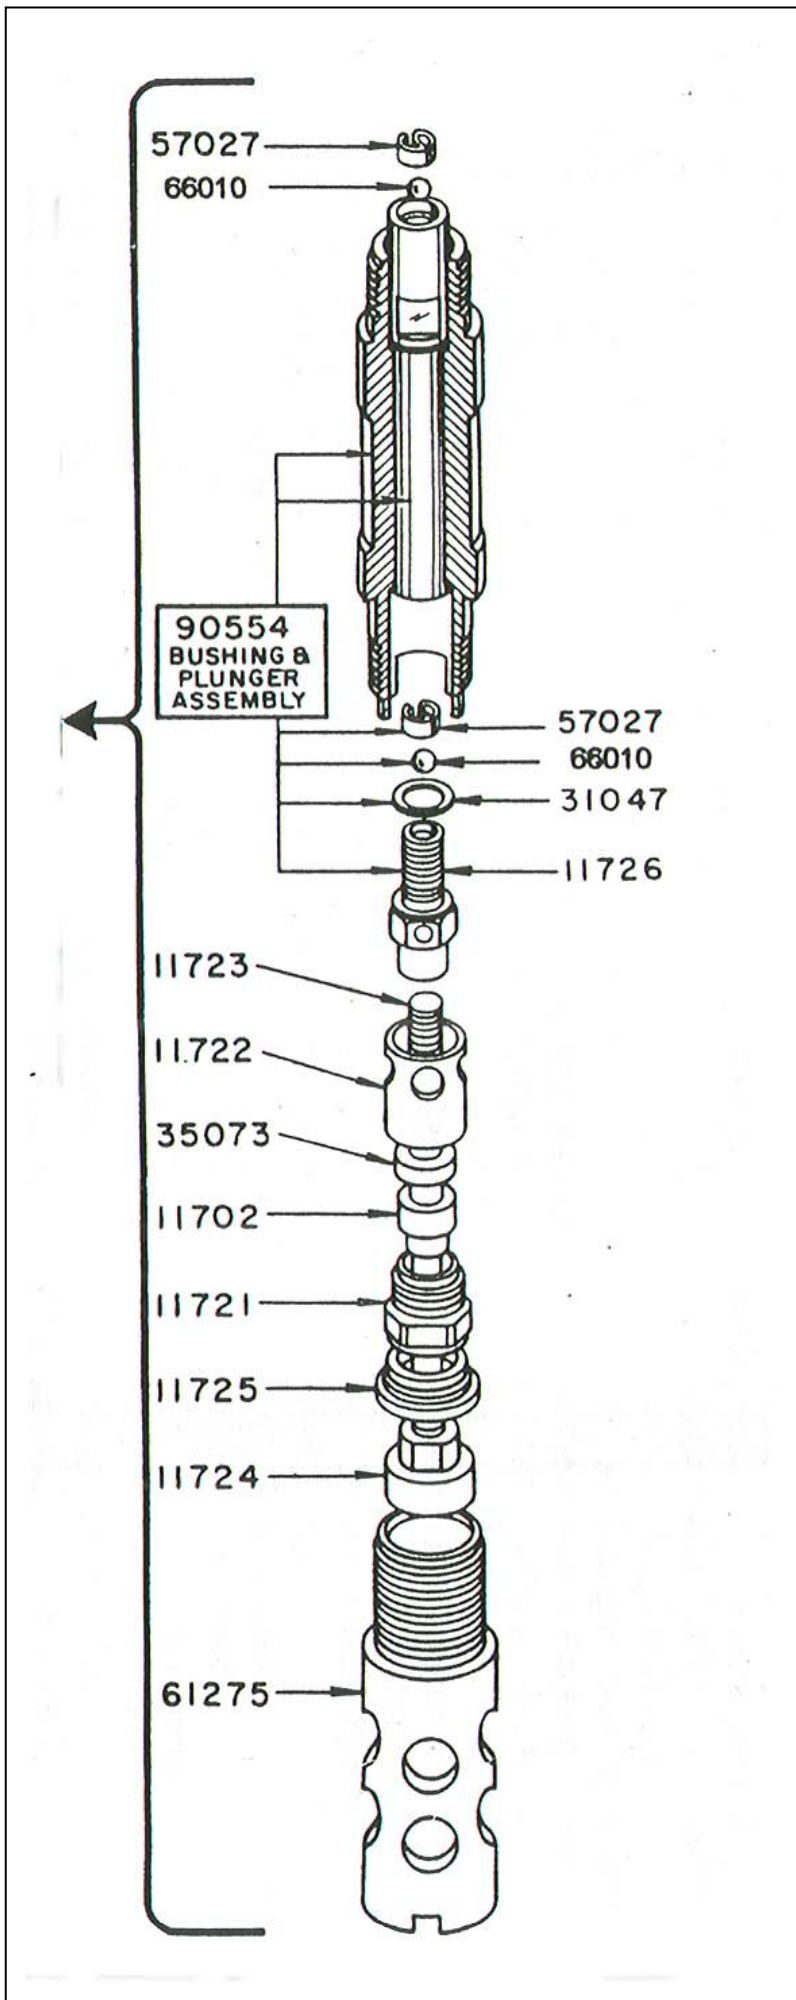
**Note #2:** You only remove that check ball (66010) if you suspect foreign material is behind the check ball. You can perform a visual inspection after the check ball is removed and if there is foreign debris behind the check ball, then continue and remove the bushing and plunger assembly as well. (See below).

When reassembling the plunger assembly, **NOTE #1:** The top and bottom of the plunger assembly. You were careful in the beginning and noted it when you took it apart. **NOTE #2:** notice the order of the ball and cage. Starting from the bottom, it is ball ; cage; then at the top of the plunger it is cage; ball; If you reverse this order, the pump will not operate at all.

The gasket ring 31047 and 11726 is inserted onto the bottom of the plunger. Use the milled flats to tighten 11726. Assemble the balance of the items in reverse order to disassembly. Note the drawing to the left. When reinstalling the bushing extension 61273(not shown), install the unit over the other interior parts and let it hang loose. Thread the rod 11723 onto the bottom of 11726. To tighten the rod, you will have to insert a small punch into the hole of 11726. See Fig B on page 1. We are now tightening the rod 11723 by putting a wrench on the plunger 11724. Assemble balance of items as shown.

Once the plunger is off of the plunger rod (it is unthreaded) you can slide the complete unit off. Sometimes the rod 11723 unthreads from the the check seat 11726, that is fine as well. If there are dirt, rocks, metal or plastic in that area, clean it out. While you have it off, replace the plunger packing 35073. We offer Buna N (black), Viton(Brown) and Teflon(White). It is a wear part.
