ATS or BD.....you decide.

The products that I'll be discussing are two competing sets of compound turbos, both installed on 2006 Dodge Ram's with Cummins Turbo Diesel engines. One set was from ATS, which included the Aurora 3000 and Aurora 5000 turbos and the other was from BD Power, which included the SuperB and R700 turbos. Both are advertised as towing / race setups.

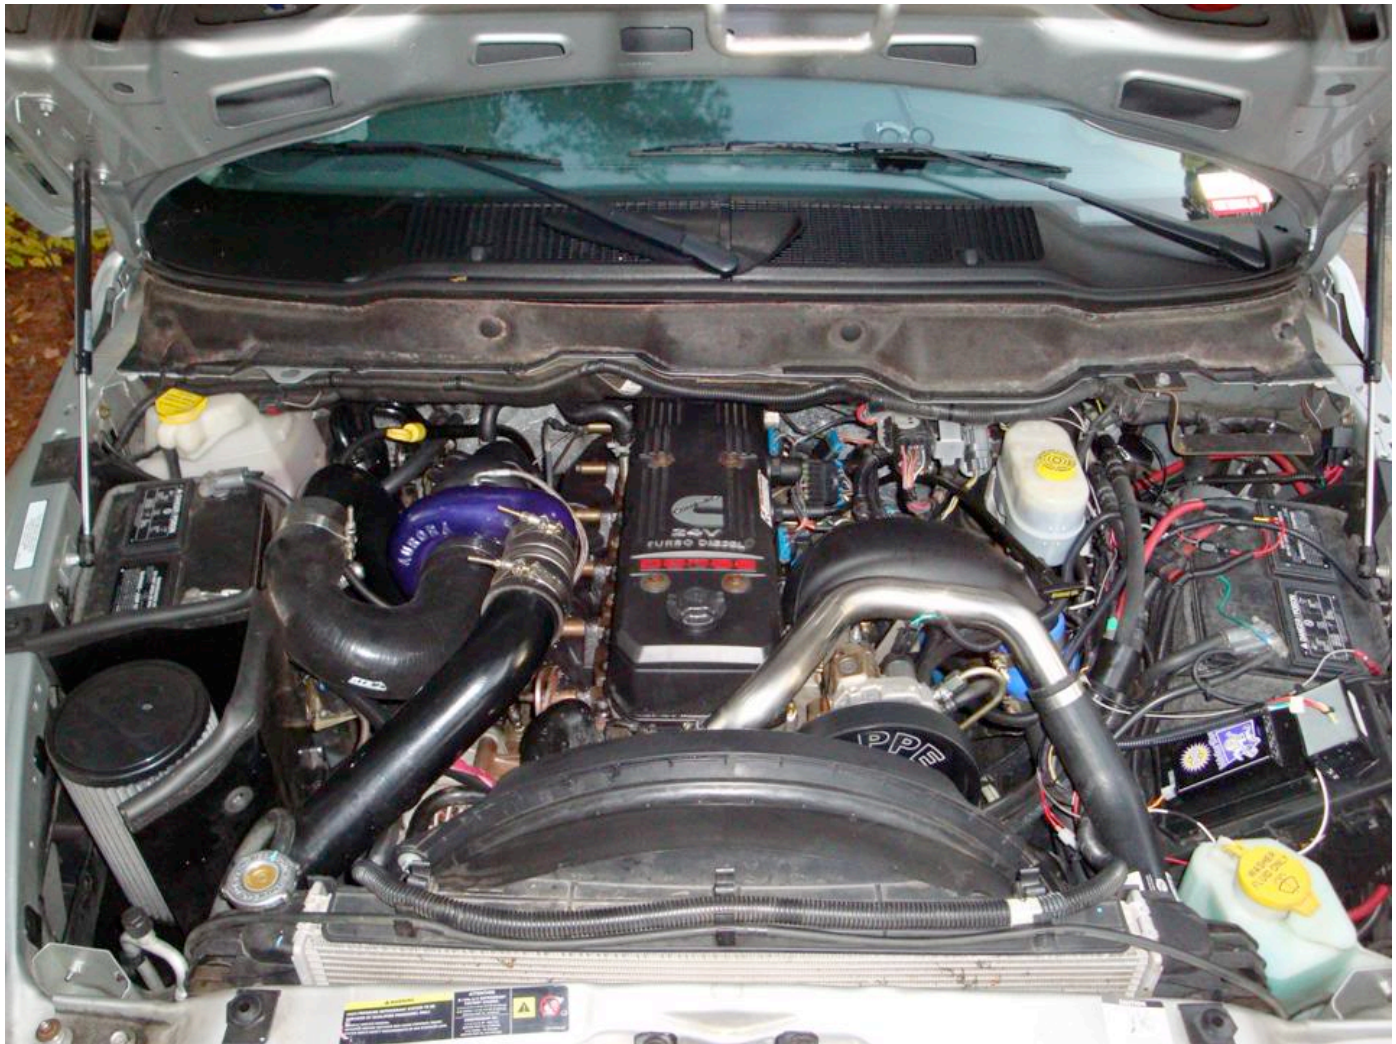
ATS Aurora Compounds on the silver 2500:

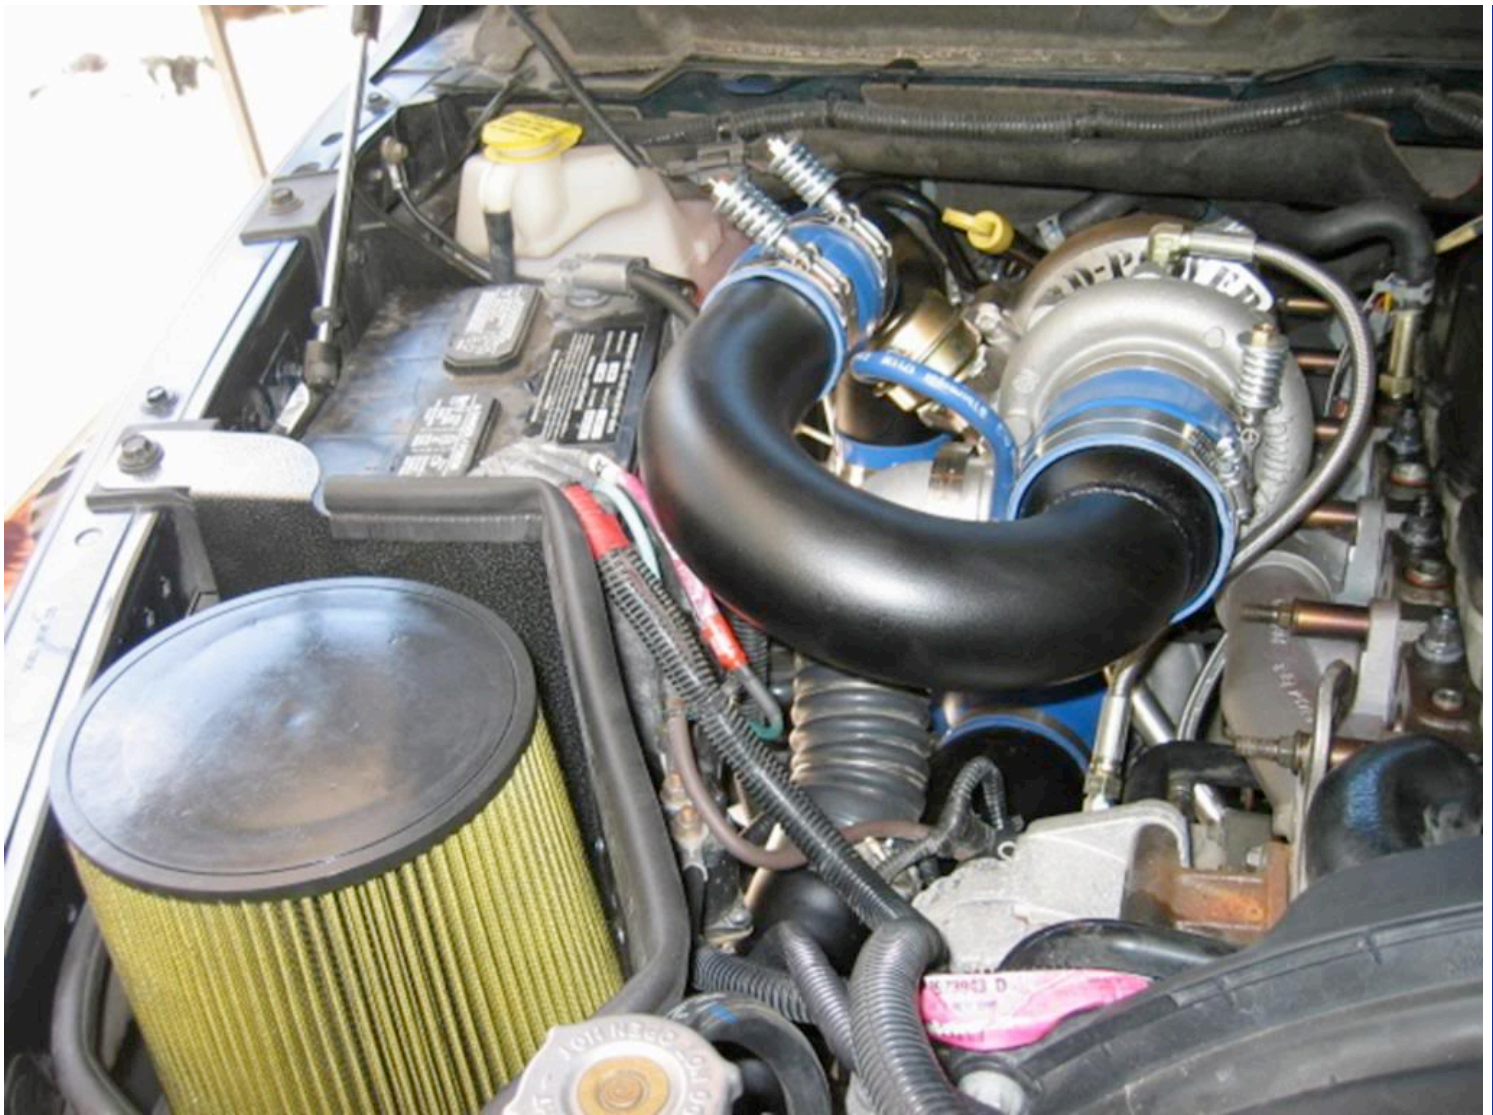
BD Power R700 Compounds on the blue 3500:
