ATS or BD.....you decide.

The products that I'll be discussing are two competing sets of compound turbos, both installed on 2006 Dodge Ram's with Cummins Turbo Diesel engines. One set was from ATS, which included the Aurora 3000 and Aurora 5000 turbos and the other was from BD Power, which included the SuperB and R700 turbos. Both are advertised as towing / race setups.

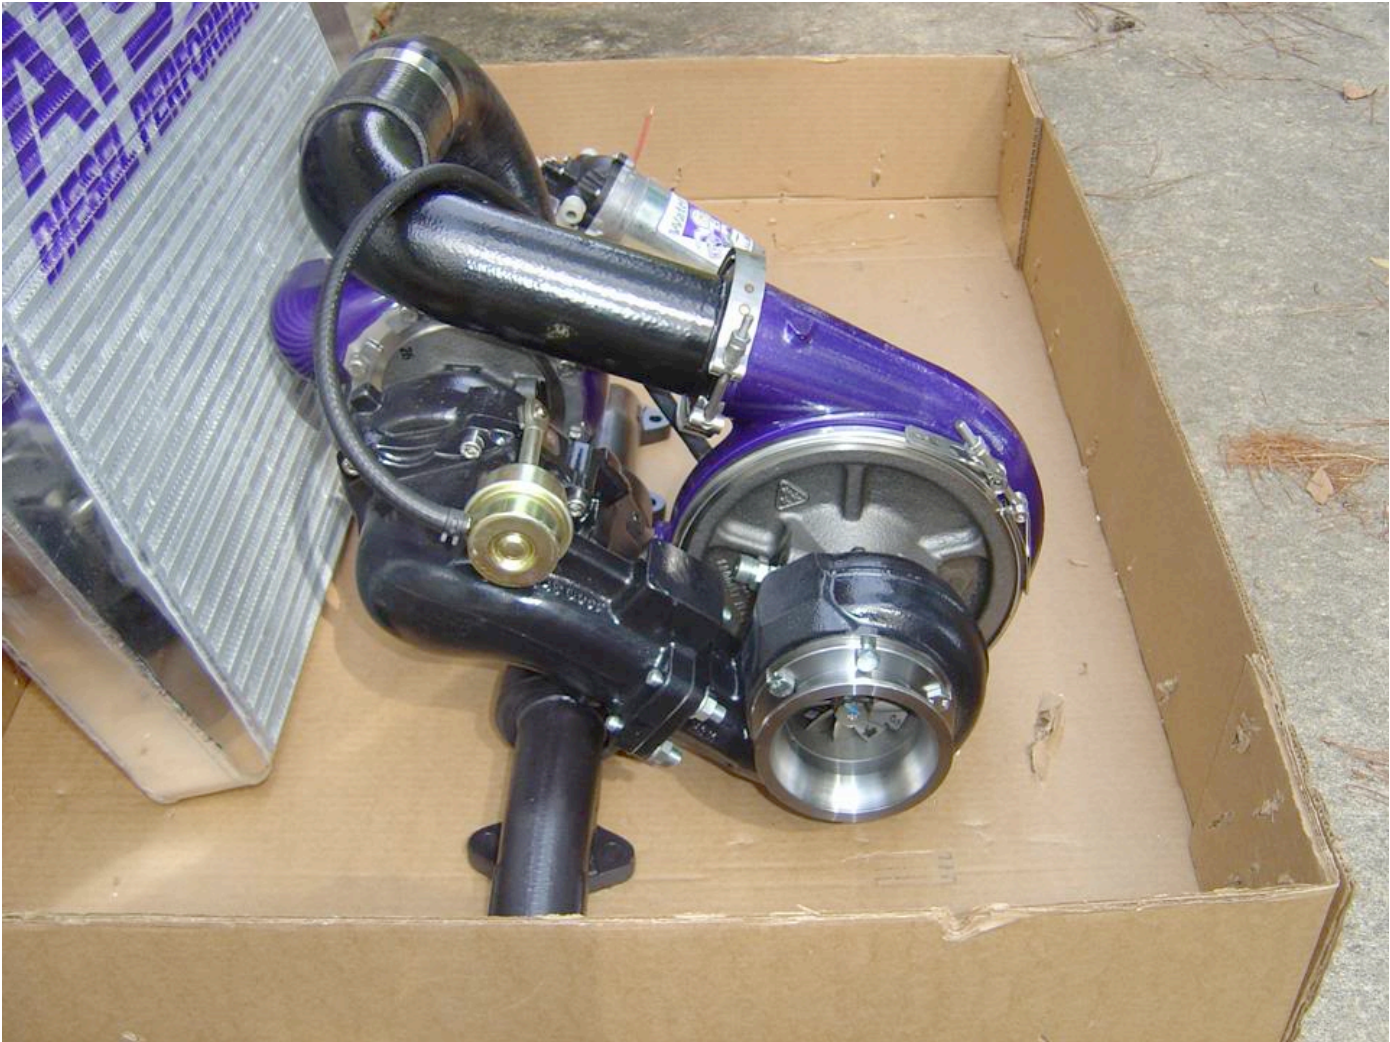
When the parts arrived, they were in very different conditions from each other. The ATS kit came completely assembled and made for a very easy install. You had the finished product to look at prior to installation.

The parts arrived complete, free of rust and corrosion and clocked correctly for the application.

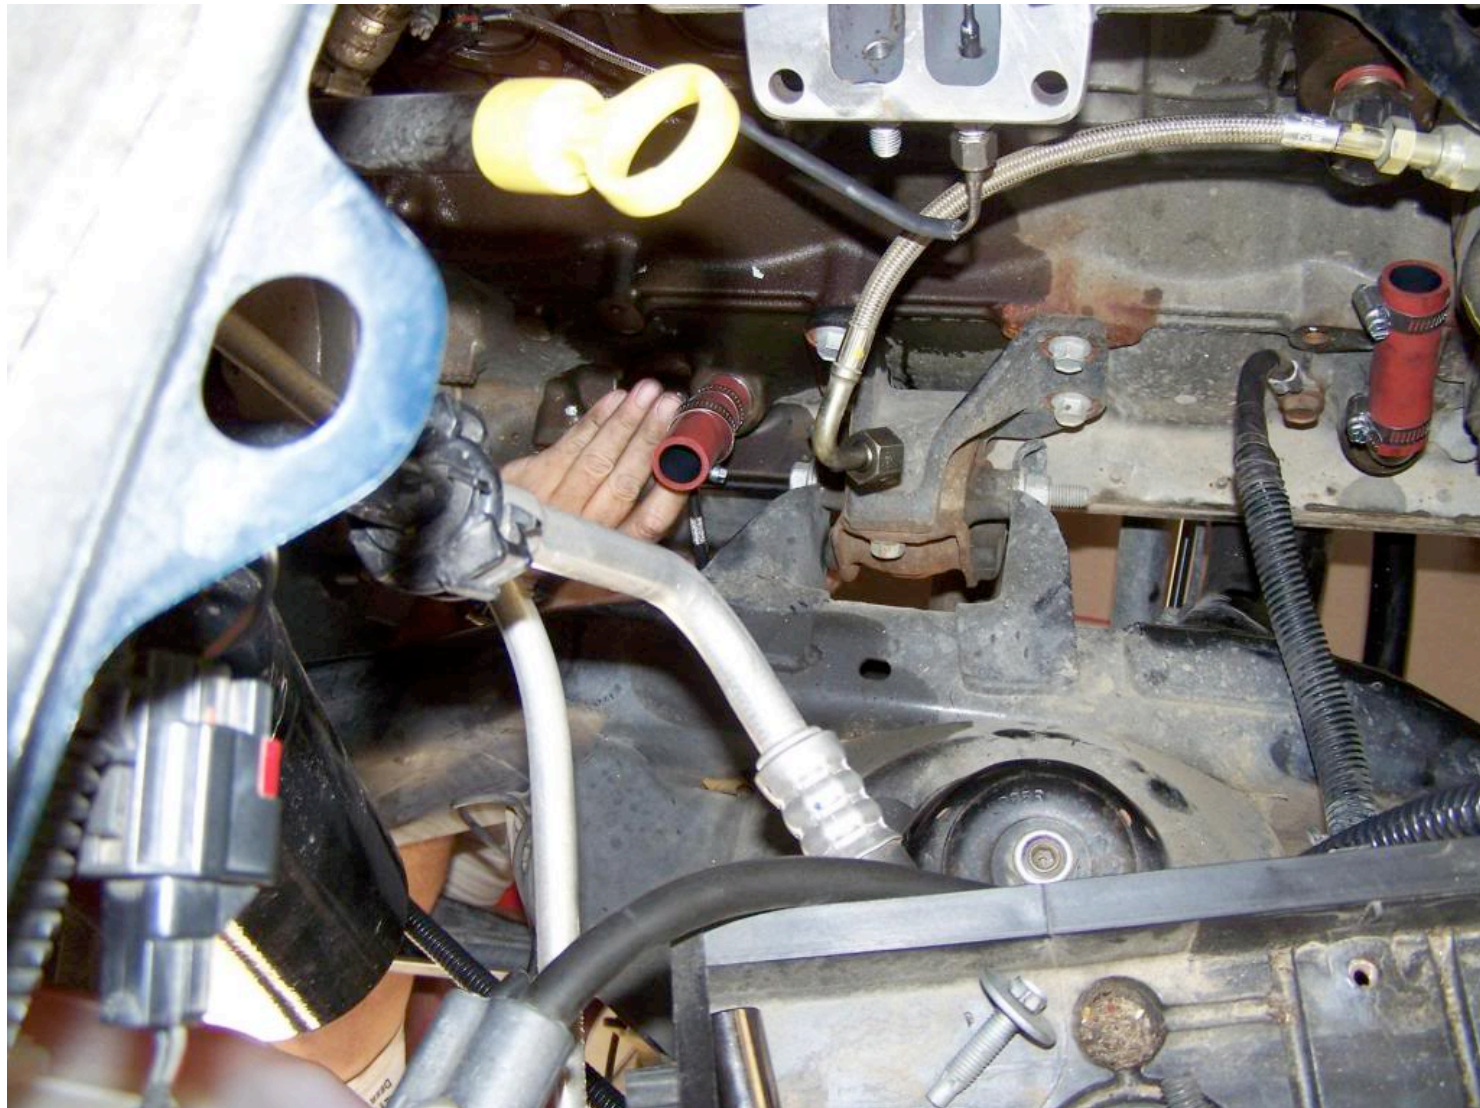
The picture below shows where the OEM return is (rear of engine) and the new secondary drain is located (front of engine)

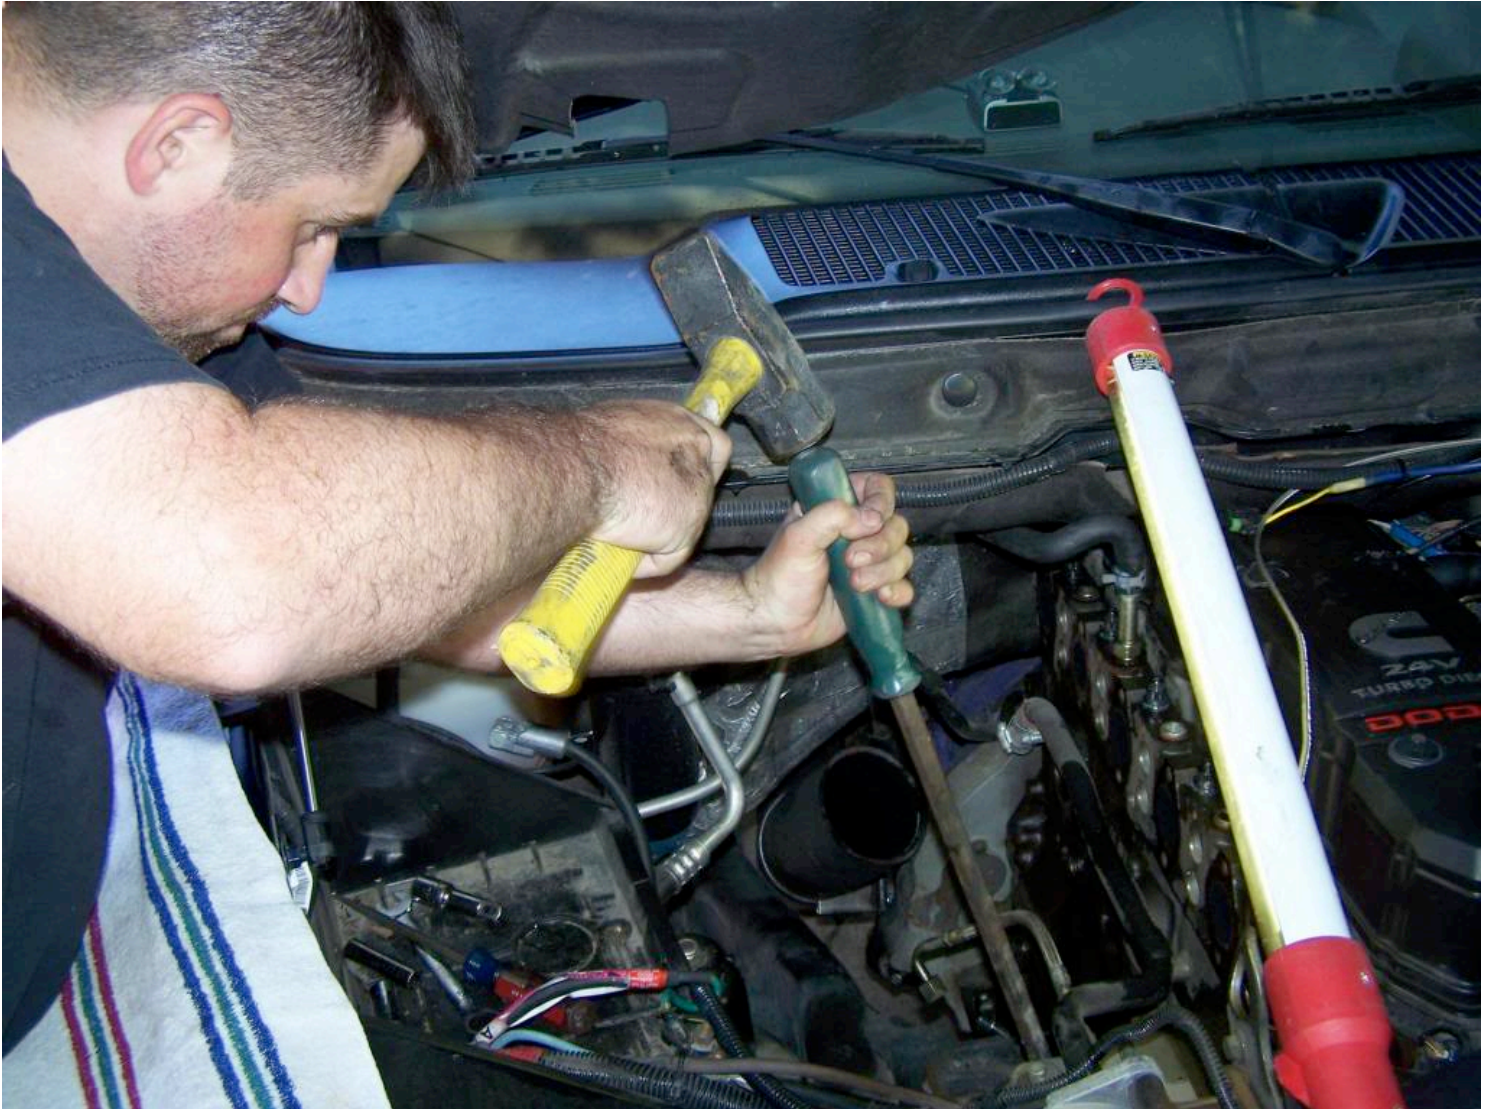
The secondary turbo also required a steel adapter to go in the frost plug hole. This adapter did not fit. The instructions said that you may have to use a punch to get it to fit....this was a mild understatement.

I tried brass and steel punches, using a reasonable amount of force and it would not even seat. I ended up need to use a pry bar and a mallet to mark the adapter where it was oversized so it could be re-sized with a die grinder.

Once it was chamfered and resized, the secondary adapter was installed. The picture below is of those two components and their associated hoses and clamps installed.

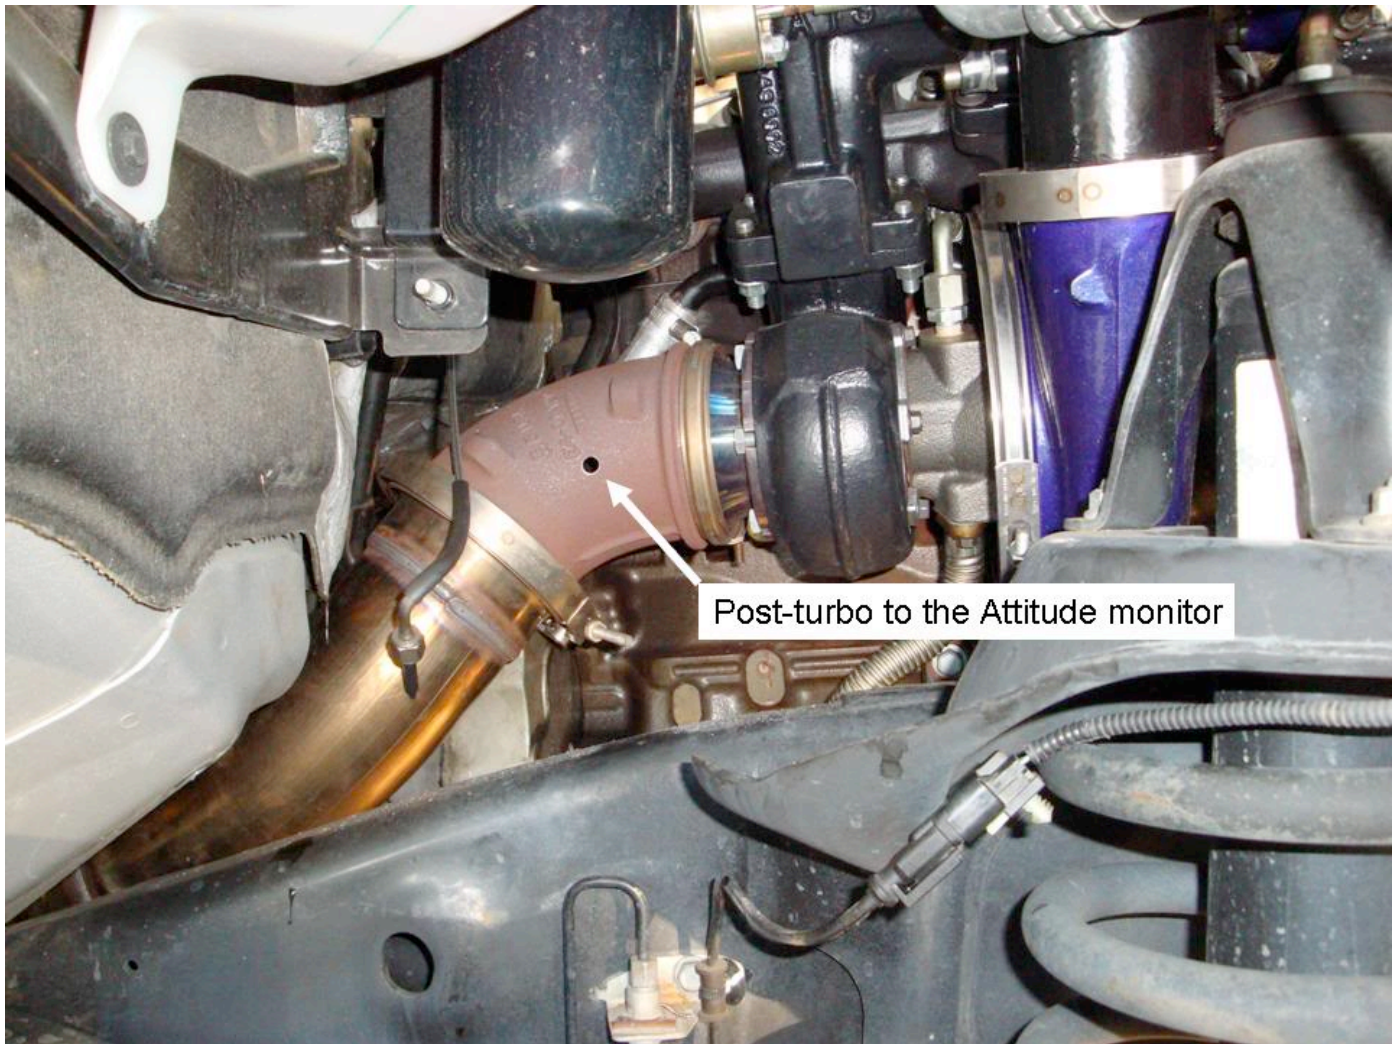
Now, from here, the ATS primary was attached the OEM exhaust elbow by removing the locator roll pins in the elbow and loosely attaching it to the existing down pipe for alignment and attachment to the secondary.

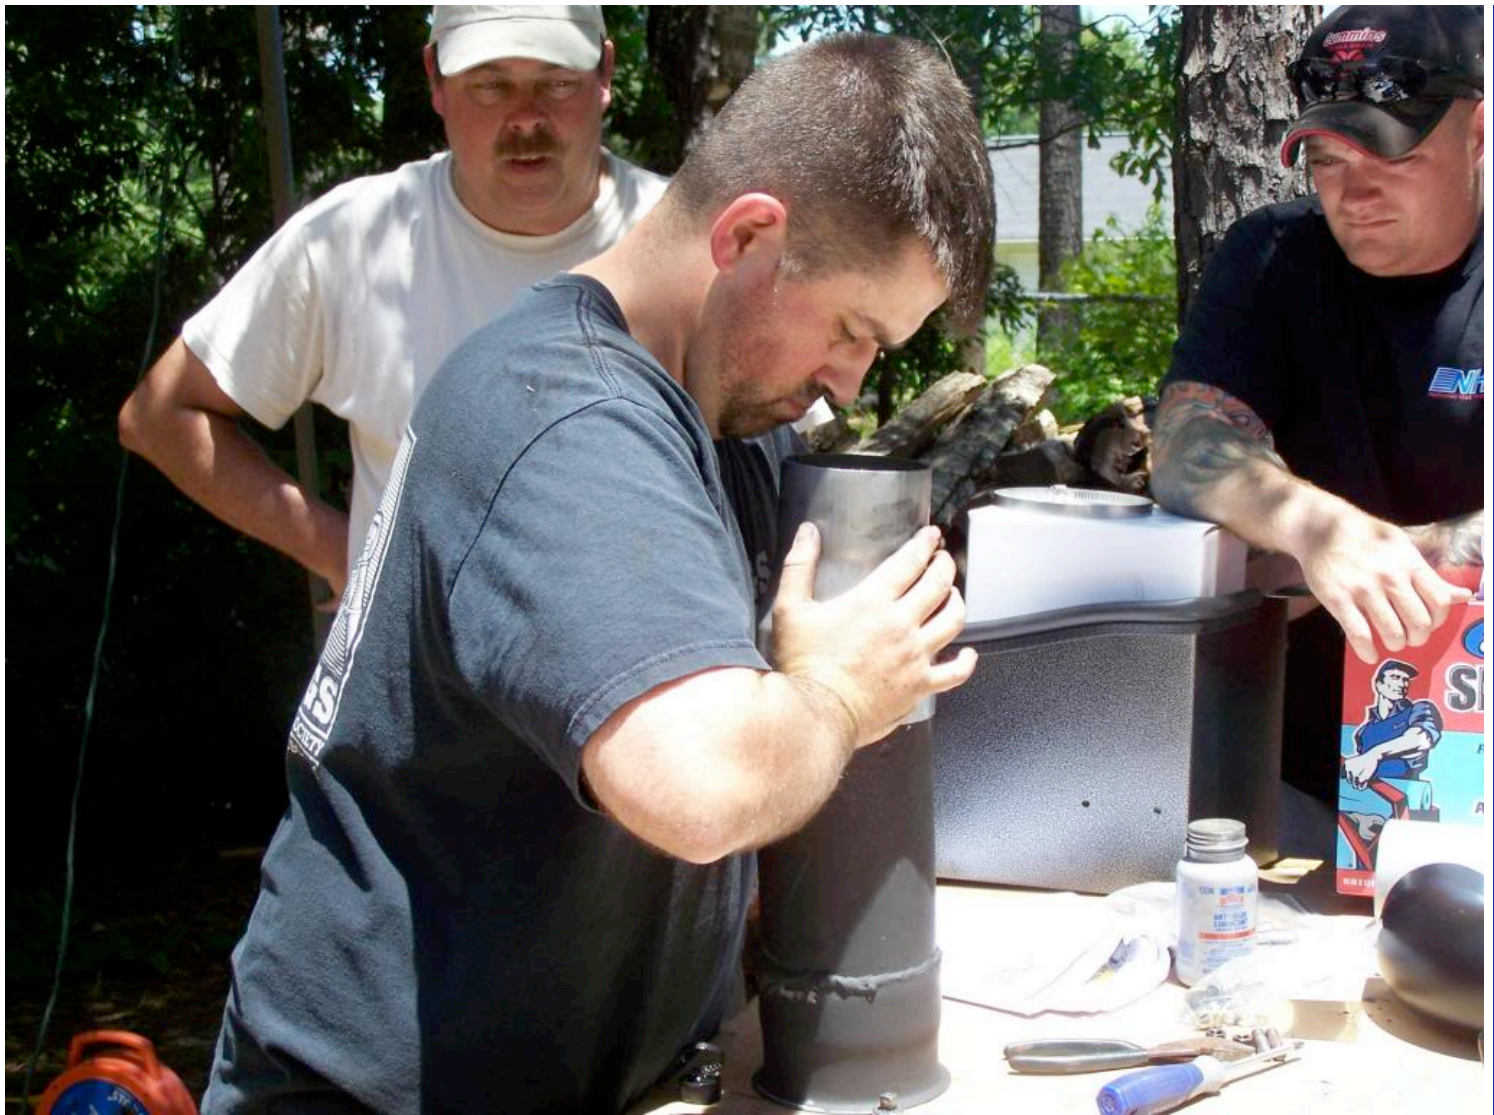
The BD kit does not sit in the OEM location and cannot reuse the existing elbow or down pipe. This presented a problem as both trucks had 5" exhausts and the BD downpipe that comes with the kit is 4", which required getting an adapter to mate the two. This also eliminated the possibility of using the existing exhaust elbow and the post-turbo pyrometer used to monitor the exhaust brake.

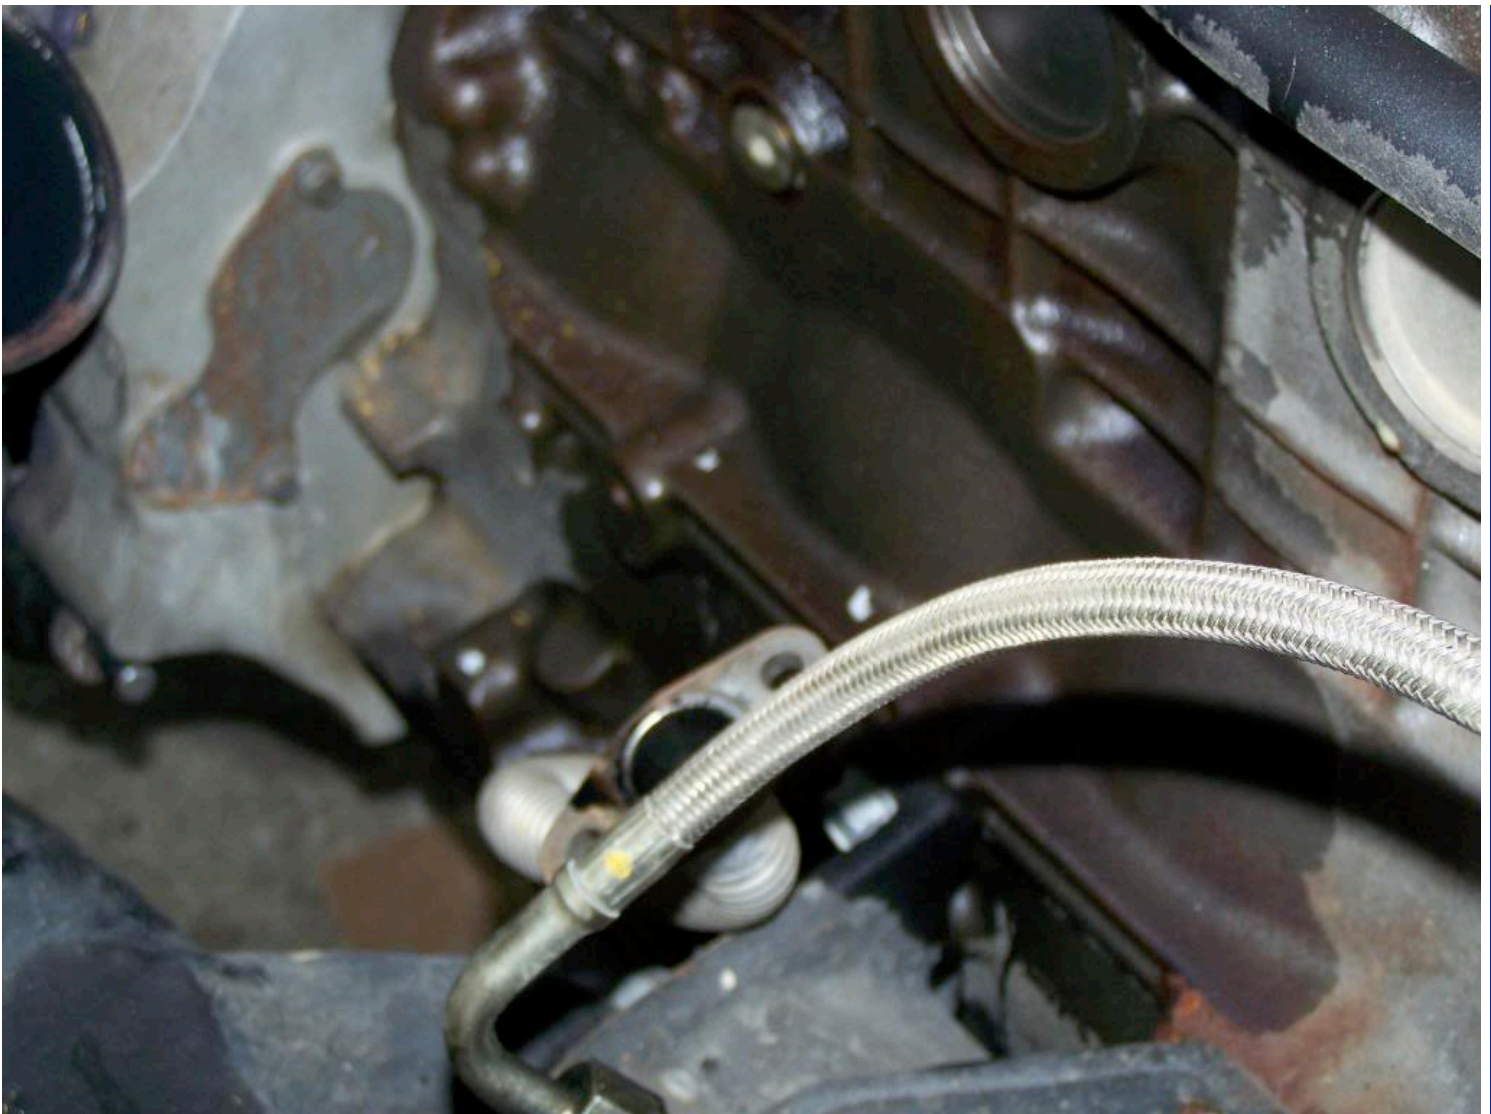
Once this modification was made, the BD kit required draining approx 3 gals of coolant from the system. This was necessary because you had to cut the tube on the steel coolant line that runs near the bottom of the engine block. This was to install an adapter that bolted to existing bungs in the block. The kit came with a 90* adapter for this cut, but it was larger than the existing pipe and would not clear the bracket. We ended up fabricating a soft coolant line from the bottom of the engine to the heater core supply fitting. This still presented a problem as the edges of the supplied bracket are very sharp and would have cut the hose quickly. We omitted using the bracket at this point.

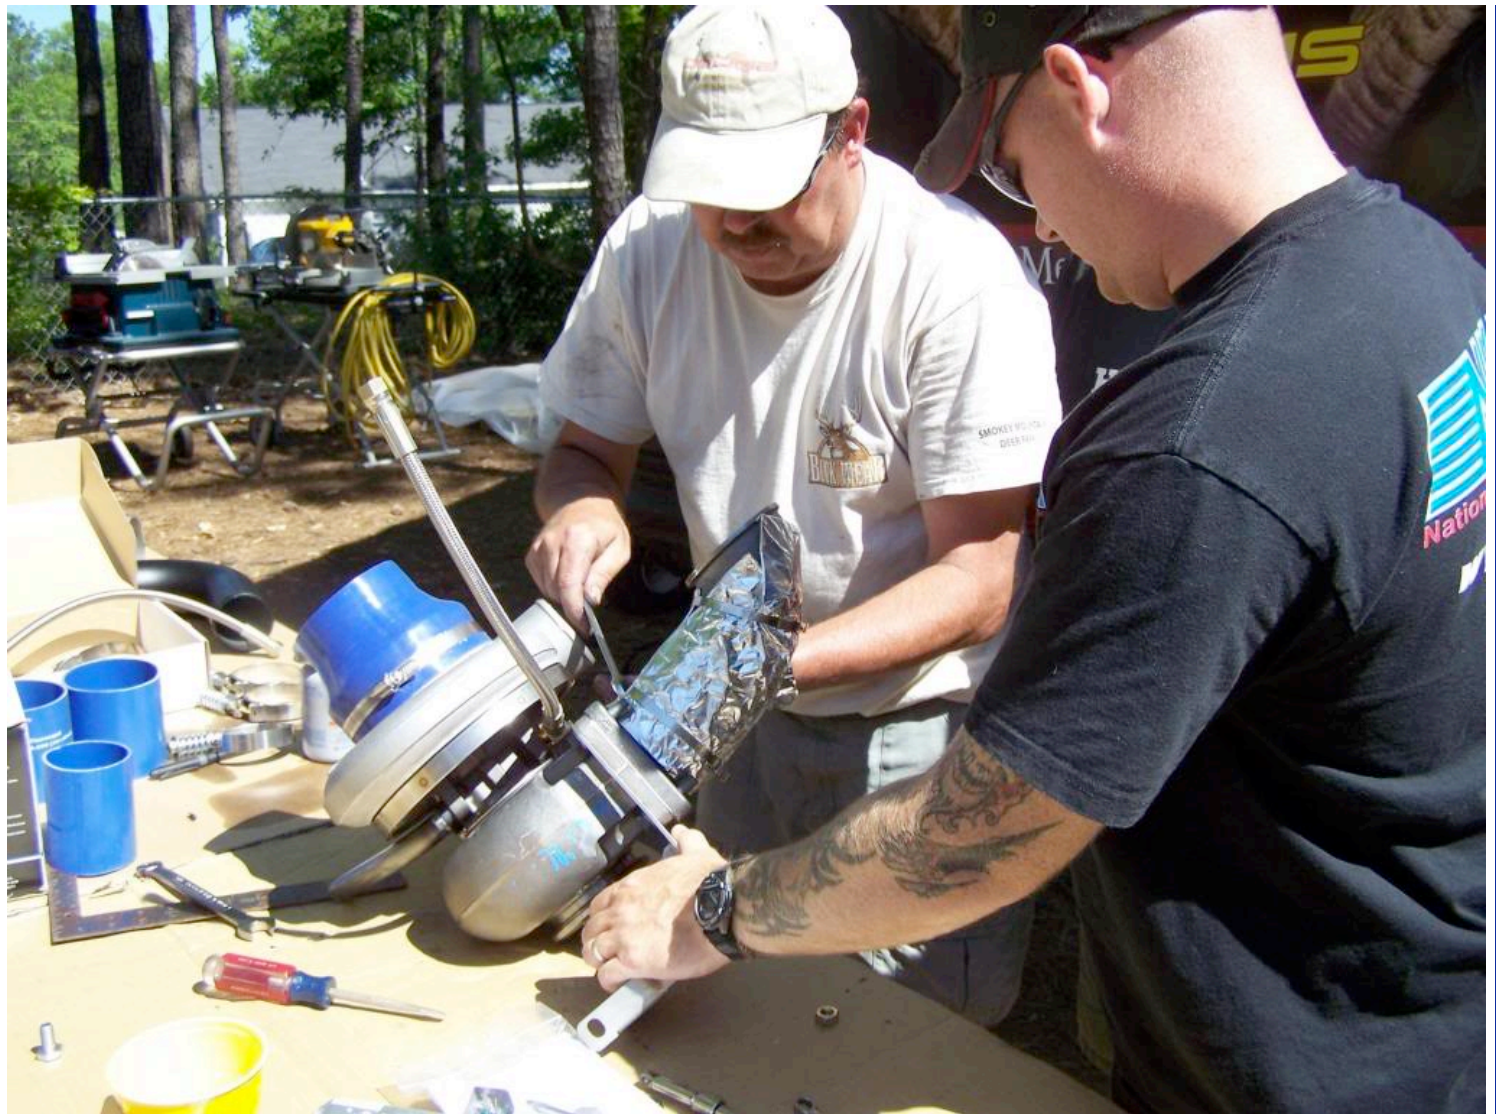
From here, you must fit the exhaust adapter from the secondary to the primary on the BD compound. This again presented a problem. The studs supplied with the kit were incorrect in thread pitch, count and coarseness. We had to run to the hardware store to get fasteners of the correct type to bolt the adapter to the primary.

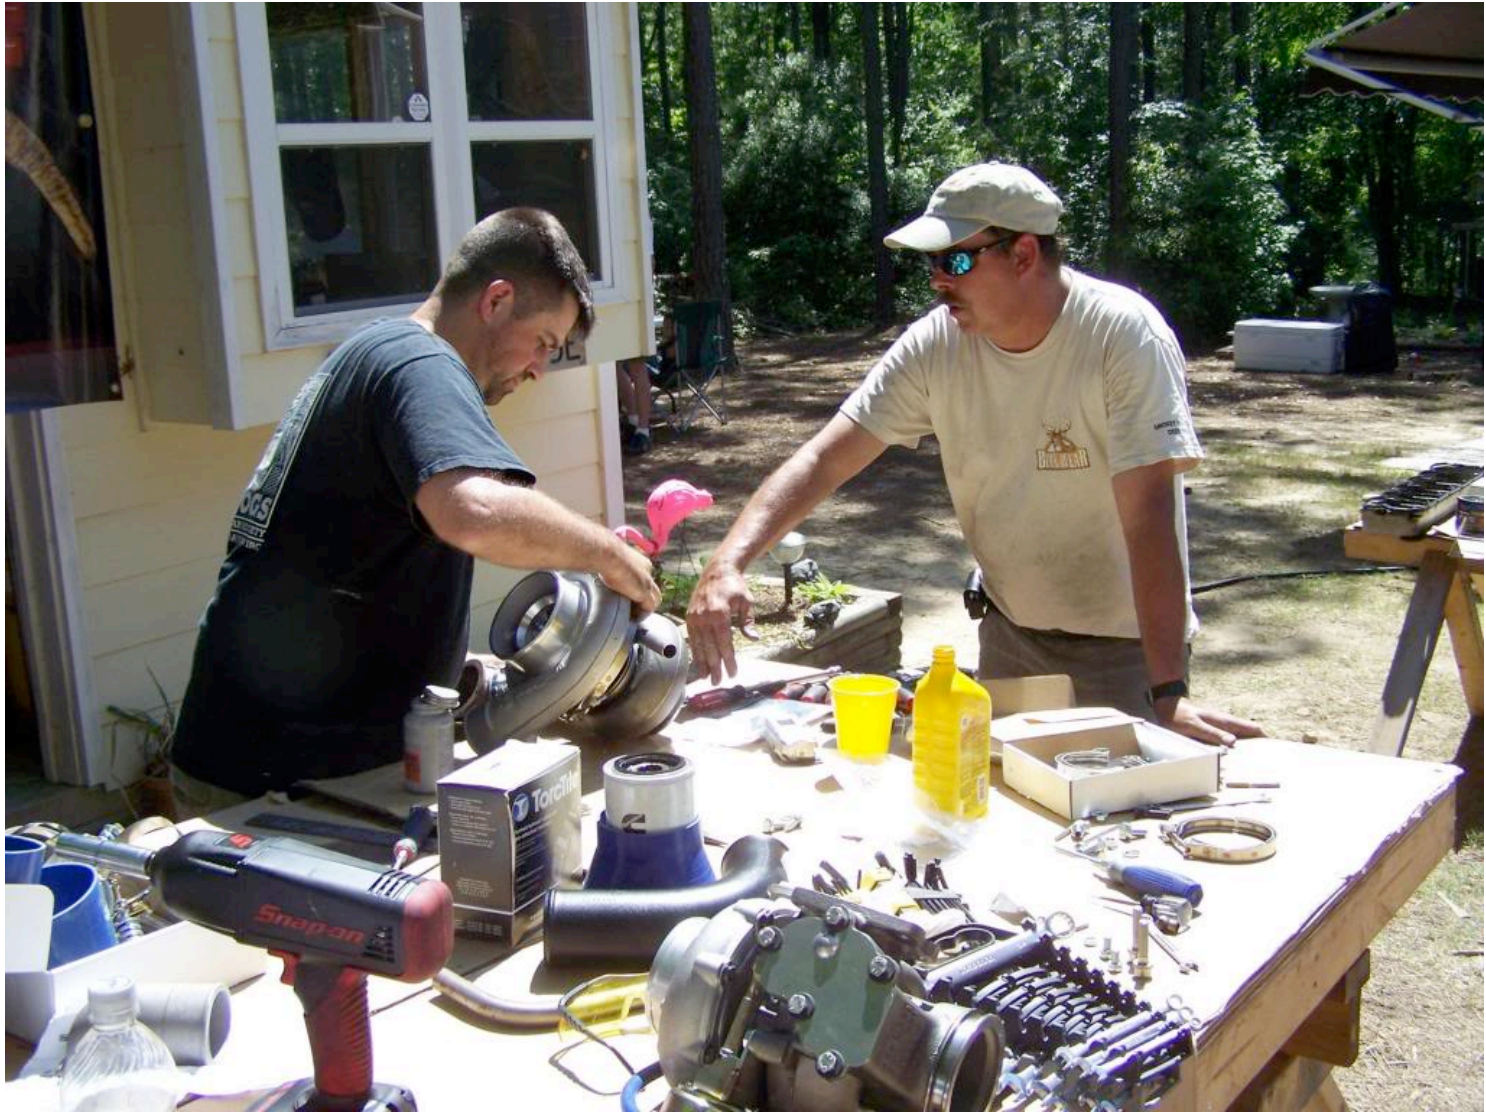
Once the primaries were positioned, we found the clocking that was called for in the BD directions was incorrect, so this was adjusted.

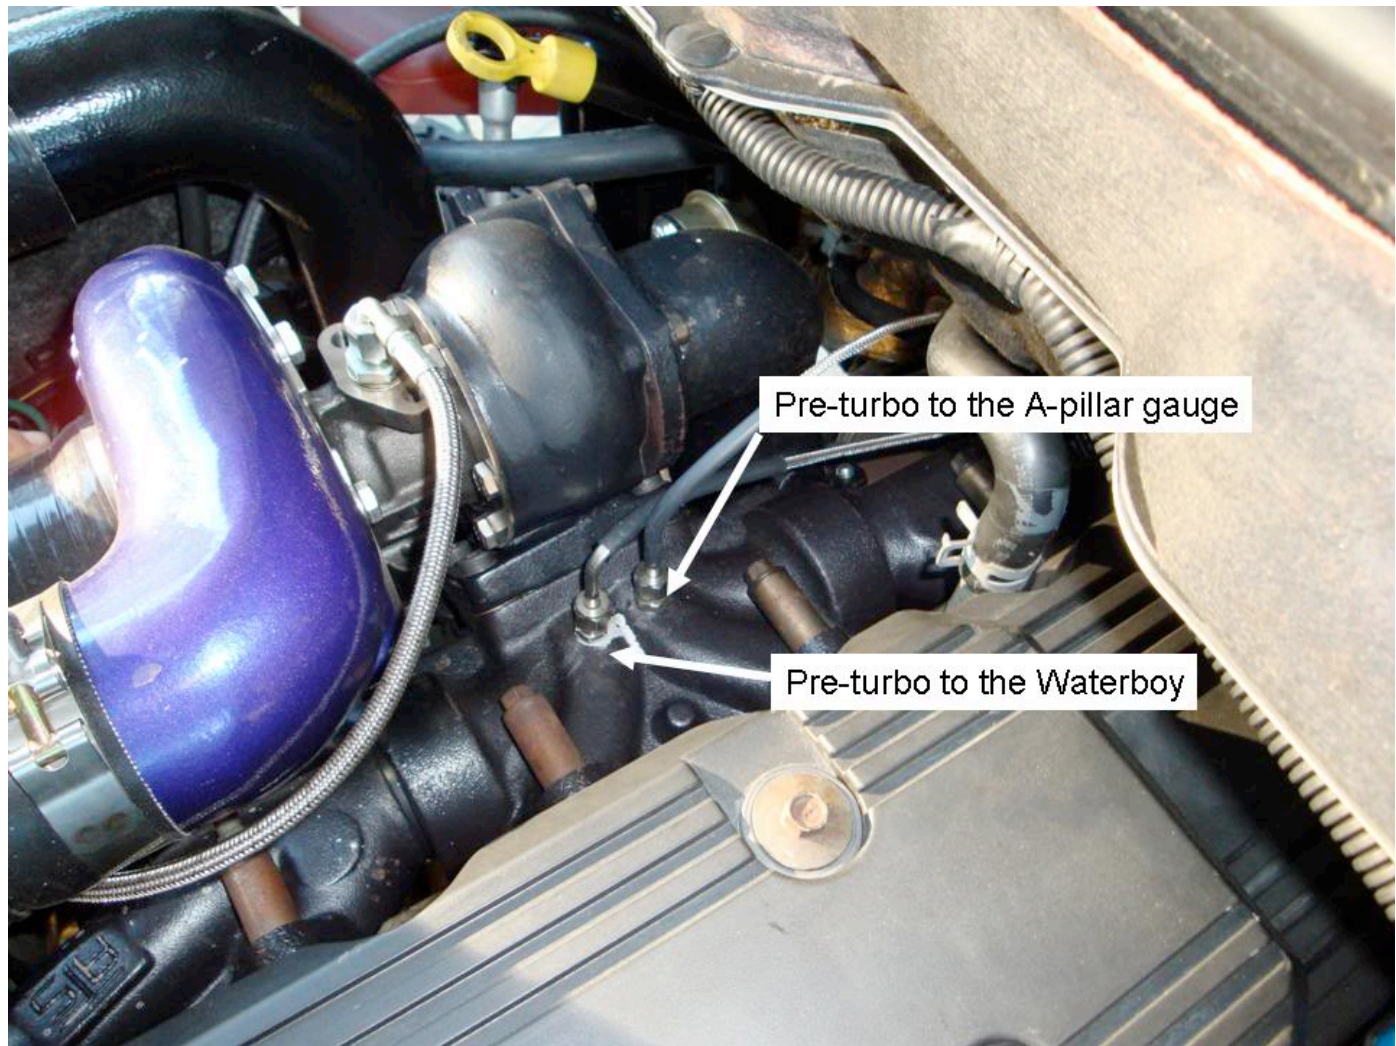
The ATS manifold came pre-drilled and tapped with four 1/8 NPT ports. Two on top and two on the bottom. These ports were in the correct locations for the application and were correctly tapped.

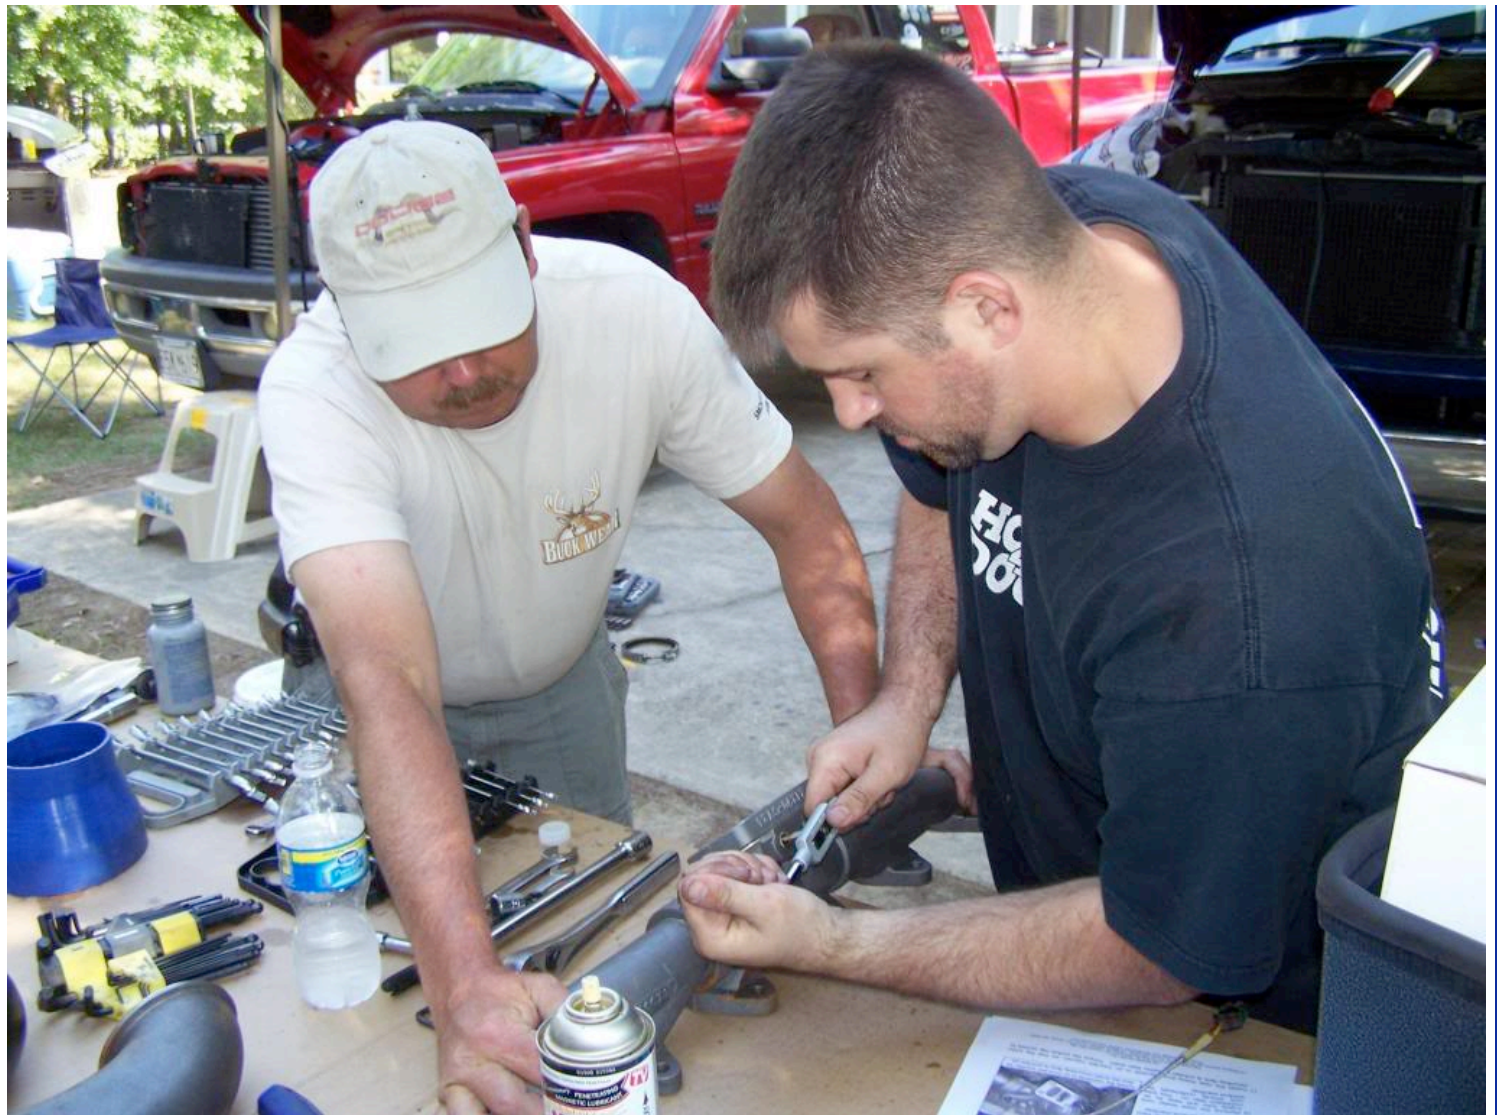
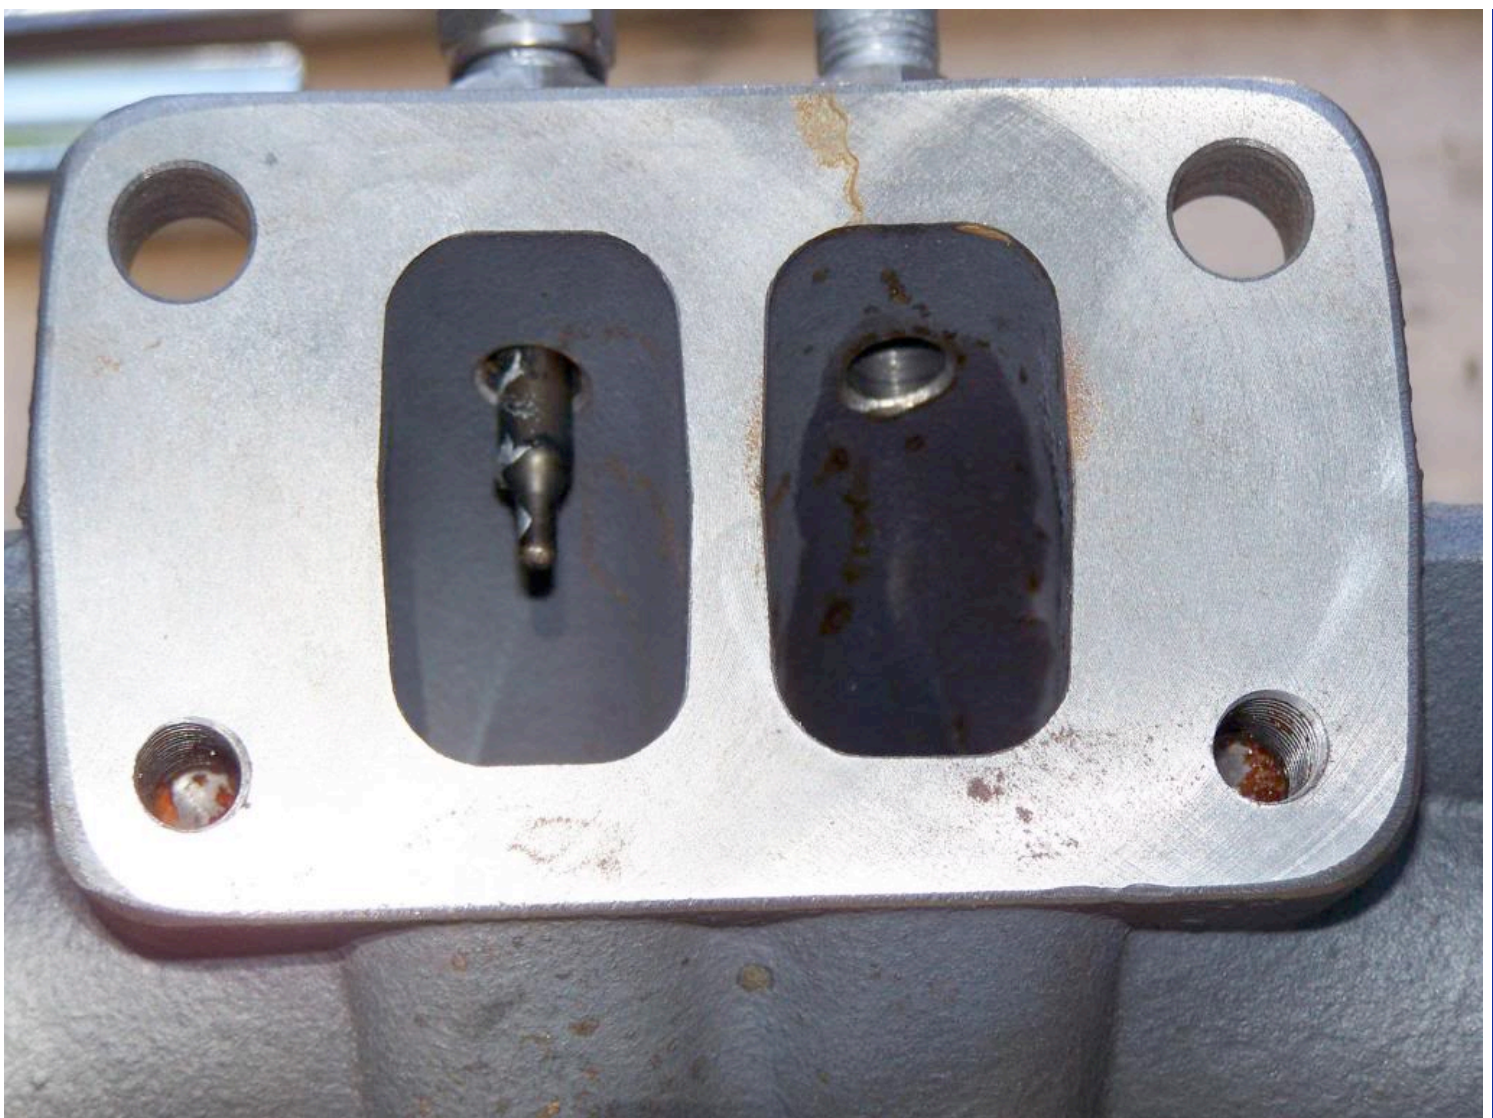
The BD kit came with two pre-drilled and tapped ports. The ports, as the manifold was to be installed, were located on the bottom of the manifold. They were also not tapped deep enough to properly seat a 1/8 NPT fitting. We could only get 2 threads of the probe fitting in before it stopped. This required tapping the manifold further to allow proper EGT probe function.

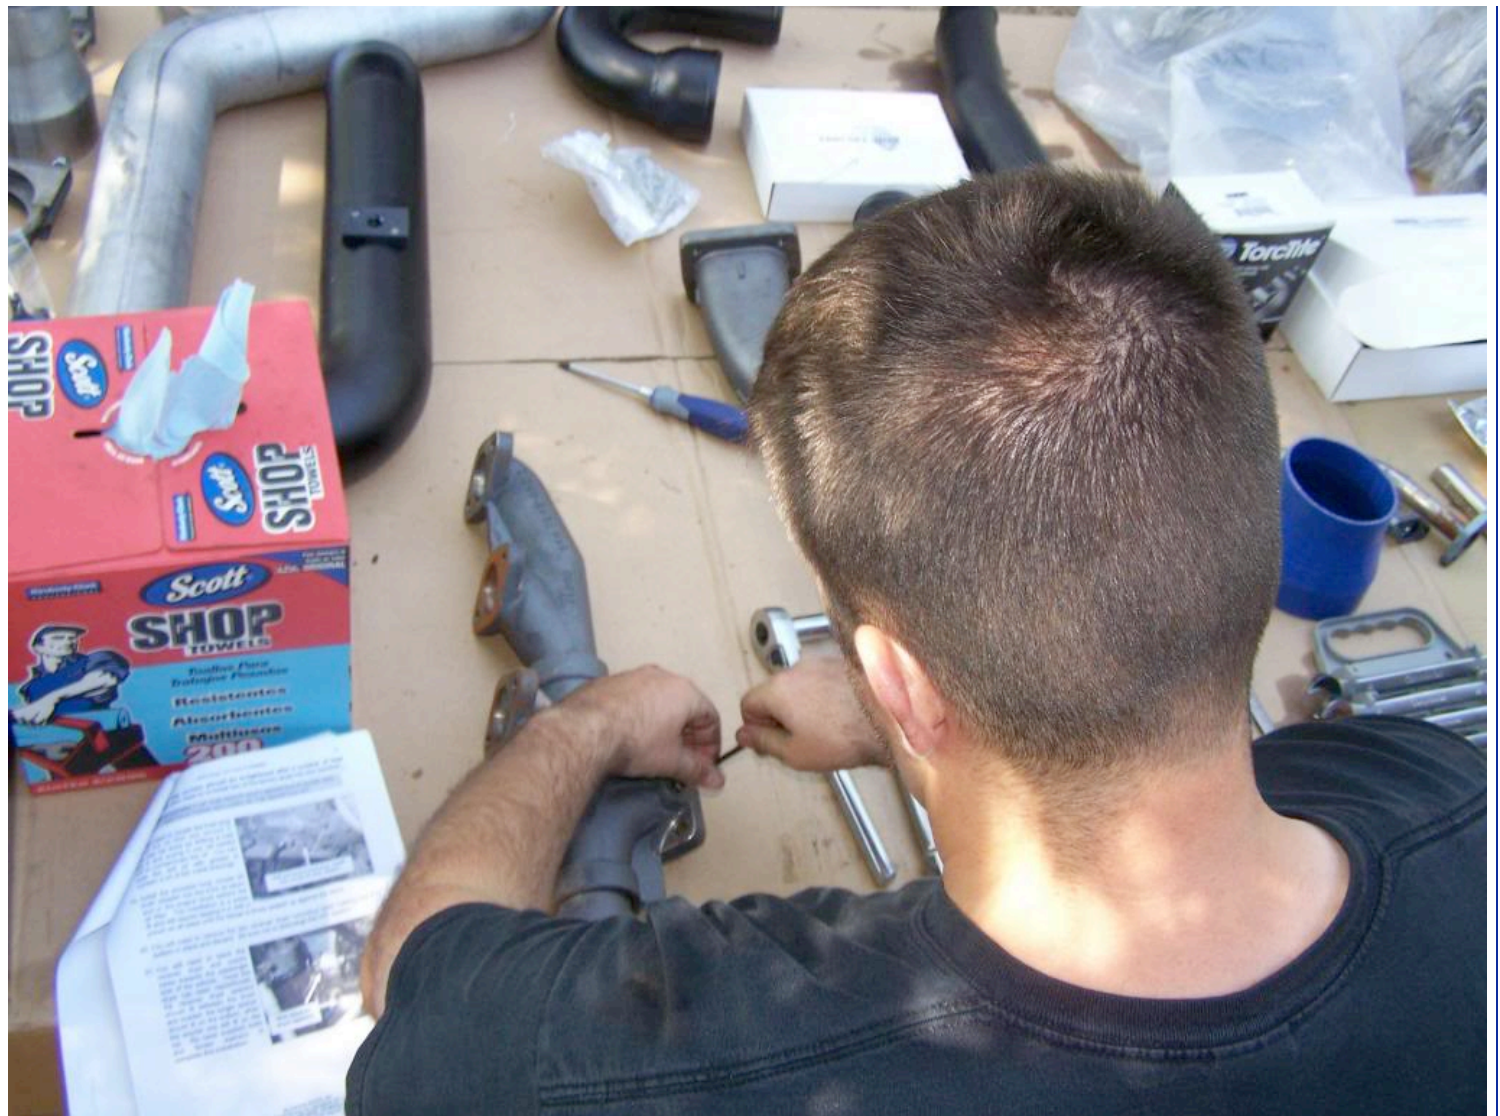
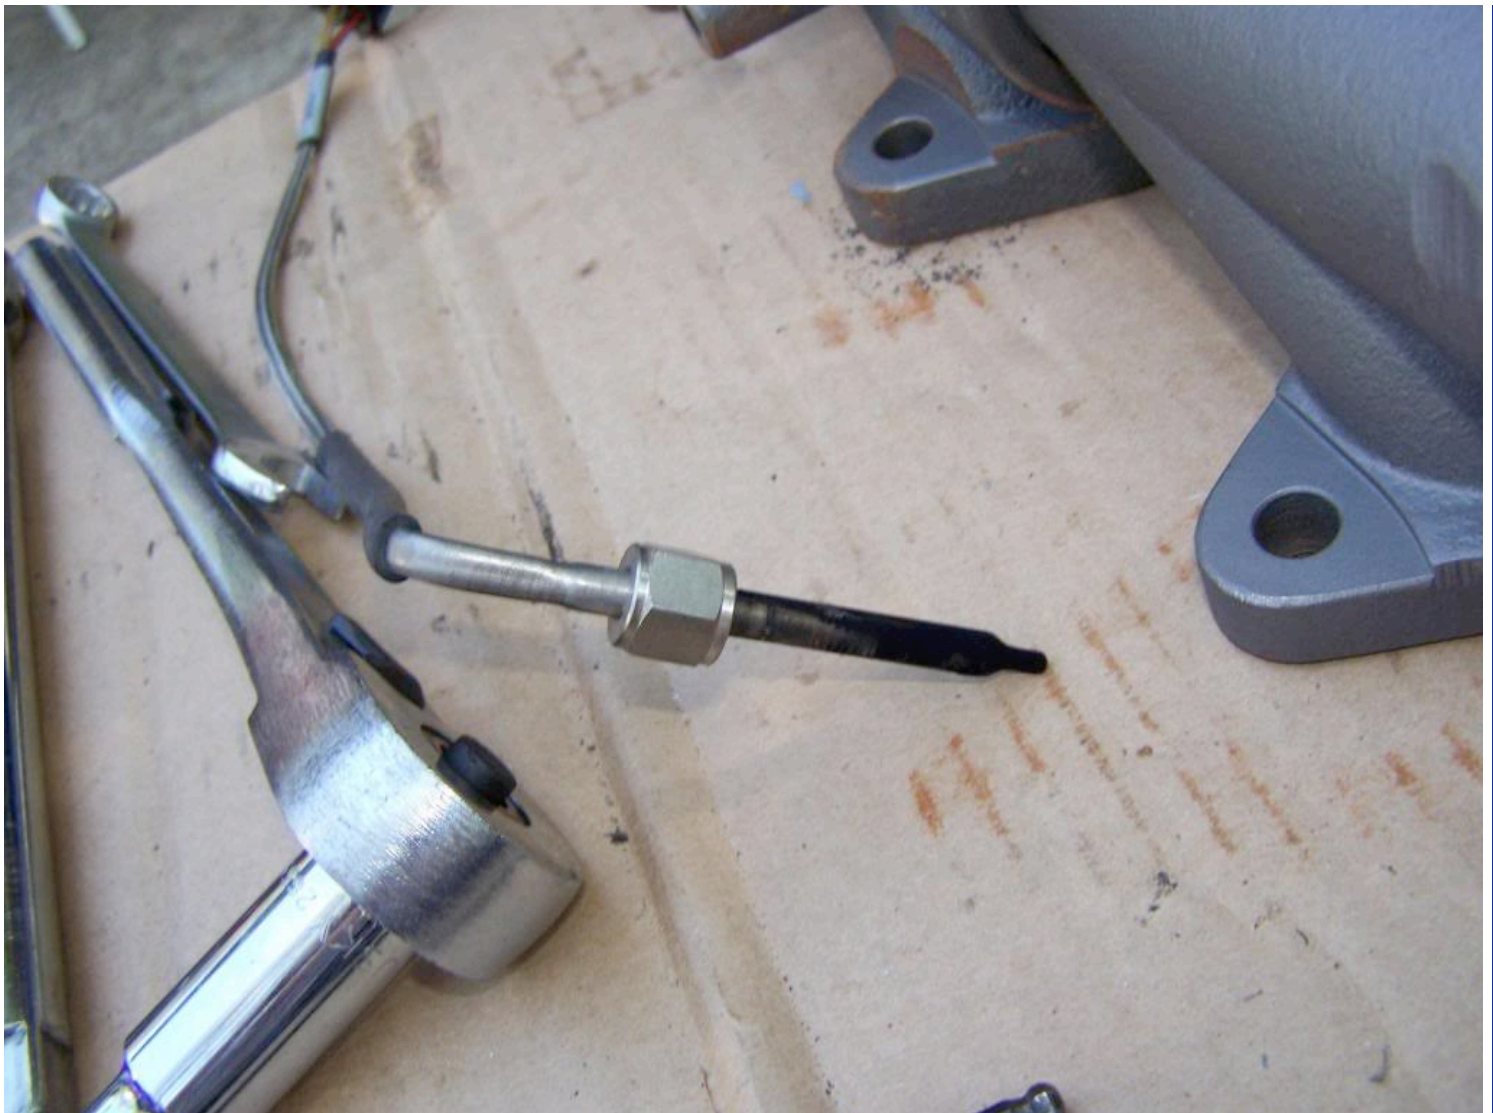
Once this was done, we installed the EGT probes and found another problem. The location of the ports on the bottom of the BD manifold did not allow enough clearance for straight type EGT probes. The probes ran directly into the side of the SuperB compressor housing. We ended up taking two 90* probes off of another truck to make them fit.
