ATS or BD.....you decide.

The products that I'll be discussing are two competing sets of compound turbos, both installed on 2006 Dodge Ram's with Cummins Turbo Diesel engines. One set was from ATS, which included the Aurora 3000 and Aurora 5000 turbos and the other was from BD Power, which included the SuperB and R700 turbos. Both are advertised as towing / race setups.

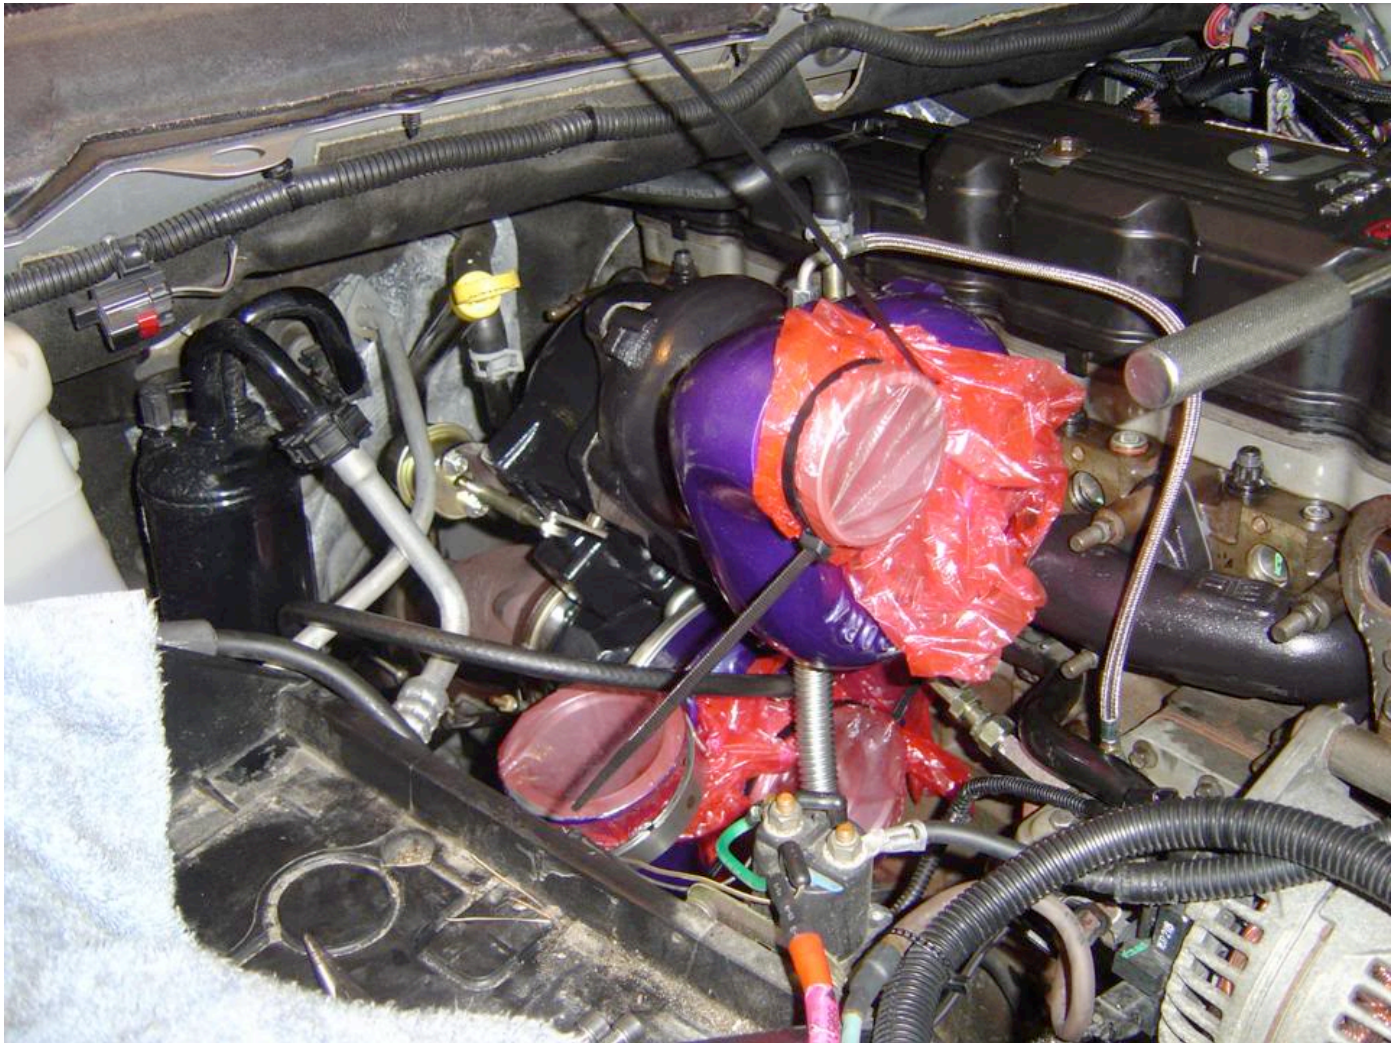
The ATS kit already had the secondary attached to the manifold, so all I had to do was check for proper torque specs on the fasteners.

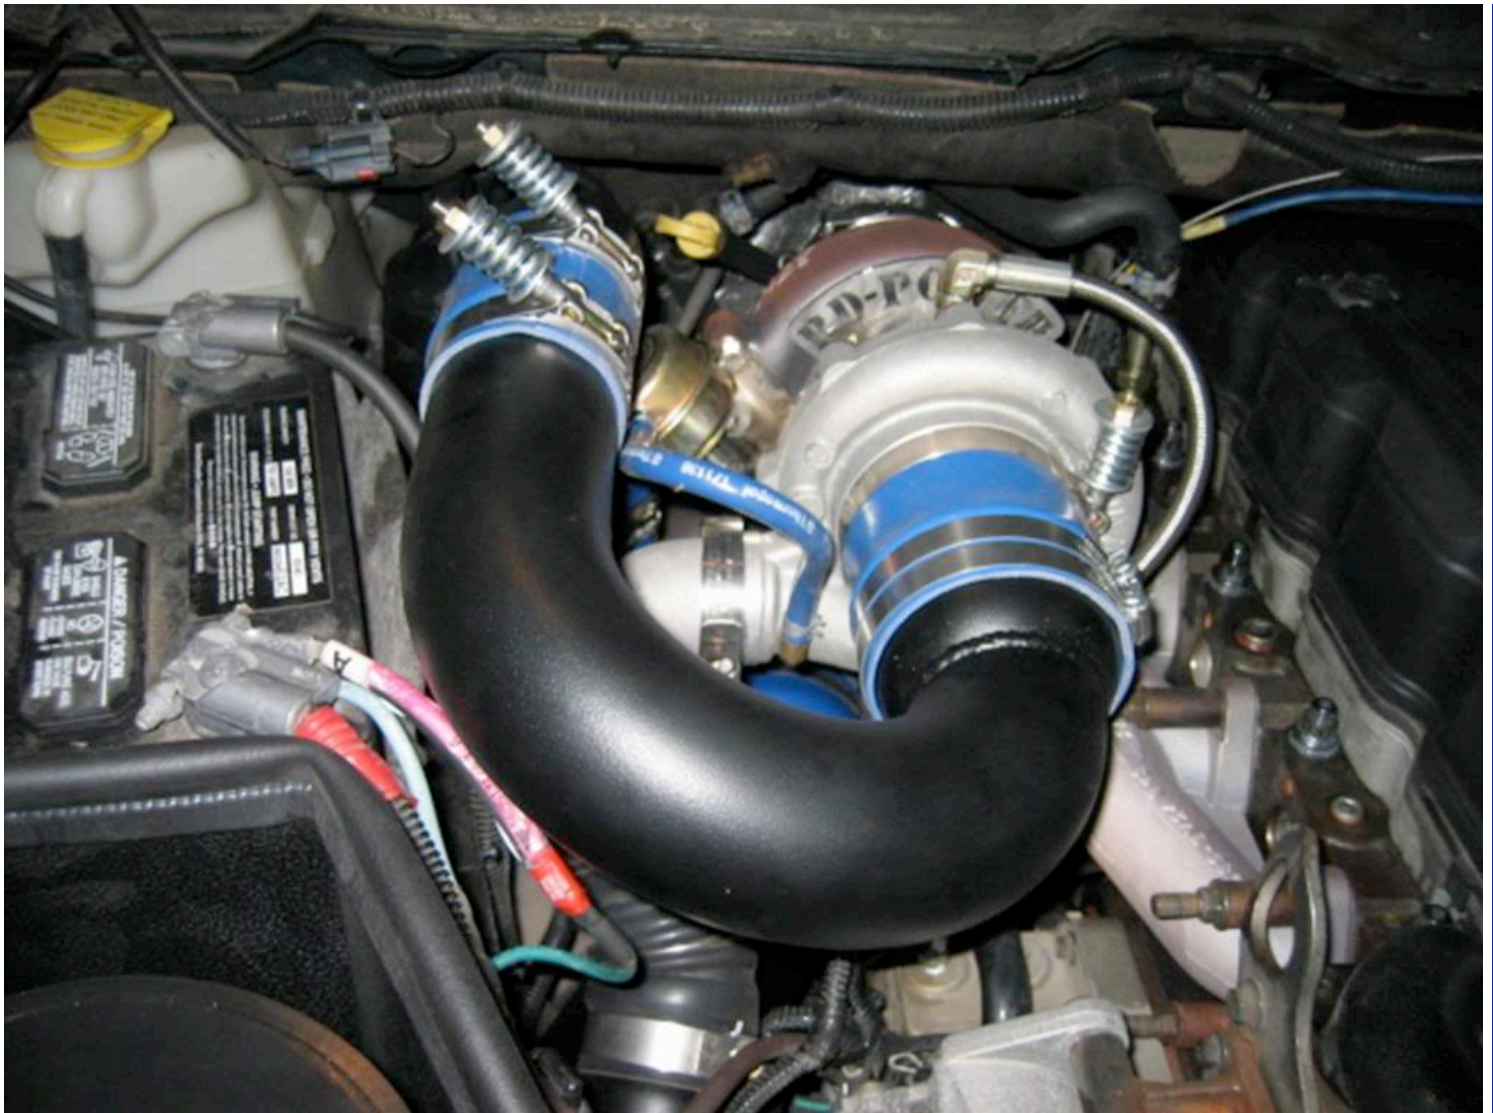
The BD kit called for new cap head bolts all the way around. These were supposed to be included in the kit, but were not, so the OEM studs were re-used. This caused another trip to the hardware store for cap head bolts to fit behind the manifold.

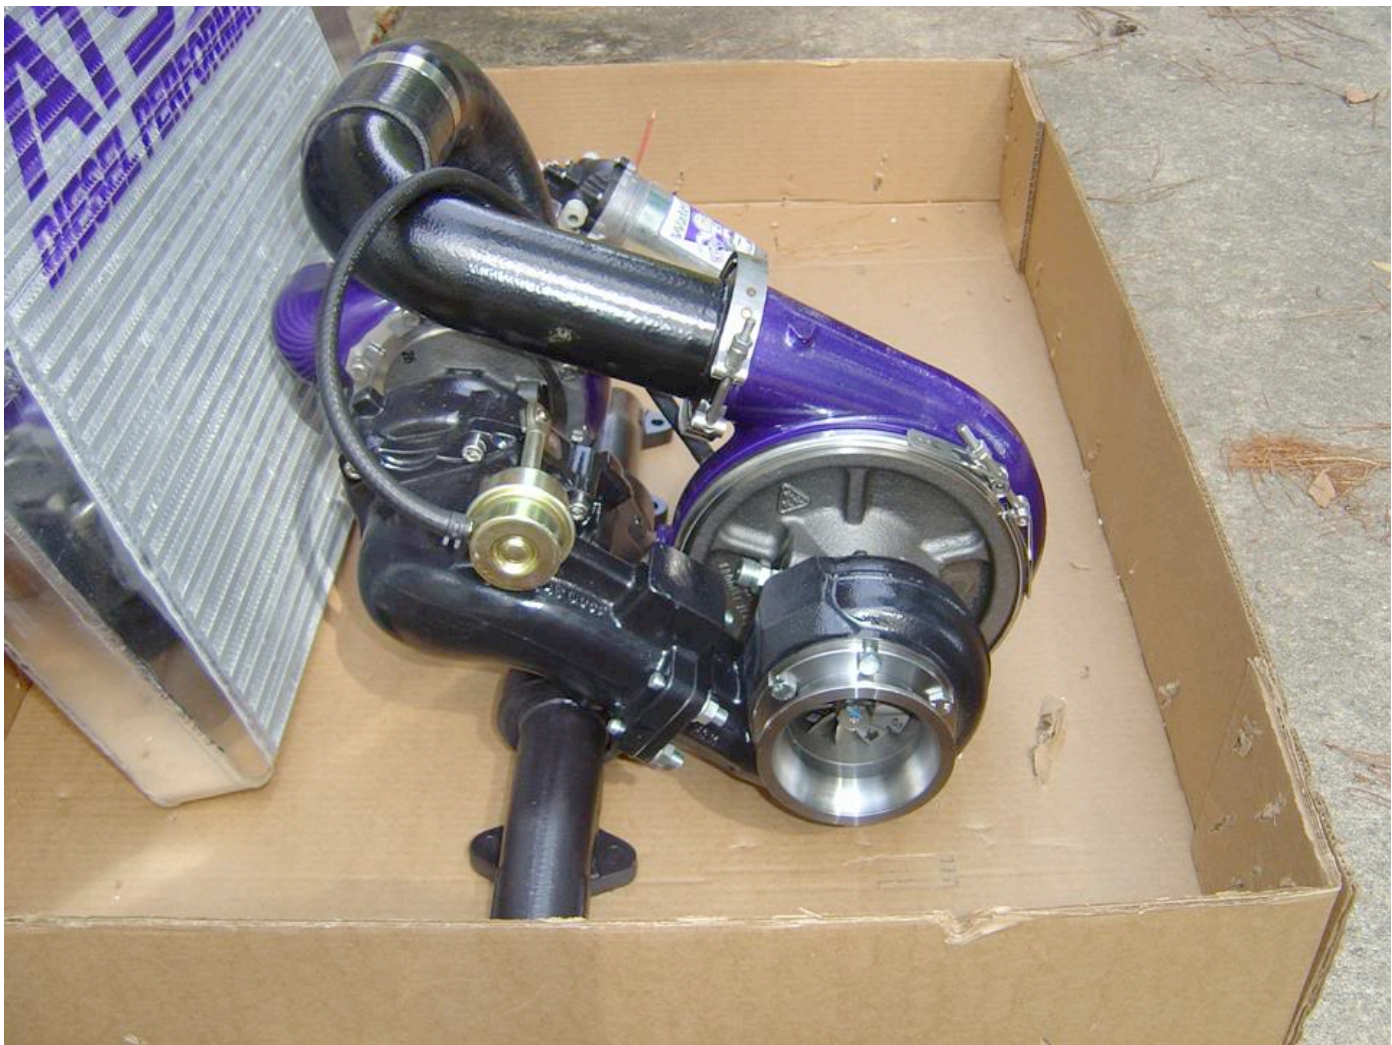
From here, the ATS kit requires attaching the exhaust adapter to the turbine housing of the secondary. This was simply a matter of lining up the holes and attaching the bolts. Using a ratchet wrench is essential here, otherwise you'll be making minute turns on two of the hard to reach bolts. The picture below shows the ATS exhaust adapter and where it fits to the secondary.

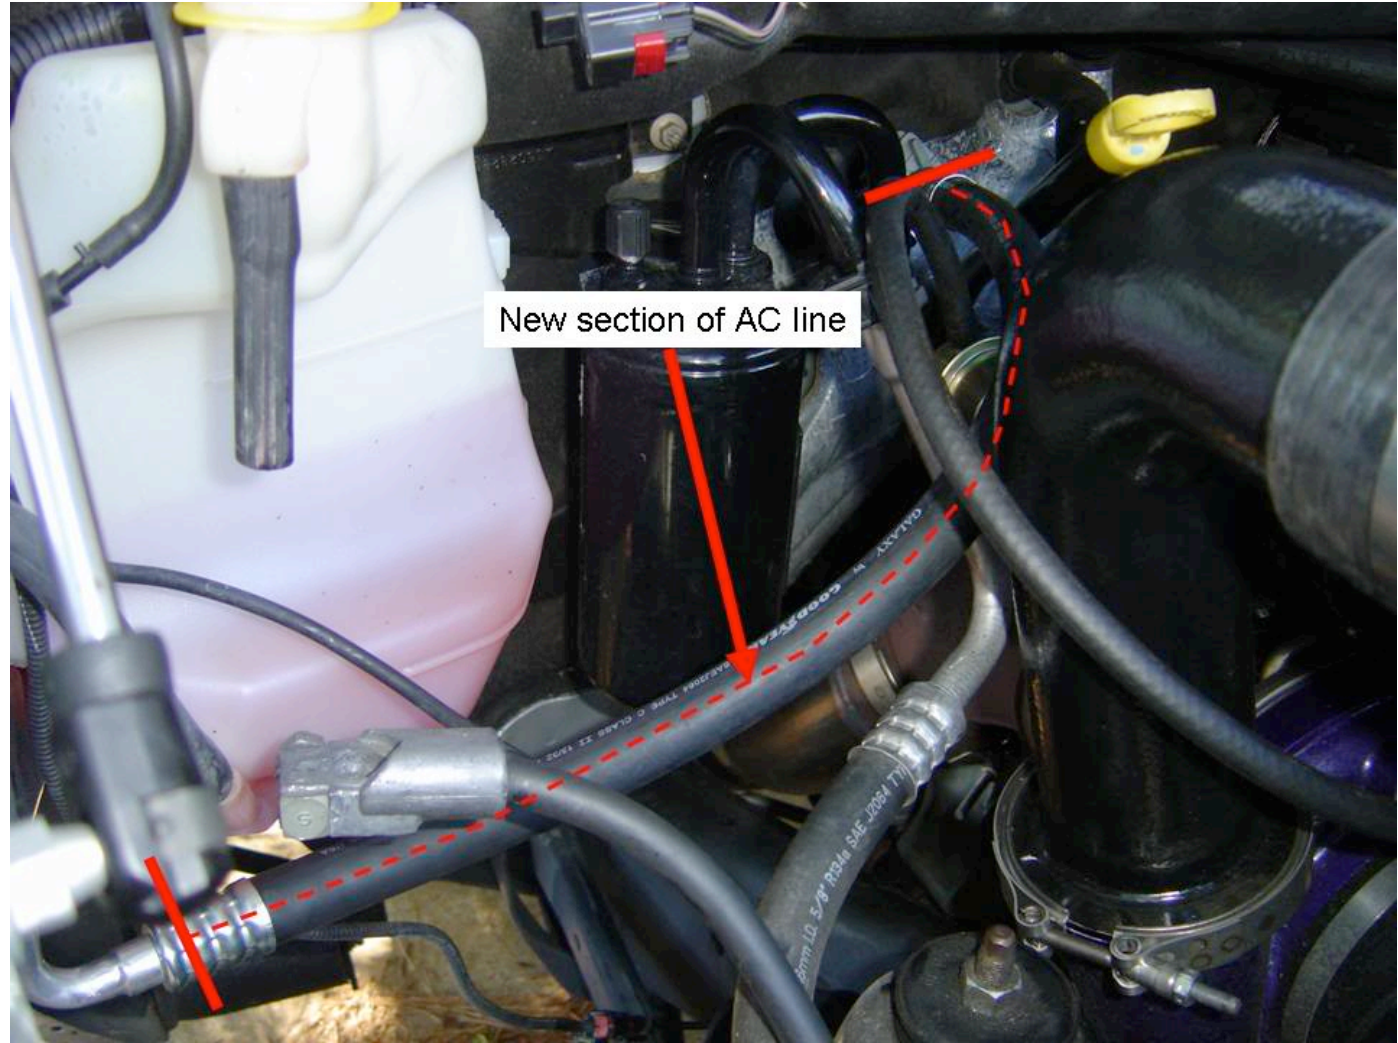
Now this is where we ran into a problem with the ATS setup. The location of the wastegate head was trying to occupy the same space as one of the AC lines. The required evacuating the AC system and removing the AC line until I could get a custom one made at a local shop. Here is the line I had to remove and the one I had had made to clear the wastegate head.

I contacted ATS regarding this, sent them the pictures and was reimbursed the that it cost me to have a new AC line made.

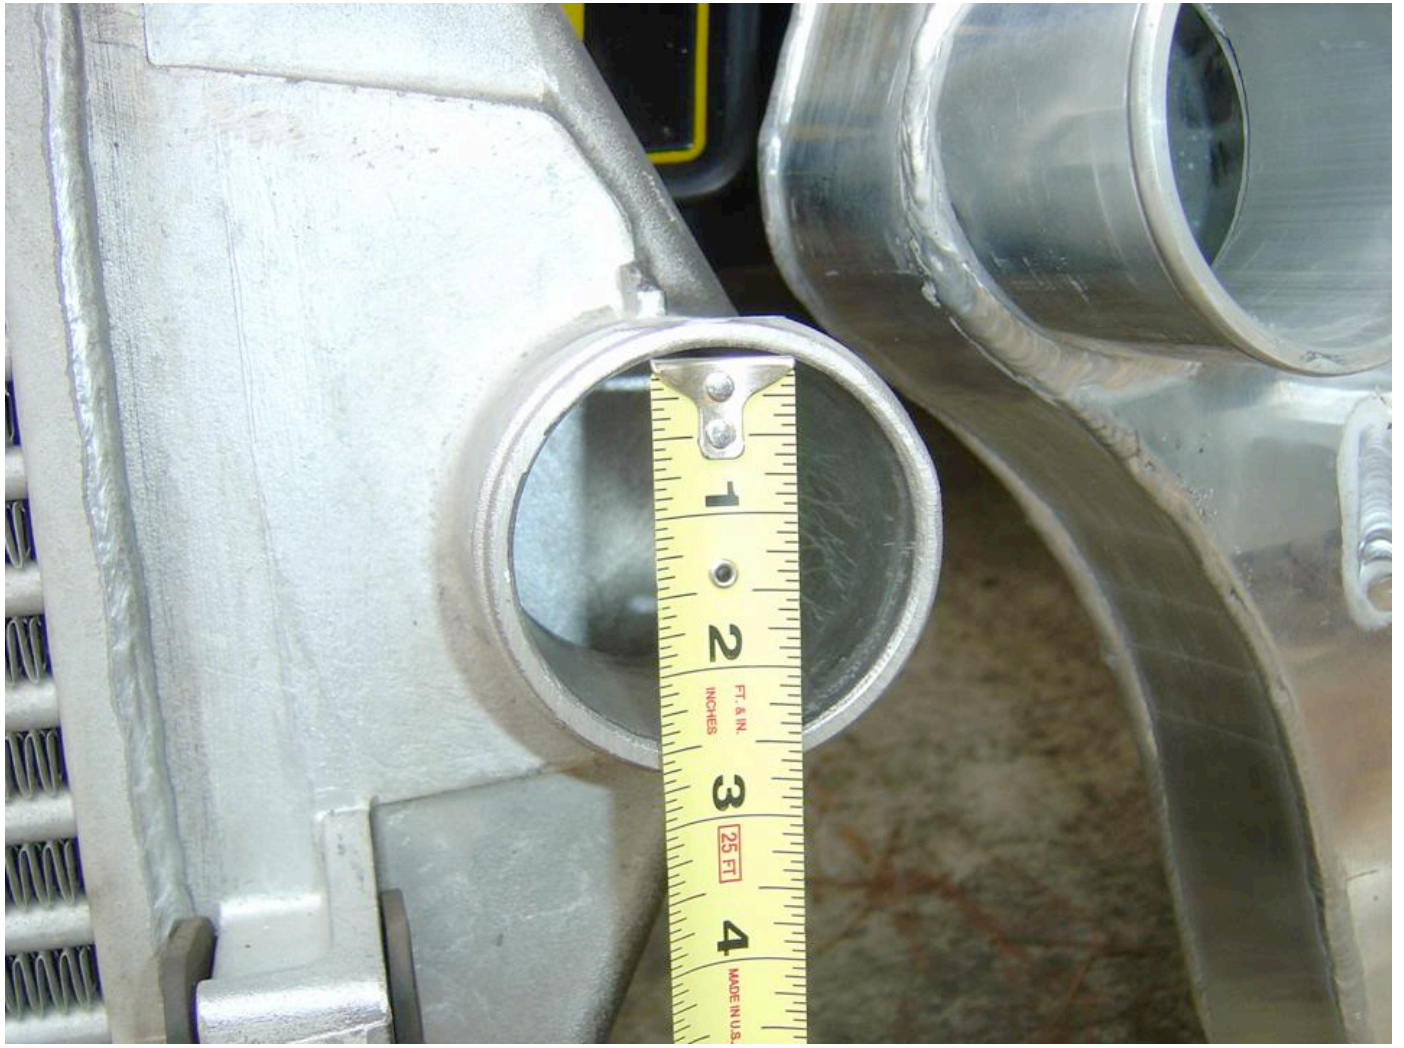
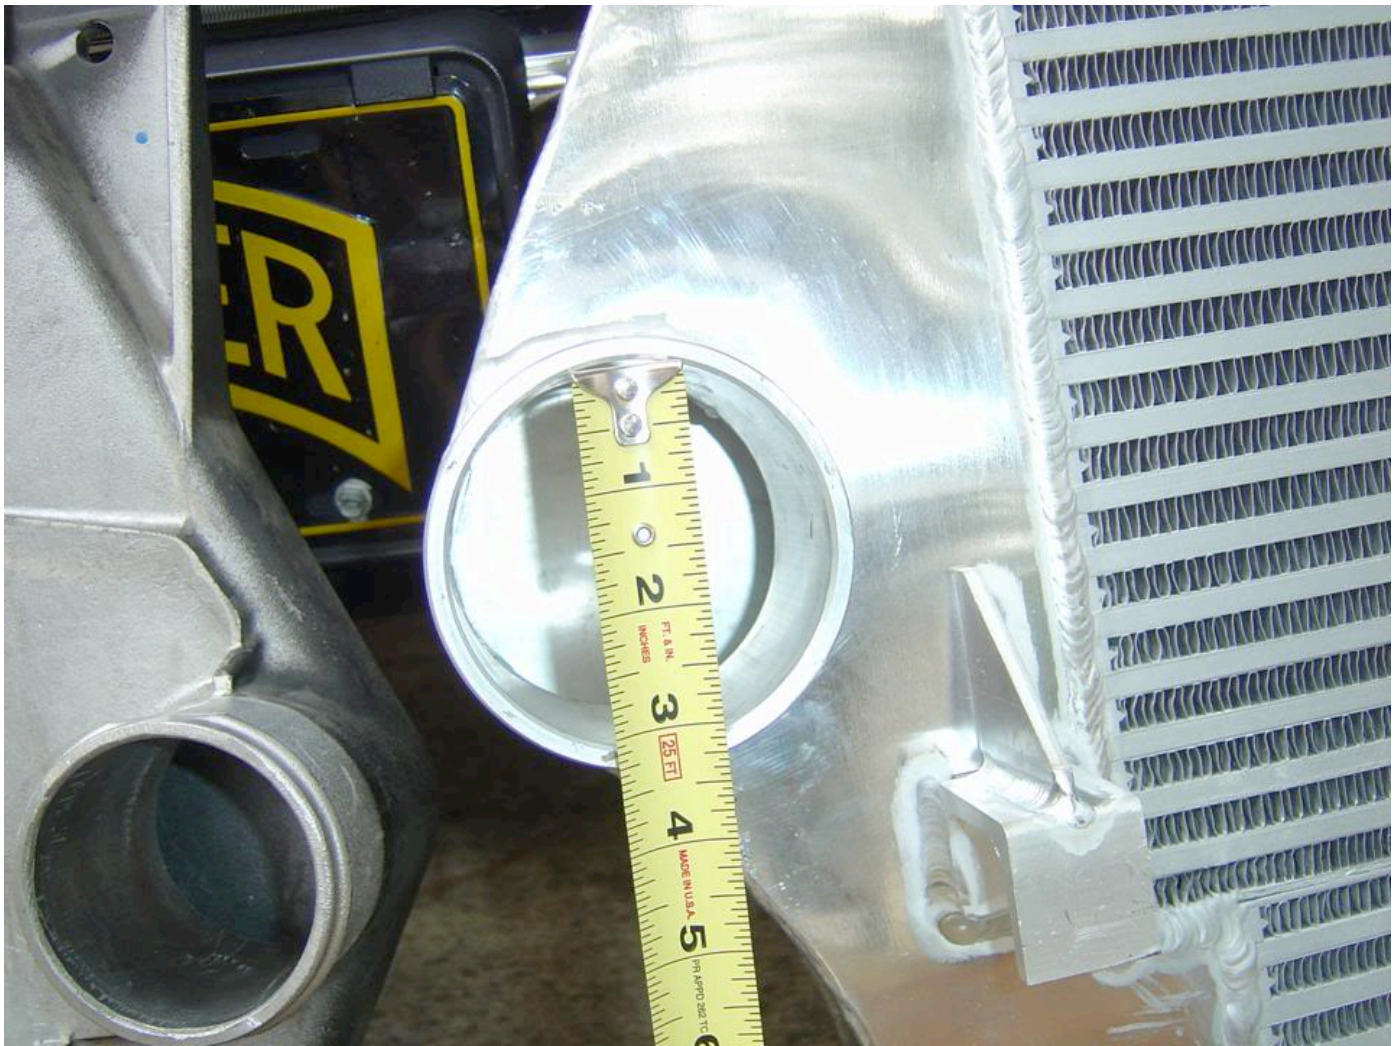
The ATS kit presented me with one final problem here. The kit comes with a 90* boost boot to go from the secondary boost tube to the intercooler opening. This boot is sized for a stock intercooler and I had the ATS intercooler that had a larger opening.

This required removing the ATS intercooler and re-installing the stock intercooler until the new one from ATS showed up, which was sent overnight.

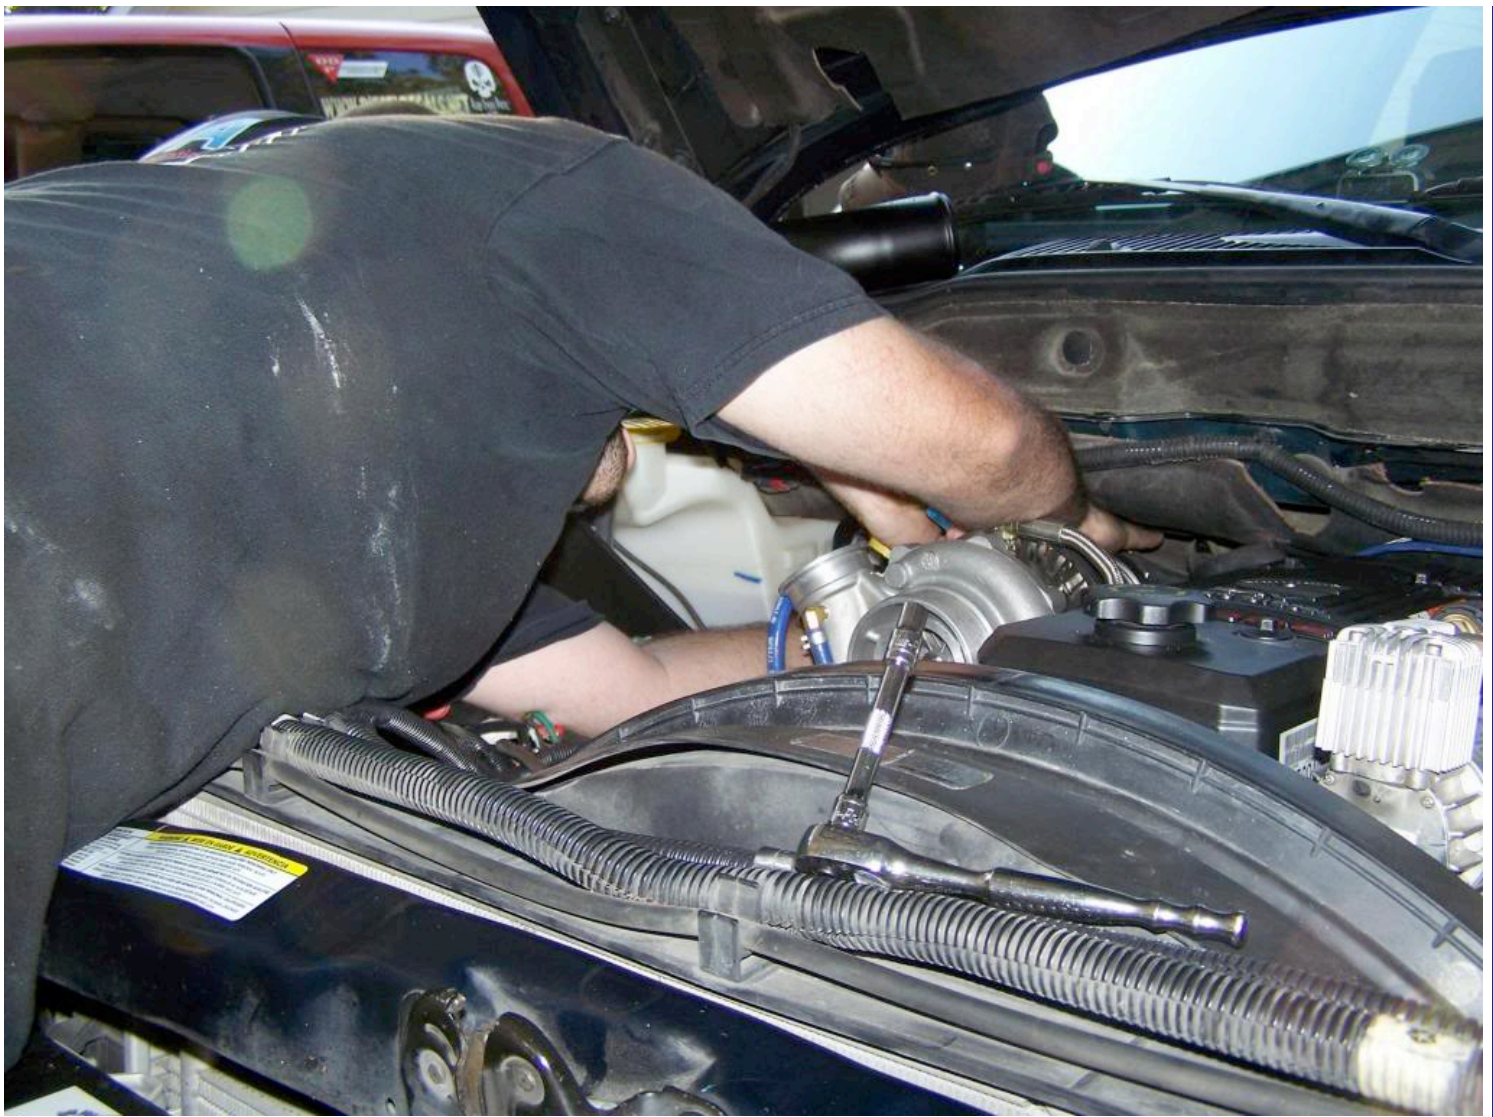
As we began routing the piping, we found that the compressor outlets still needed some tweaking to line up. Other than it being a pain to reach all the hold down bolts at this point, we found that the location of the wastegate head made it impossible to turn the compressor outlet to the correct position. You could go toward the engine, as it would hit the manifold and you couldn't go toward the battery as you hit the wastegate head. So, we had to remove the wastegate head, clock the compressor housing and then re-install the head. Now, the location to the wastegate head and it's 3 bolts make this a task for a contortionist. This took us a little while an increased our vulgarities count significantly.
