Installation Instruction:

Product: NDS6223EP

Car Model: 2014-2015 Lexus LS460

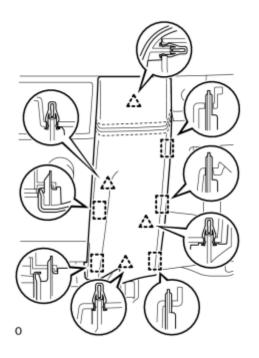
11. REMOVE LOWER NO. 2 INSTRUMENT PANEL FINISH PANEL.

(a) Detach the 4 clips and 5 guides and remove the lower No. 2 instrument panel finish panel.

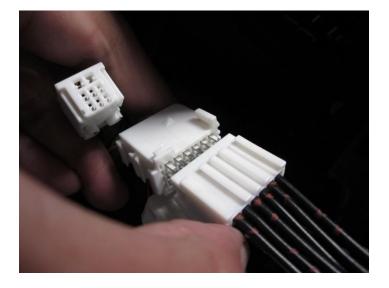
(e) Connect the male side of the NDS6223EP connector to the female connector which was disconnected from the previous step. Make sure the connection is secure and that none of the pins are exposed on the side.

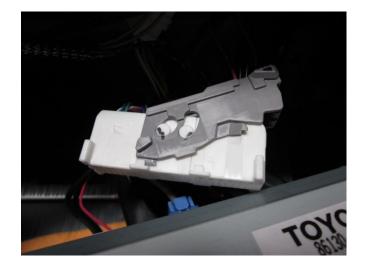
(f) Take the female side of the NDS6223EP connector and link it back to the main connector, then mount the gray bracket back to the main connector.

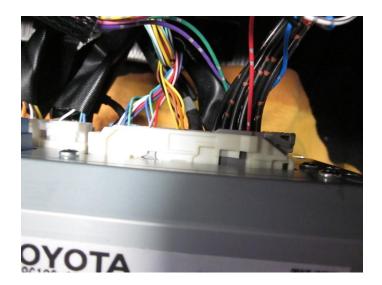
(g) Once the main connector is in one piece with the gray bracket, insert it back to behind the oem head unit.

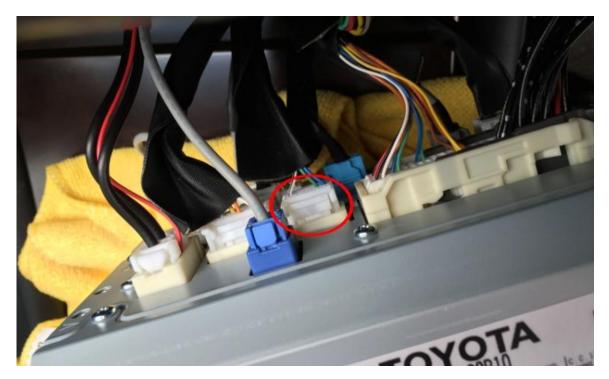
• Locate the matching connector behind the OEM head unit as shown on the photo.

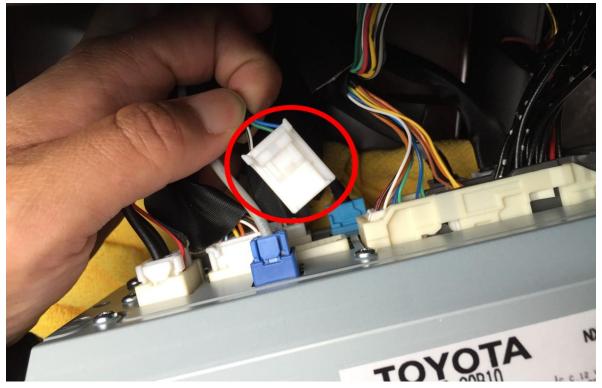
• Disconnect the steering wheel control connector.

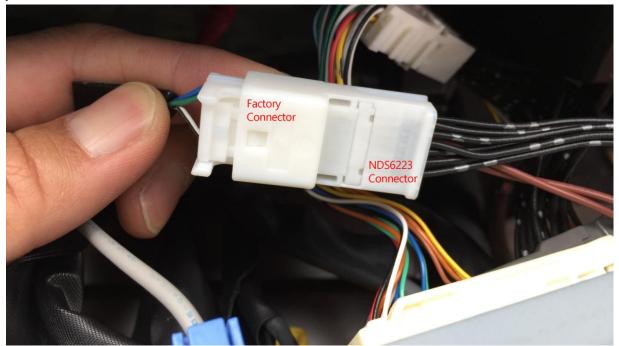
• Connect the matching connector on the NDS6223EP to the factory steering wheel control connector what you just disconnected from the head unit.

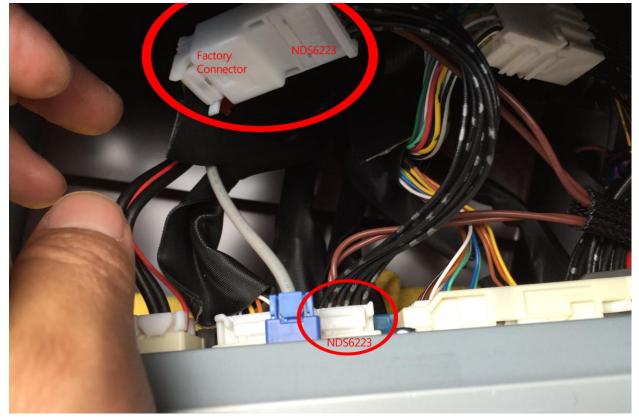
• Connect the other side of the NDS6223EP connector to the factory head unit.
