Vehicle Application:

Chevrolet Colorado/GMC Canyon 6' bed 2015-Current Part Number: 19220

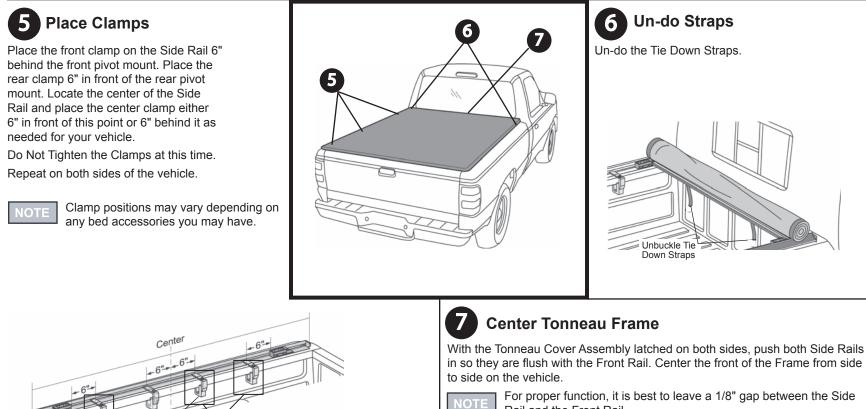
in so they are flush with the Front Rail. Center the front of the Frame from side

Rail and the Front Rail.
