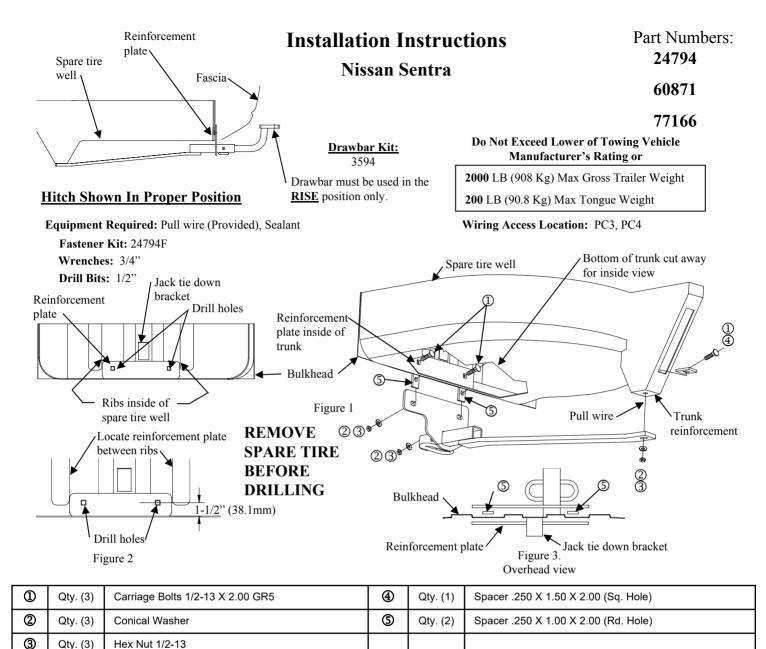
- 1 REMOVE SPARE TIRE FROM TRUNK. Remove jack from tie down bracket.
- 2 Remove the (2) plastic rivets that fasten the fascia tabs to the vehicle. Note: Remove the center of the rivet with a screwdriver. Rivets to be reinstalled.

- 3 Scrape undercoating off bottom of the surface of the trunk reinforcement.
- 4 Attach pull wire to carriage bolt and through spacer (Item 4) insert using slot located behind the trunk reinforcement making sure the spacer and carriage bolt sit flat at the bottom.

- 5 Place reinforcement plate inside spare tire well, at the bottom of trunk. Locate the 1-1/2" length against the bottom of the trunk. Place between the ribs as shown in Figure 2. Drill two holes.

- 6 Insert the carriage bolts through the reinforcement bracket and place (2) spacer (Item 5) on the carriage bolts from opposite side of bulkhead.
- 7 Lift hitch into position onto the two carriage bolts, sandwiching the spacer between the bulkhead and hitch. See Figure 3. Loosely attach conical washer and hex nuts.

- 8 Attach bar to trunk reinforcement using conical washer and hex nut (Item 2 & 3).
- 9 Center hitch on vehicle and <u>Tighten all 1/2-13 GR5 fasteners with torque wrench to 75 Lb.-Ft. (102 N*M)</u>.

- 10 Apply sealant at carriage bolt attachments inside spare tire well to prevent the intrusion of water and exhaust fumes to vehicle interior.
- 11 Reattach plastic rivets to fascia. Replace spare tire and jack.
