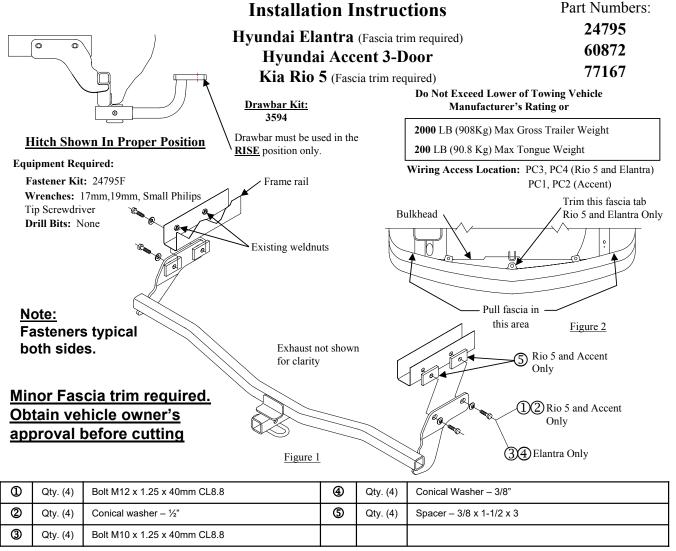
- <u>Elantra and Rio 5 models</u>: Trim center fascia tab. Obtain vehicle owner's approval before cutting. See figure 2.
- Lower vehicle exhaust by removing rubber exhaust hanger.

- Lift hitch into position, passenger side first. Place crosstube over top of tail pipe, with the side bracket as far into space behind
  wheel well, rotate into position on the outside of the frame rail. It will be necessary to pull the fascia gently out of the way. See
  Figure 2.

- Raise the drivers side of the hitch into position on the outside of the frame rails and in front of bulkhead. Once again pull the fascia gently out of the way. See Figure 2.

- Install fasteners as shown in Figure 1. Hand tighten fasteners.
- Push hitch toward the rear of the vehicle and tighten all fasteners.
- Reattach rubber muffler hanger.

Tighten all M10 CL 8.8 fasteners with torque wrench to 42 Lb.-Ft. (57 N\*M) Tighten all M12 CL 8.8 fasteners with torque wrench to 76 Lb.-Ft. (103 N\*M)
