Installation instructions

90-97 Mazda Miata

Set # 11.3106

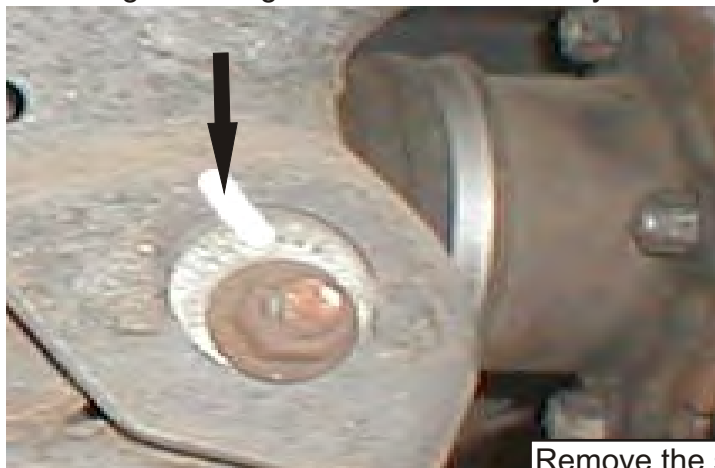
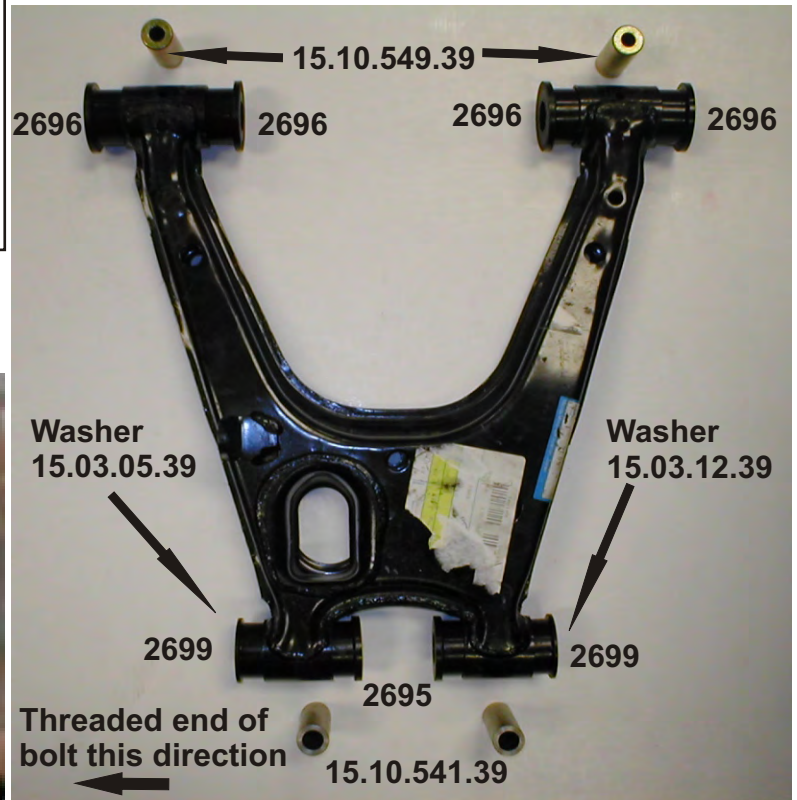
Remove the stock bushings from both control arms using heat rather than a hydraulic press to avoid accidentally bending the control arms.

Apply light heat evenly around the outside of the outer metal casing, just enough to brake the bond with the rubber. When you see light smoke coming from the sides of the bushing the bond should be broken. At no time should there be any flames coming from the rubber, if there are any flames, you need to back off with the heat. Just push the old rubber and inner metal sleeve out. Let the outer metal casing cool off before cleaning the inside.

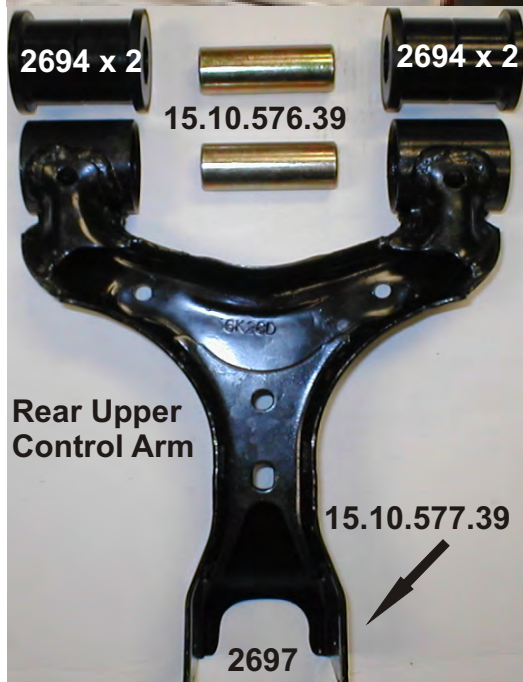
Remove the O.E bushing from the position in the hub, clean, lubricate and install poly bushings and sleeve.
