# Installation instructions

For set # 4.3168  
98-11 FORD RANGER 2WD  
WITH COIL SPRINGS

**ENERGY**  
**SUSPENSION**

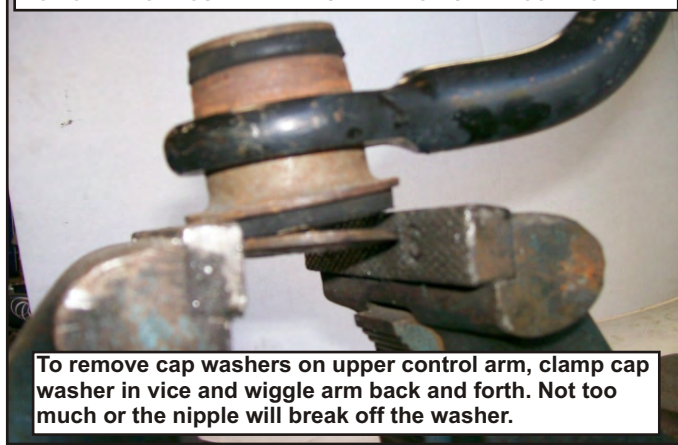
DO NOT REMOVE OUTER METAL SHELL FROM UPPER CONTROL ARM.

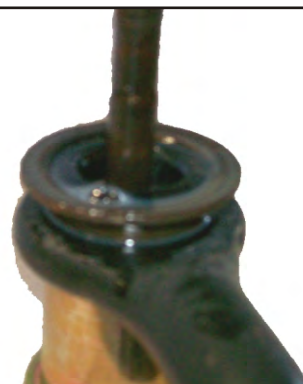
Rubber bushing is not bonded to outer metal shell. Use an arbor press and spray lube to push the rubber bushing out of the shell. Make sure inside surface of shell are free of all old bushing material and sharp edges.

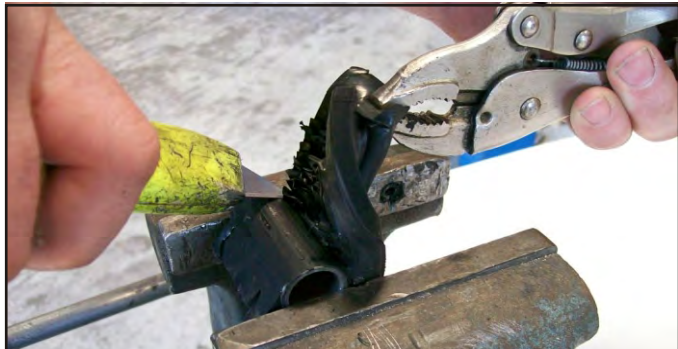
Inner sleeve is bonded with the old rubber bushing. To remove the old rubber bushing from the sleeve, clamp the sleeve in a vise and using a utility knife, slice the bushing longways away from yourself. Clamp the bushing with vicegrips pulling the rubber back and slice as close to the sleeve as possible. Rotate the sleeve in the vise until you get all the way around. Clean as much rubber off the sleeve until smooth.
