# INSTRUCTION SHEET FOR SET #5.3134

## 2003 Mitsubishi Lancer Evolution 8, Rear Control Arm Set

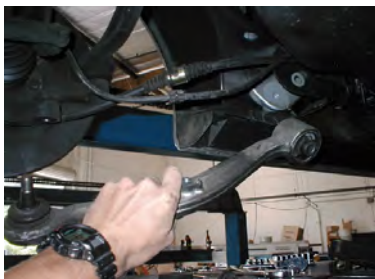
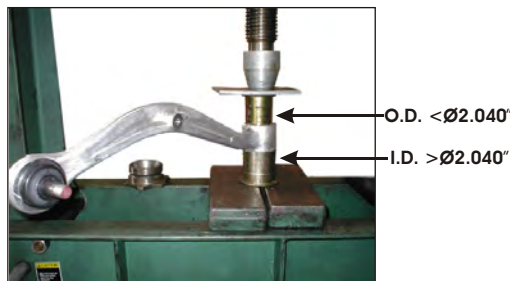
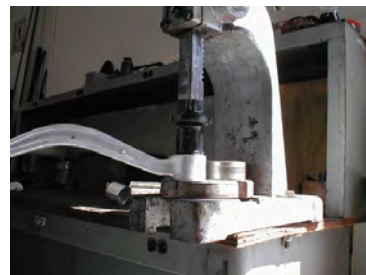
Using a hydraulic press, remove the OEM bushing and shell from the control arm.

Using an arbor press, install Energy Suspension bushings and sleeves, apply grease to bushings and sleeves, reinstall control arm and tighten all bolts/nuts to factory specifications.
