## **INSTALLATION**

# TRIFECTA Tool Box

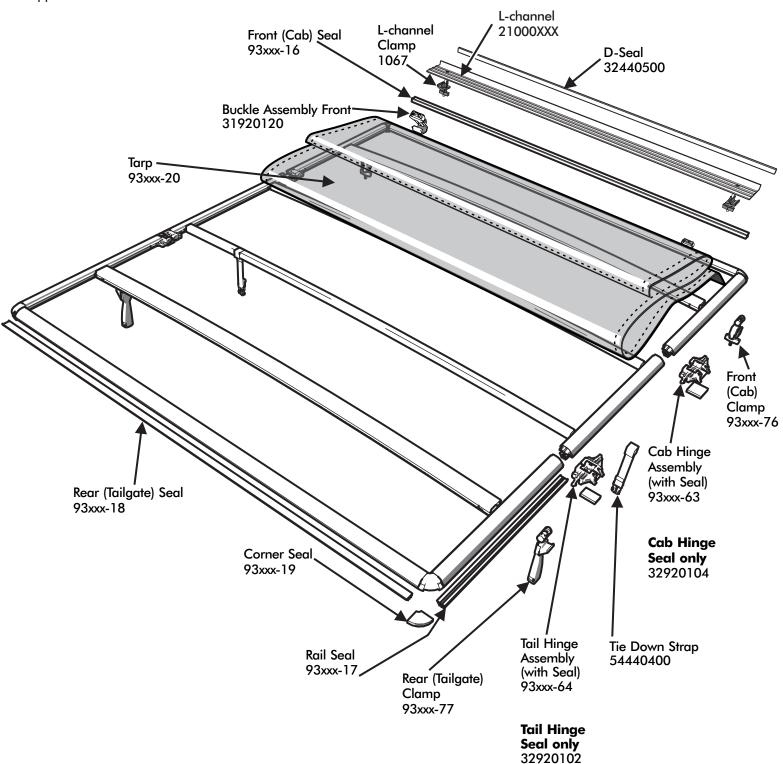
### **Replacement Parts**

NOTE: To order replacement parts, it's best to contact our Customer Service Department for assistance, to ensure getting the correct part for your vehicle application. When ordering, xxx represents the 3-digit suffix, as referenced on the sales receipt or vehicle application list.

Specify: Year, Make, Model, bed length, Driver or Passenger side. Call Customer Service if frame or bow sections are required.
