FT92023 DRIVESHAFT CARRIER BEARING KIT
FORD F-250/350 SUPER DUTY

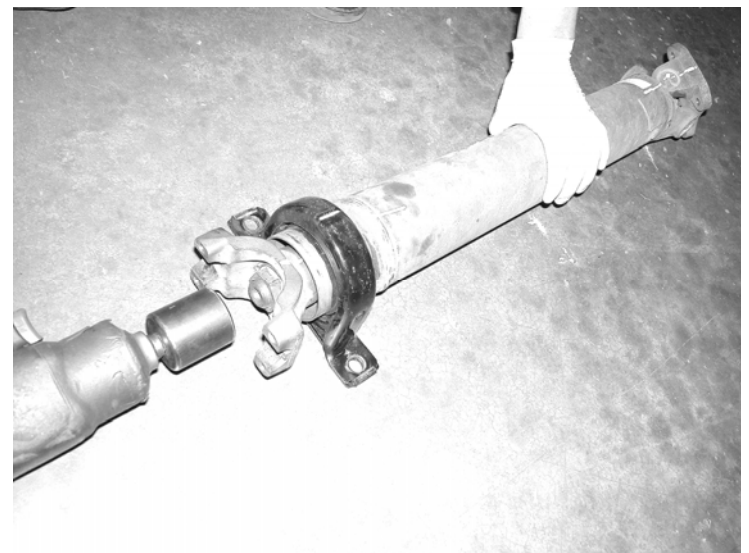
8. Re-align the marks on the drive shaft and the yoke and tighten the nut. SEE PHOTO BELOW.

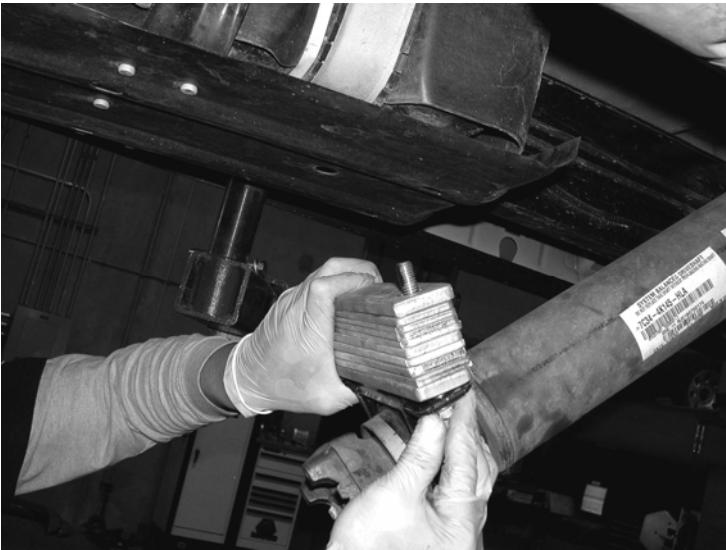
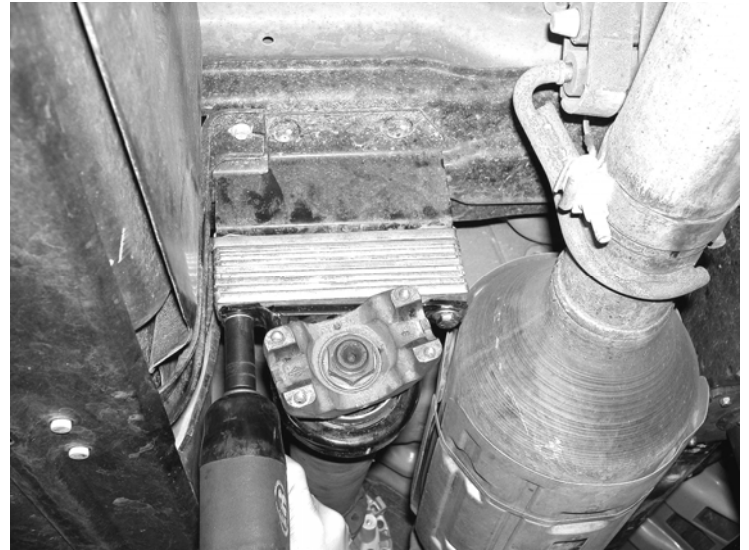
10. Install required FT419 Carrier Bearing Shim Kit at this time and re-attach carrier bearing to the frame cross member. SEE PHOTOS BELOW AND NEXT COLUMN.

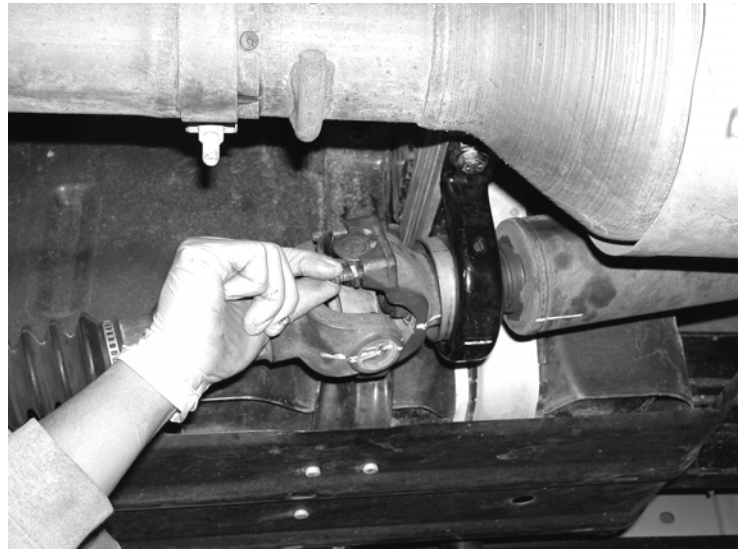
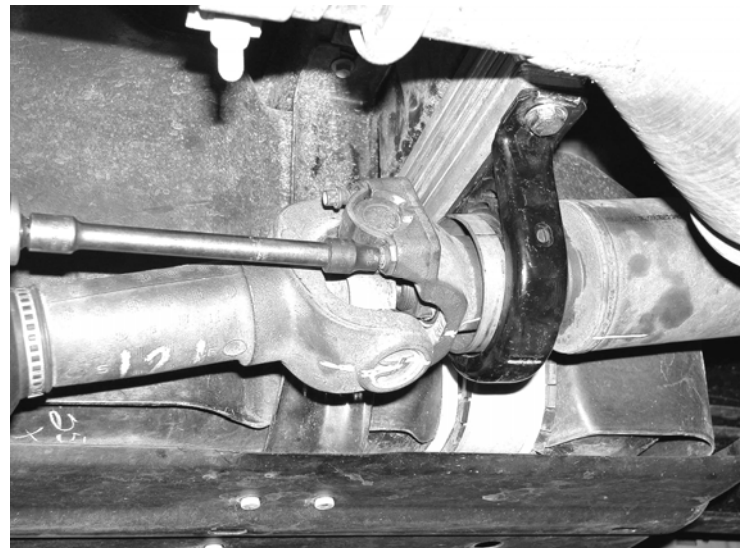
11. Re-align marks on front and rear drive shaft halves and re-attach with factory hardware. SEE PHOTOS BELOW.
