WATER PUMP
TROUBLESHOOTING GUIDE

GMB
Your success is our Future.

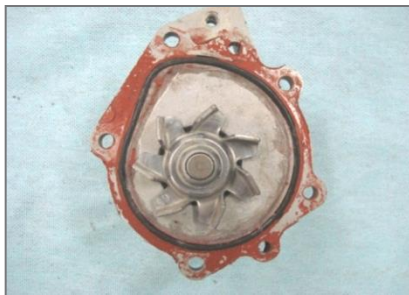
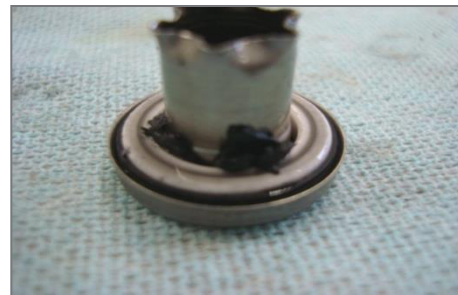
2. Do not apply liquid sealant to O ring

By applying liquid sealant for O ring type seal, excess amount of liquid sealant mixes with coolant inside the water channel and intrudes into the mechanical seal contact surface which will cause leakage.

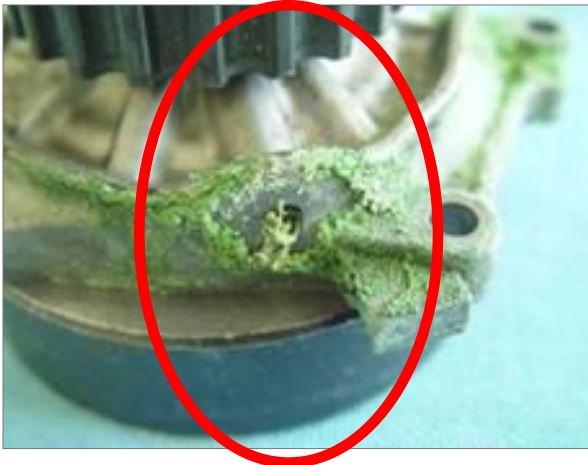
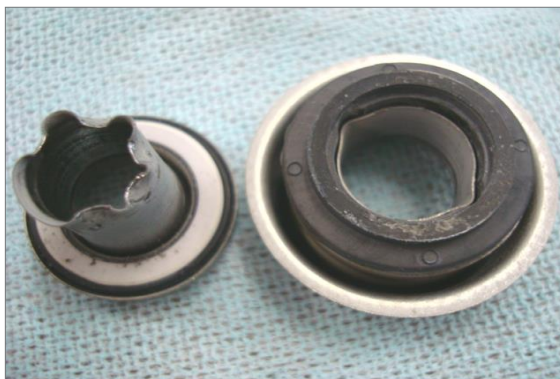
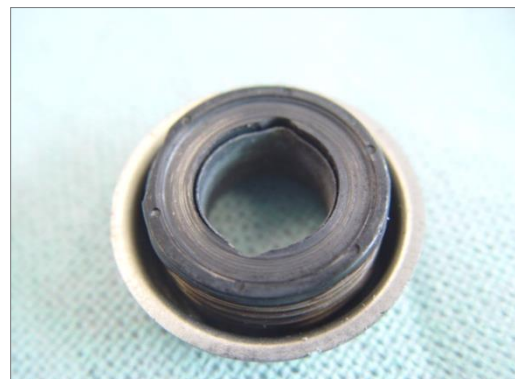
1. Leakage out of weep hole

Wear by Coolant

Resulting from sludge or rust from metallic corrosion carried by coolant intruding into the mechanical seal surface and abrading sealing surface so sealing performance decreases

Prevention

- Coolant needs regular maintenance
- Cooling system should be flushed completely at replacement.

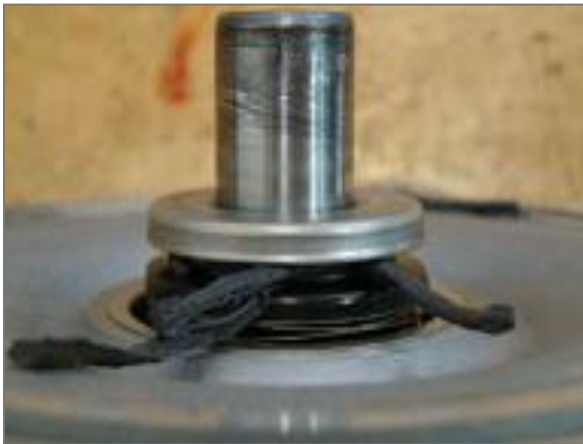
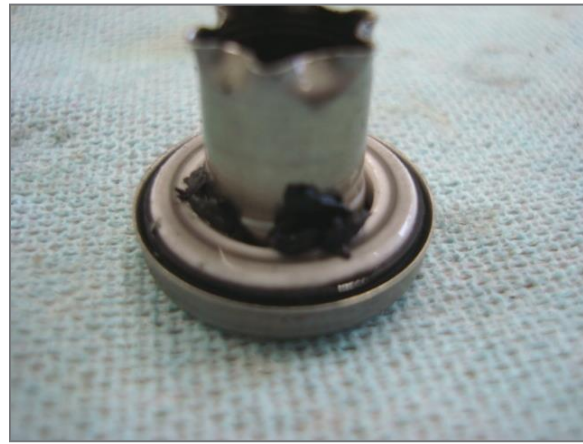
Cause2

Usage of excess liquid sealant

Excess amount of liquid sealant mixes with coolant and intrudes between opposing sides of the mechanical seal, stopping full seal being made and causing leakage

Prevention

- Liquid sealant must be applied evenly to water pump gasket surface. However, do not apply liquid sealant for O ring and metal gasket

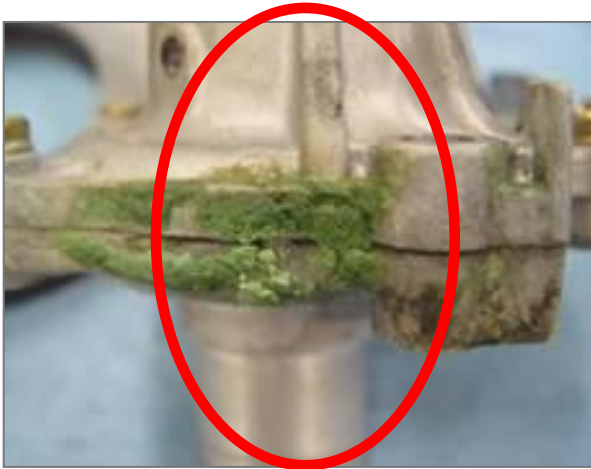
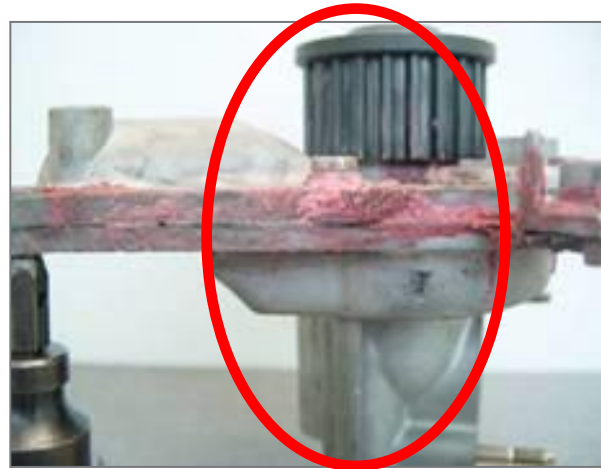
2. Leakage from Mounting Surface

Contamination on mounting surface(Sealant grime etc.)

Liquid sealant is not applied

Applying sealant on supplied O ring, Metal gasket

Improper installation

• Ensure mounting surface is free from remaining gasket /sealant without causing damage on mounting surface

• Apply sealant on both side of supplied gasket

• Do not apply liquid sealant on O ring type seal.

• Tighten mounting bolts using manufacturer's specified torque evenly in a diagonal pattern

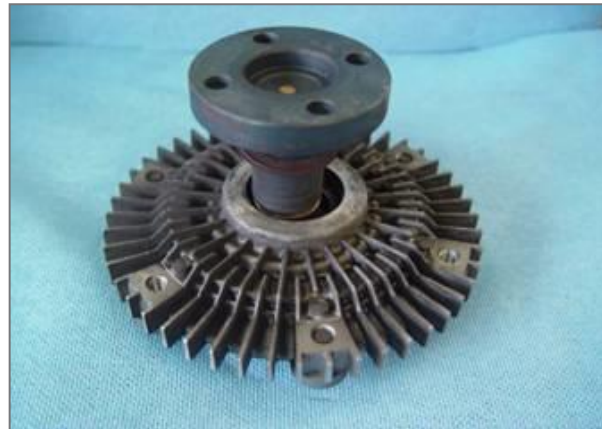
3. Noise

Fan clutch bearing blocked
→ breakage

Bearing Noise

Mechanical seal failure
causes coolant to intrude
into the bearing

Excess vibration by other
installed parts(pulley/fan)

Excess belt tension

• Regular coolant
maintenance

• Fully check abrasion
condition, run-out of
pulley/fan and replace
them if found abnormal

• Keep belt tension within
the values specified by car
manufacturer

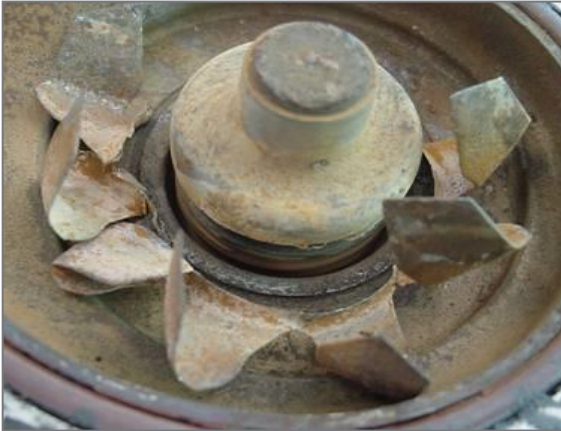
Impeller Corrosion

Frozen coolant

Corrosion due to coolant deterioration (oxidation etc.)

Prolonged use of coolant exhausts the rust preventive chemicals and ethylene glycol which are main element of antifreeze turns into formic acid

- Use coolant specified and suitable for cold districts

- Do not recycle used coolant

- Use a good quality coolant with concentration corresponding to respective area climate

- Regular maintenance of coolant

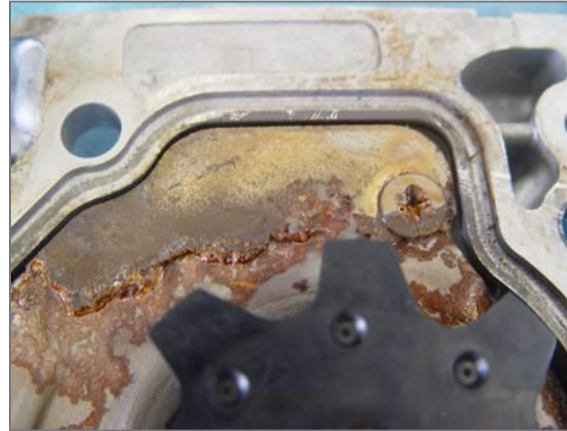
Bottom plate corrosion
