• '04-08 Ford F-150 • '06-'08 Lincoln Mark LT

#119

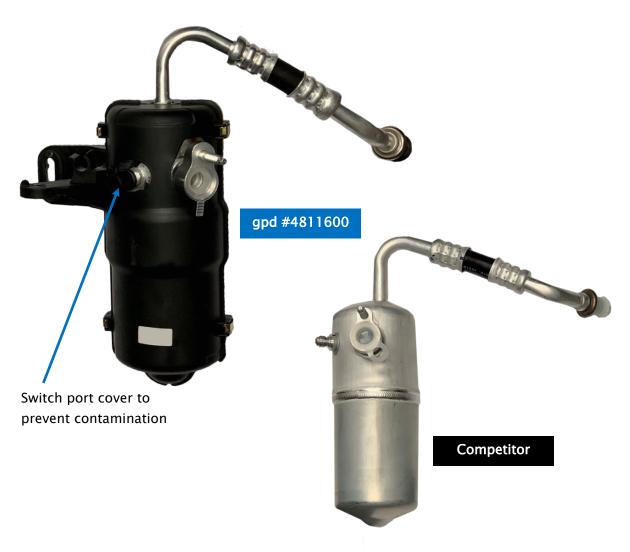
Not all accumulator replacements are the same. Some Ford accumulators are designed with a protective cover around the accumulator. This protective cover is often ignored by aftermarket air conditioning suppliers. To save customers time and money, gpd has included the protective cover around the accumulator for the applications listed above.

The protective cover on the accumulator for these vehicles helps reflect heat from the engine bay and functions as a mount. Over time, the plastic can get brittle when subjected to heat and vibration within the engine bay. The protective cover is held together by spring steel clips that often get lost during replacement. The cover may also be unusable if the mounts break off. The plastic covering, by itself, would need to be purchased directly from a dealer. Save time and money with gpd's direct replacement accumulator #4811600.
