2014–2017 Chevrolet (Silverado, Suburban, Tahoe) GMC Sierra, or Cadillac Escalade. 6513078

Are you or your customer repairing a 2014–2017 Chevrolet Silverado, Chevrolet Suburban, Chevrolet Tahoe, GMC Sierra or Cadillac Escalade? If so, are you aware that there is a major issue with the condenser leaking on this vehicle?

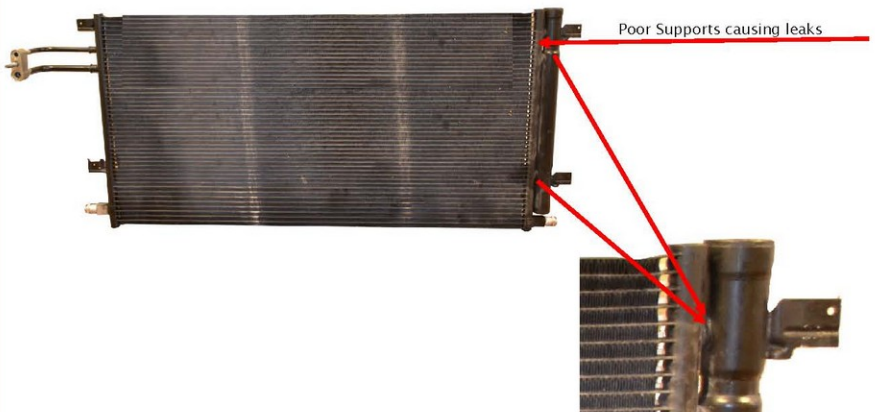
When looking at the grill, you will notice that the condenser leaks on the driver's side at the top right drier fitting between the driers and the condenser. Before doing a compressor job twice or before someone returns under warranty, make sure you double check the condenser first, it may save you a lot of time. gpd's condenser replacement for these vehicles is gpd #4283C.

If the system is low on refrigerant, the compressor will not pump at full stroke, which leaves the technician to believe that the compressor may be faulty. However, the real issue could be a leaking condenser.

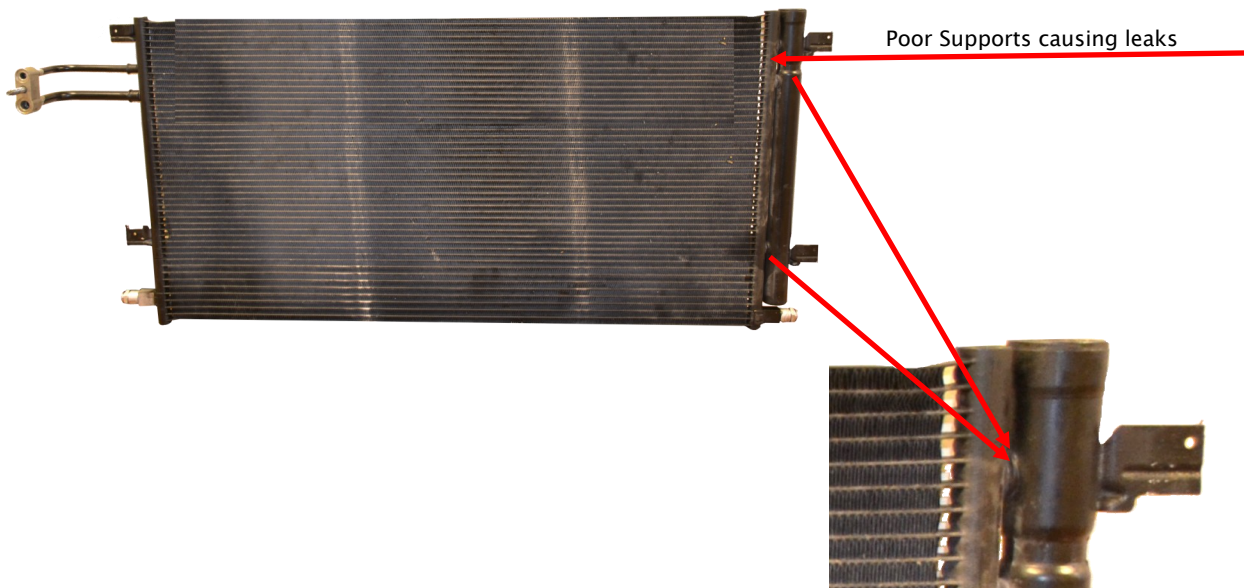
When looking at the grill, you will notice that the condenser leaks on the driver's side at the top right drier fitting between the driers and the condenser. Before doing a compressor job twice or before someone returns under warranty, make sure you double check the condenser first, it may save you a lot of time. gpd's condenser replacement for these vehicles is gpd #4283C.

If the system is low on refrigerant, the compressor will not pump at full stroke, which leaves the technician to believe that the compressor may be faulty. However, the real issue could be a leaking condenser.
