### Ford Instruction Supplement Form: 500-1017

Beginning in 1966, some Ford vehicles have a small (unused) stub protruding from the end of steering shaft. To allow adequate clearance for GT 3 horn button, it will be necessary to cut-off this portion of the shaft.

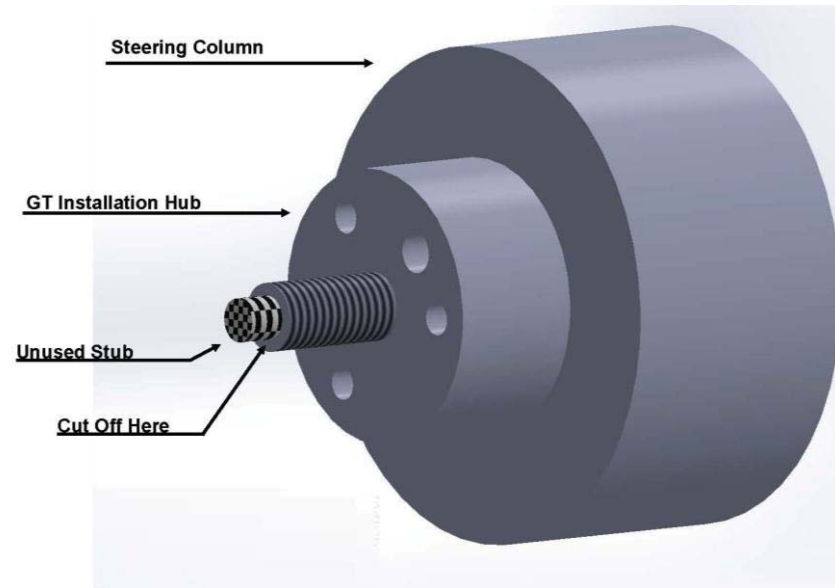
- 1) Position nut onto shaft and thread down just below stub portion of shaft.
- 2) Shield column so no shavings get into the column.
- 3) Using a hacksaw, cut-off stub portion of shaft **flush** with threaded portion of shaft.
- 4) Remove shaft nut and proceed with installation.
