PART #	DESCRIPTION
98505DJ	04-UP F150/14-UP EXPEDITION BILLET UCA DJ KIT

ICON VEHICLE DYNAMICS®
PERFORMANCE SUSPENSION SYSTEMS AND SHOCK ABSORBERS

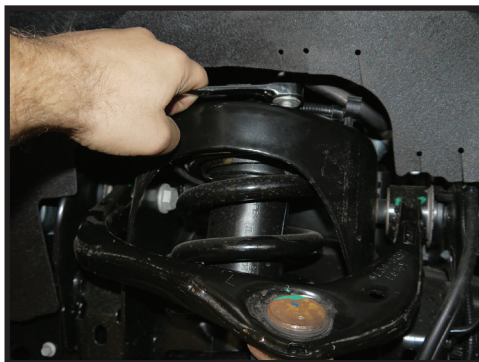
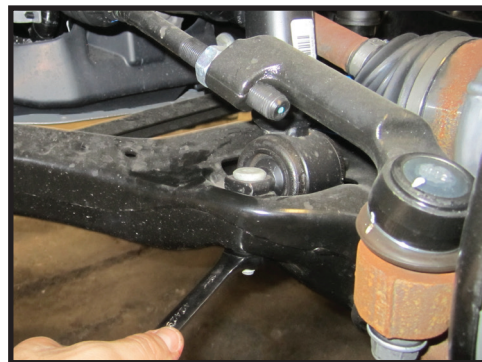
- Using a properly rated jack, raise the front of the vehicle and support the frame rails with jack stands. Ensure the jack stands are secure and set properly before lowering the jack. NEVER WORK UNDER AN UNSUPPORTED VEHICLE. Remove the front wheels.
- Remove the coilover/strut assembly to gain access to the upper control arm bolts. Remove the lower shock bolt and then remove the (3) nuts on top of the coilover (use a 15mm, 27mm & 30mm socket/wrench for stock assembly, 9/16" & 15/16" socket/wrench for ICON assembly). Removing the lower shock end out of the pocket in the arm can be difficult because you are fighting the bushing stiffness from the lower control arm and sway bar tension. Disconnect the sway bar links and/or the top of the other shock to relieve some of this tension. [FIGURE 1 & 2]

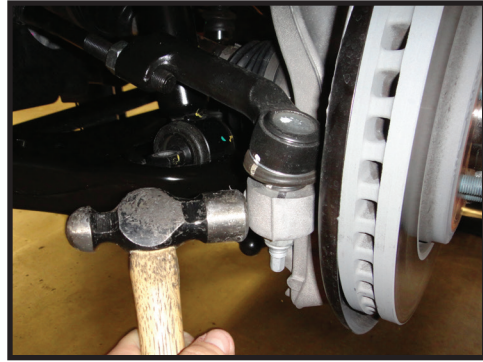
3. Loosen the taper on the upper ball joint and the tie rod end using a 21mm socket/wrench. Using a hammer, strike the steering knuckle to separate the upper ball joint taper and tie rod end. Take care not to damage the threads. Support the steering knuckle so that it does not overextend the CV joints when detached. [FIGURE 3 & 4]

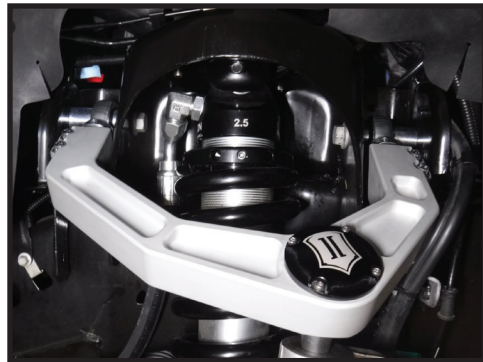
FIG.6

6. Place the ICON upper control arm into the mounts on the chassis and hand tighten using OEM hardware. [FIGURE 6]

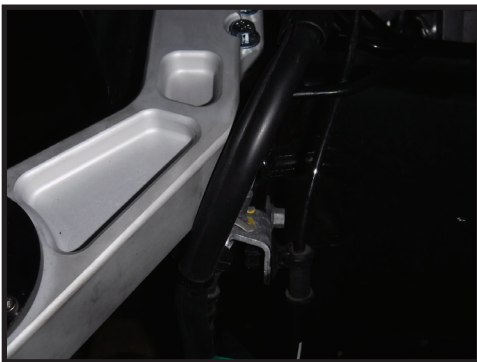
9. If the brake line bracket behind the arm is making contact at the full droop position, bend the bracket outward slightly to allow clearance. Be careful not to damage the ABS wires or brake line. [FIGURE 7 & 8]

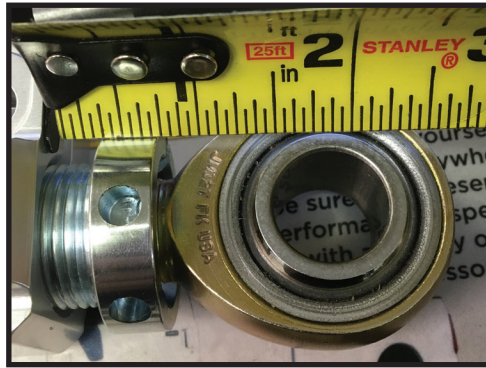
[TECH NOTE #3]

(2) 157507 BILLET UCA DUST COVER	
TOOLS REQUIRED	
JACK JACK STANDS 3MM ALLEN WRENCH TORQUE WRENCH	15MM SOCKET / WRENCH 21MM SOCKET / WRENCH 24MM SOCKET / WRENCH 3/8" 12PT SOCKET / WRENCH
TECH NOTES	
<p>1. ALL ICON UPPER CONTROL ARMS HAVE BEEN ENGINEERED TO ALLOW FOR THE MOST POSSIBLE CASTER, WHILE STILL ALLOWING THE VEHICLE TO BE PROPERLY ALIGNED. NOTIFY YOUR PROFESSIONAL ALIGNMENT SHOP OF THIS INFORMATION SO THAT MAXIMUM RIDE QUALITY CAN BE ACHIEVED.</p> <p>2. ICON DELTA JOINTS ARE PRE-GREASED FROM THE FACTORY. ICON RECOMMENDS GREASING THE DELTA JOINT EVERY 3,000 MILES (OR EVERY OIL CHANGE). ADD NEW GREASE UNTIL ALL OF THE OLD GREASE IS EXPELLED FROM THE BOTTOM OF THE DELTA JOINT ASSEMBLY, WIPE AWAY EXCESS WITH A RAG OR SHOP TOWEL.</p> <p>3. DO NOT EXCEED 1.875" ADJUSTMENT FROM THE CENTER OF THE ROD END TO THE EDGE OF THE BILLET UPPER CONTROL ARM. FAILURE CAUSED BY EXCESSIVE ADJUSTMENT WILL NOT BE COVERED UNDER ICON'S WARRANTY POLICY. REFER TO TECH NOTE PHOTO.</p>
