Part number SES1500TT

2017-18 Honda Civic

1.5L turbo 4cyl.

1- 3 piece cat back dual exhaust

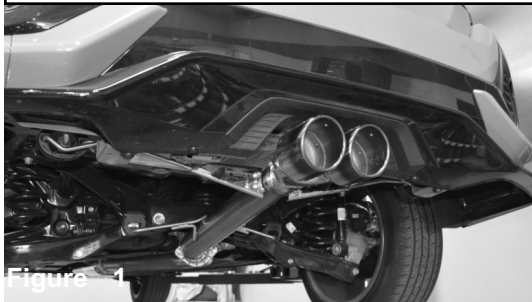
Figure 1

Complete kit:

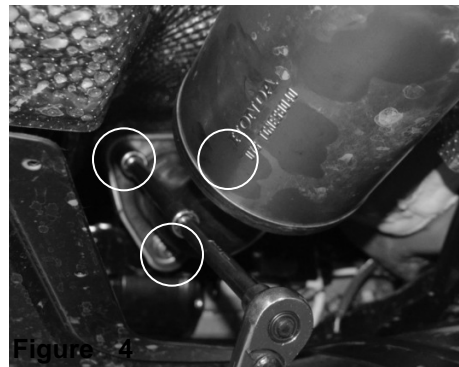
Figure 4

Loosen the 3 nuts holding in the pipe using 14 mm socket with wrench. Save these 3 nuts for later install.

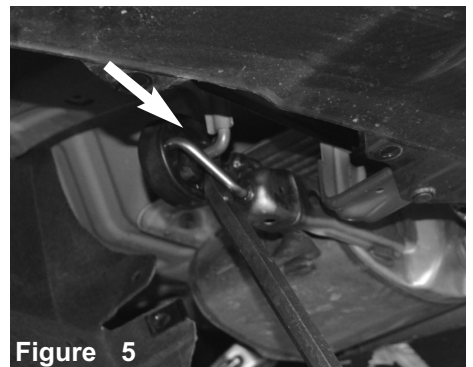
Figure 5

Pull back the rear covers allowing for access to the rear hangers. With lubrication, remove all the exhaust hangers from the rubber isolation mounts.

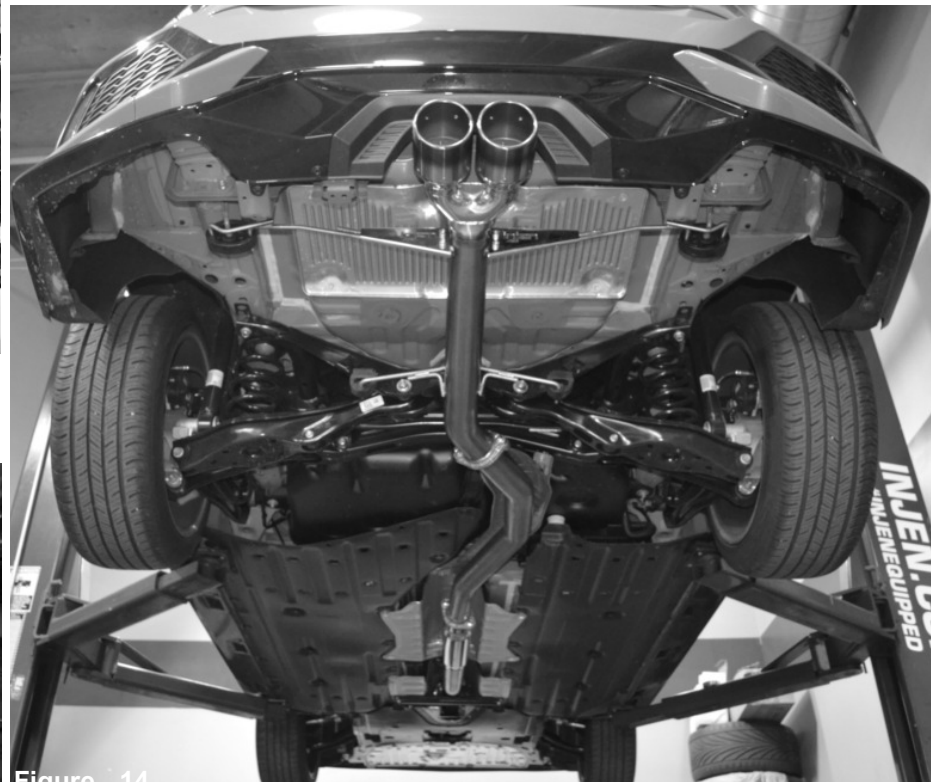
Figure 14

Congratulations! You have just completed the installation of this exhaust system. Verify and adjust the rear section of the exhaust, make sure muffler and tip do not touch any plastics or it can melt. Periodically, check the alignment of the exhaust, normal wear and tear can cause nuts and bolts to come loose. **Note: Check clearance and adjust if needed! Failure to check the alignment and adjust the exhaust can cause damage that will void the warranty. Injen Technology is not responsible for any damages caused by/from improper installation.**
