Part Number SP1125

2007-09 BMW 335i
 2008-09 BMW135i
 3.0L Twin Turbo L6

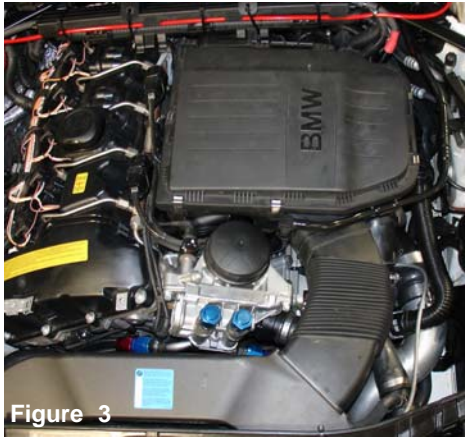
Figure 3

Stock box shown in this picture

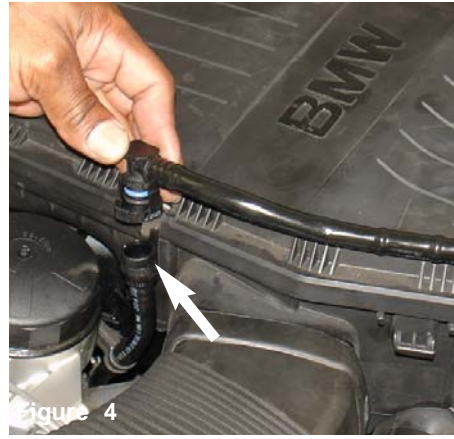
Figure 4

The hard plumbing vacuum line is detached from the lower hard line.

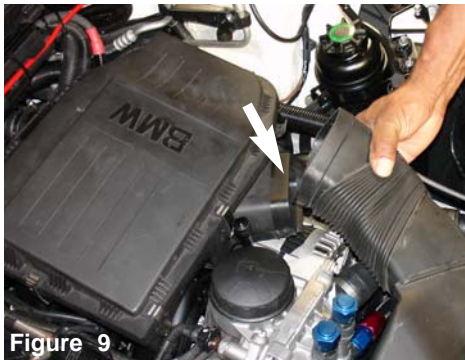
Figure 9

Pull the air scoop inlet from the air box inlet as shown above.

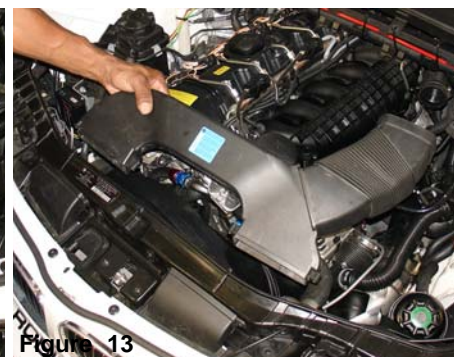
Figure 13

Once all four bolts have been removed, continue to pull the air scoop duct out.

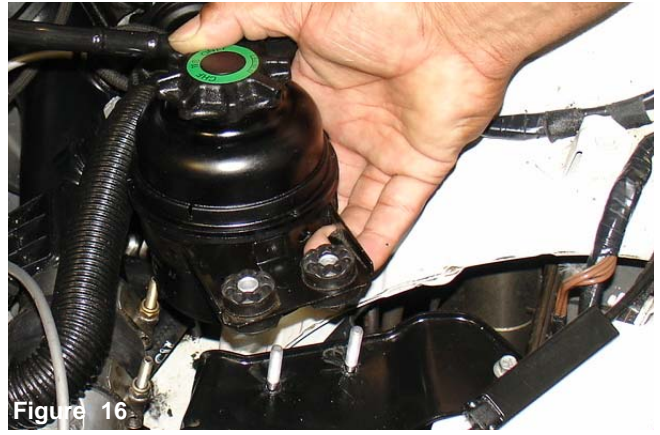
Figure 16

Once both m6 nuts have been removed, continue to pull the power steering reservoir from the two studs.

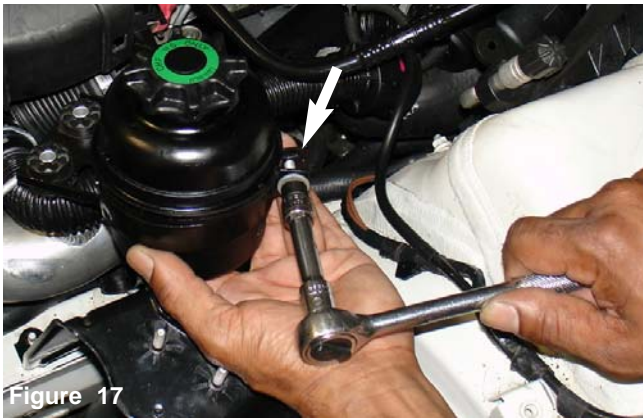
Figure 17

Remove the m6 bolt from the power steering clamp.

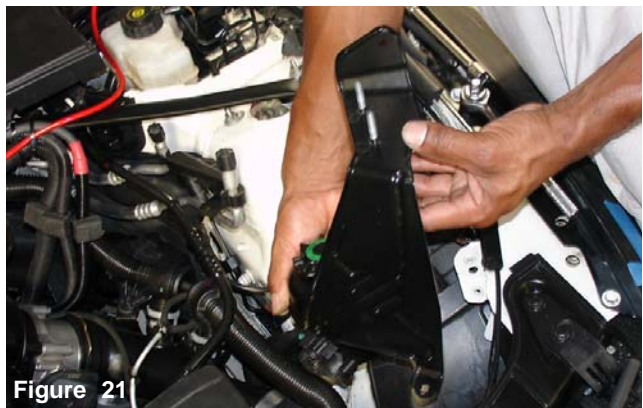
Figure 21

Once you have removed all nuts and bolts, continue to pull the power steering brace out of the engine compartment.

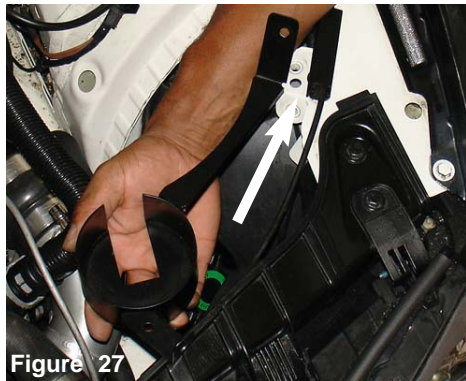
Figure 27

The reservoir cup is lowered into the engine compartment. The long cup bracket is aligned to the fender wall brace.

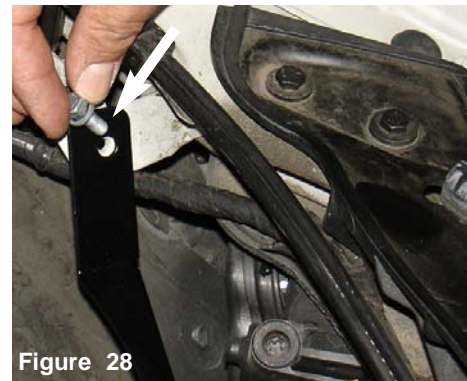
Figure 28

The stock M6 bolt is screwed into the pre-tapped hole.

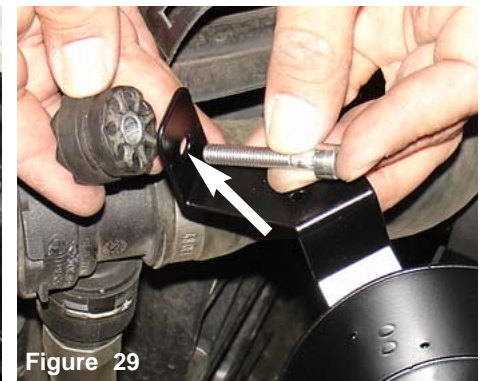
Figure 29

The 35mm bolt is inserted into the bent bracket attached to the cup and into the stock grommet.

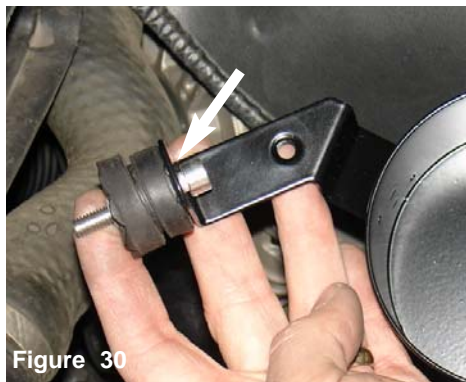
Figure 30

The 35mm bolt is inserted into the bracket and stock grommet.

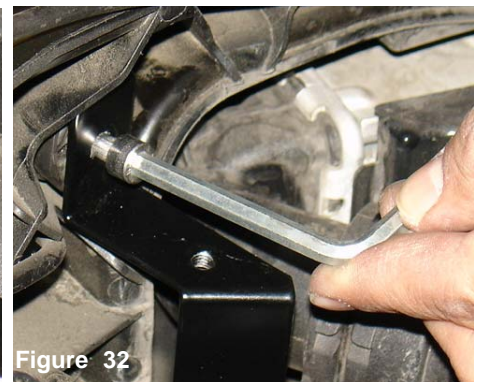
Figure 32

An allen wrench is used to tighten the 35mm bolt into the head lamp pre-tapped hole.

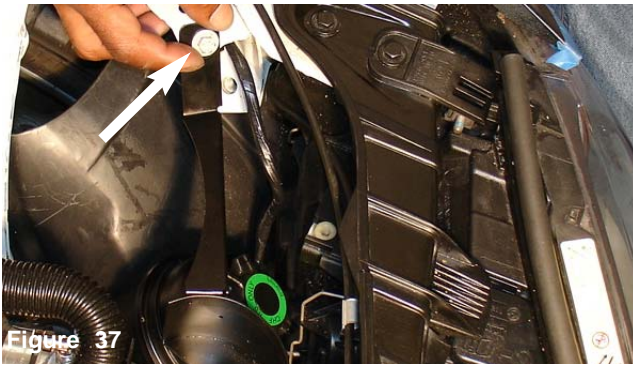
Figure 37

The stock m6 bolt is used to fasten the extended bracket located on the new power steering cup.

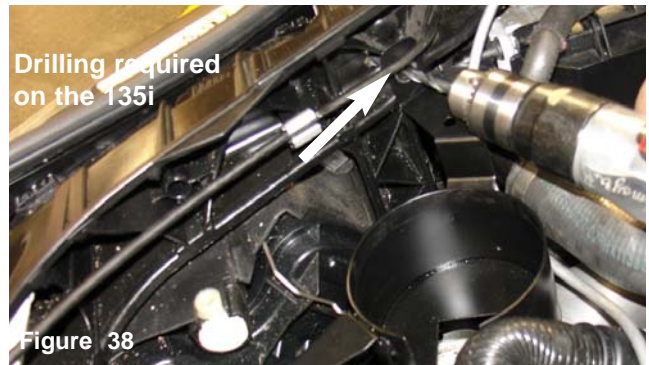
Figure 38

Applicable to the 135i only: Use a 1/4" drill bit to drill a hole through the composite cross member, the short bracket on the cup is used as a pattern.

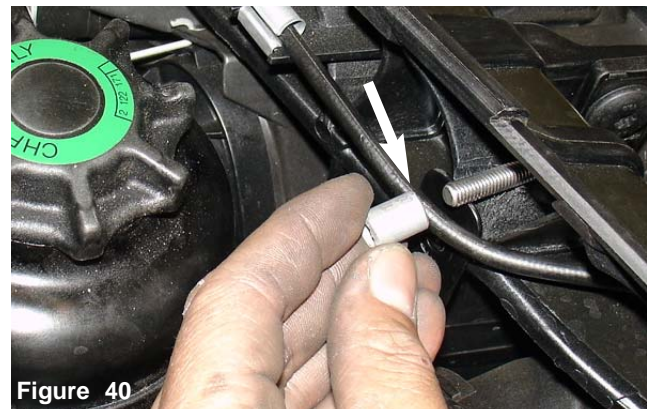
Figure 40

The 3/16" aluminum spacer is slipped over the m6 x 35mm bolt used to secure the reservoir bracket. **NOTE: Spacer is only required on the 135i**

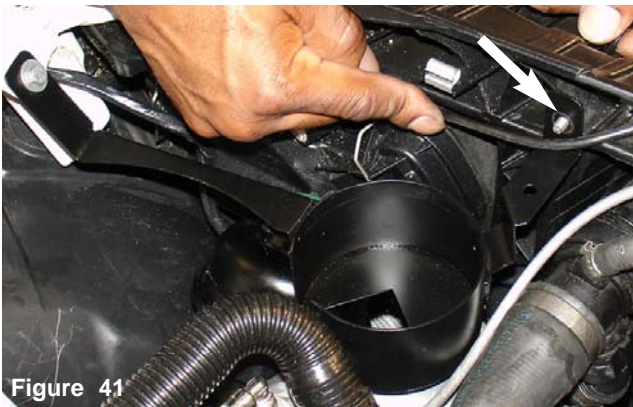
Figure 41

The m6 x 35mm hex bolt is inserted through the cross member, and into the 3/8" aluminum coupler. The aluminum coupler is used as a back support for the reservoir bracket as shown in figure 28.

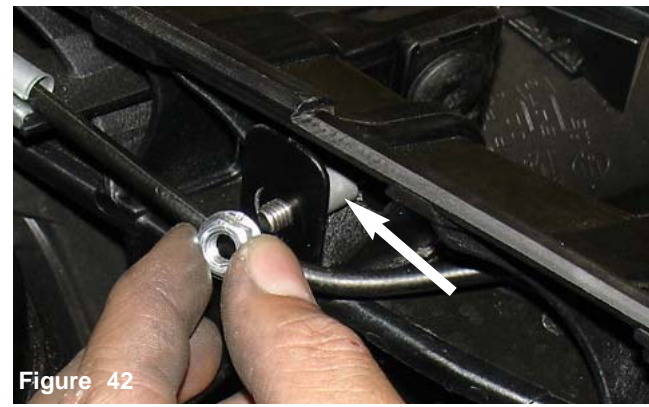
Figure 42

The m6 flange nut is used to tighten the reservoir bracket in place. **Note:** The 3/16" spacer between the bracket and cross member, used to support the bracket to keep it from distorting.

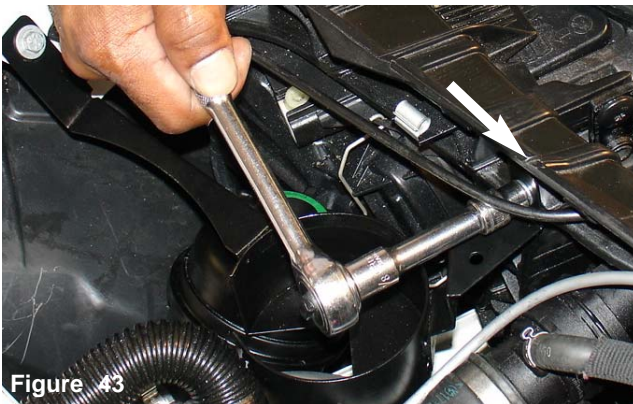
Figure 43

A 10mm socket and ratchet is used to fasten the flange nut to the m6 bolt.

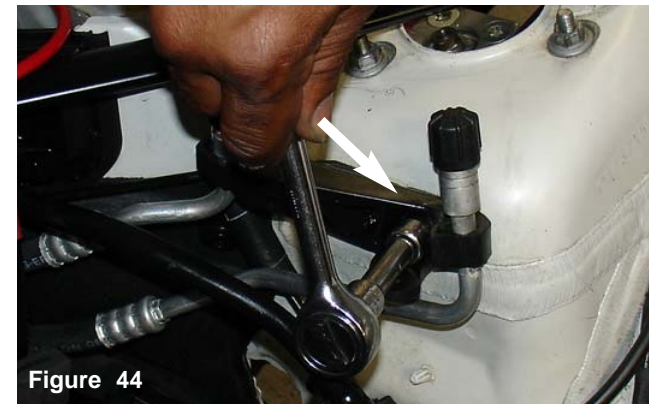
Figure 44

Remove the 10mm nut that holds the air conditioning lines to the side of the tower mount as shown above.

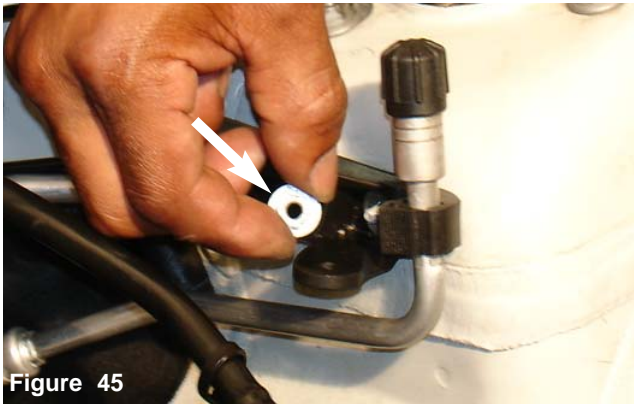
Figure 45

The two m6 nuts is loosened and removed from the threaded stud supporting the hard line and brace.

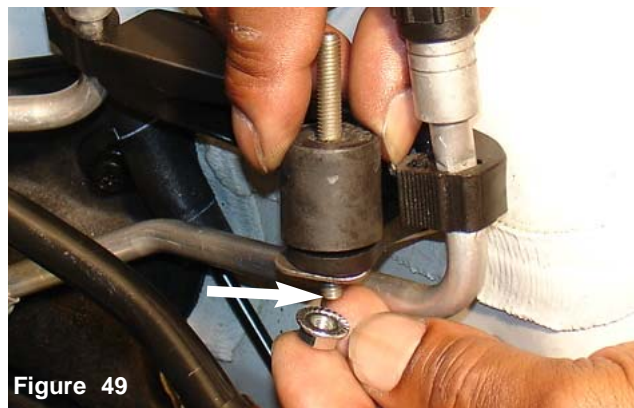
Figure 49

The vibra-mount is inserted into the new stainless steel bracket and the m6 flange nut is aligned to the vibra-mount stud.

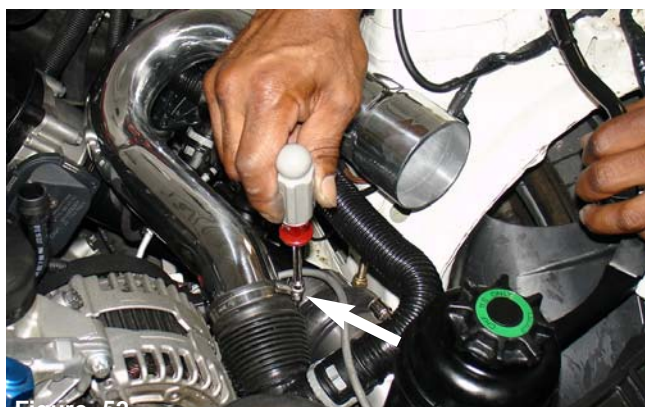
Figure 52

The air duct clamp is tightened as shown above.

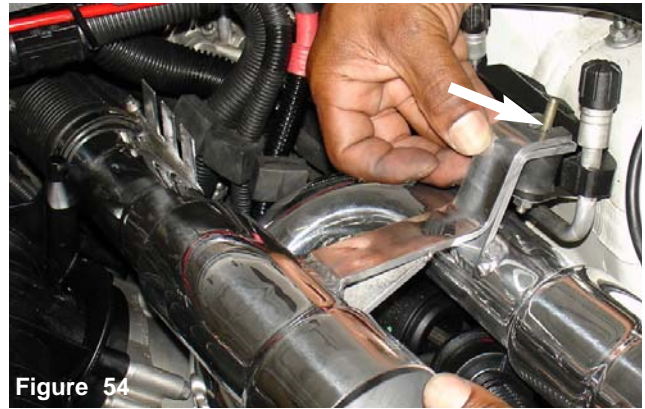
Figure 54

Once the intake has been inserted into the air intake duct, the intake bracket is aligned to the vibra-mount stud.

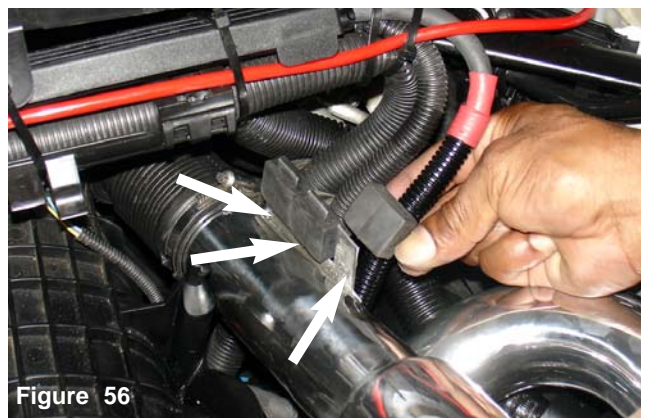
Figure 56

The three rubber harness hangers are pressed over the aluminum prongs located on the air intake as shown above.

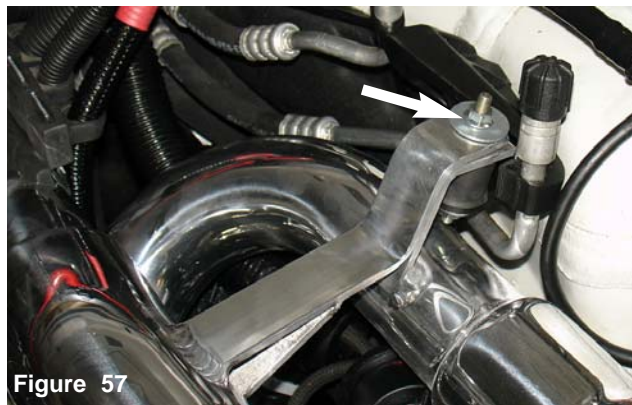
Figure 57

The m6 flange nut and fender washer is used to fasten the secondary intake to the vibra-mount stud.

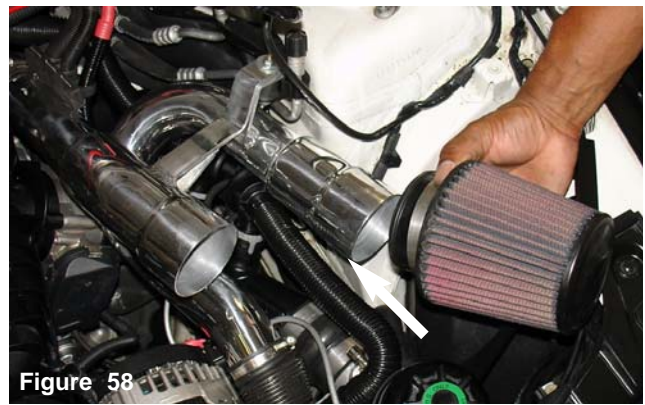
Figure 58

The first filter is aligned and pressed over the U-bent air intake.

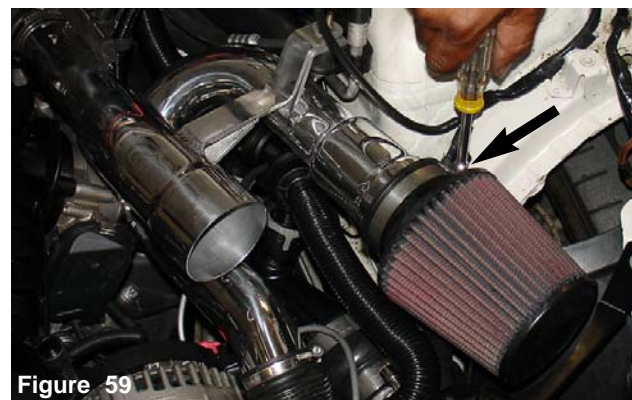
Figure 59

Once the intake end has butted up against the filter stops, continue to tighten the filter clamp.

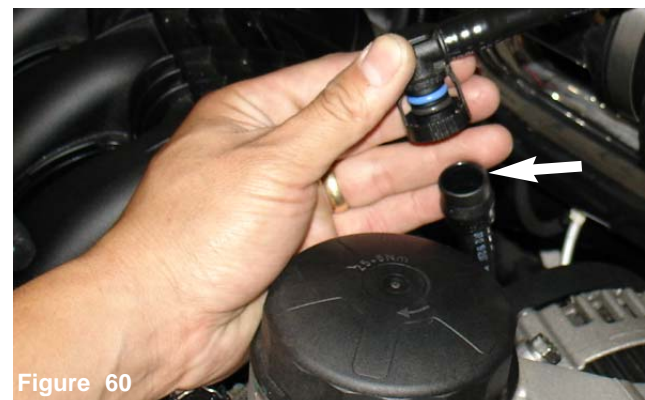
Figure 60

Important: The vacuum brake line is realigned as shown above. Vacuum line must be connected prior to starting engine.

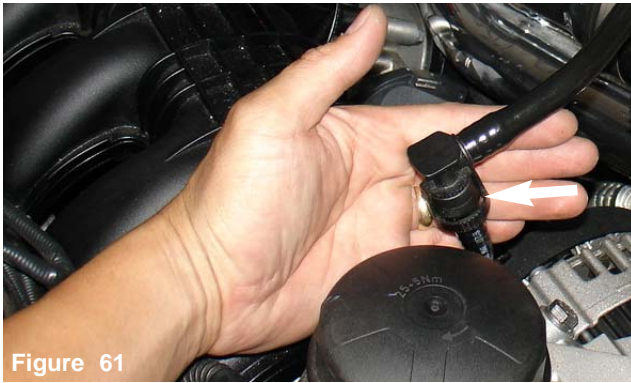
Figure 61

The brake vacuum hard line is pressed over the lower female hard line.
Do not attempt to drive vehicle until this line has been reconnected.

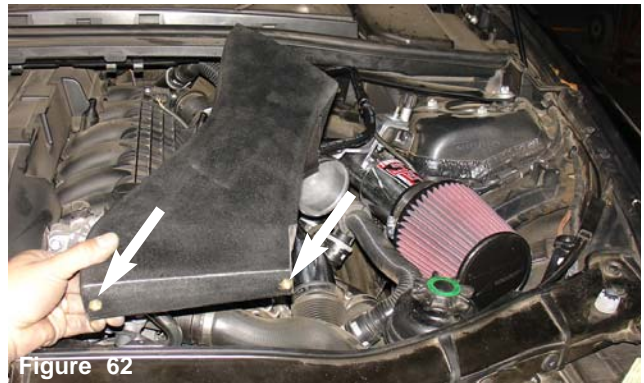
Figure 62

The air scoop is lowered into the engine compartment, The press nuts are aligned to the cross member pre-drilled holes.

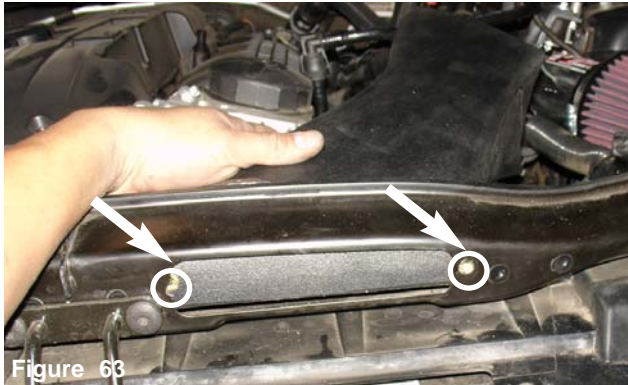
Figure 63

Both hole patterns will line up to the pre-drilled holes on the 135i, use two m6 x 16mm bolts to fasten the air scoop. The 335i will only take one bolt on the air scoop, the scoop bracket will be used to strengthen and attach the air scoop to the reservoir bracket.

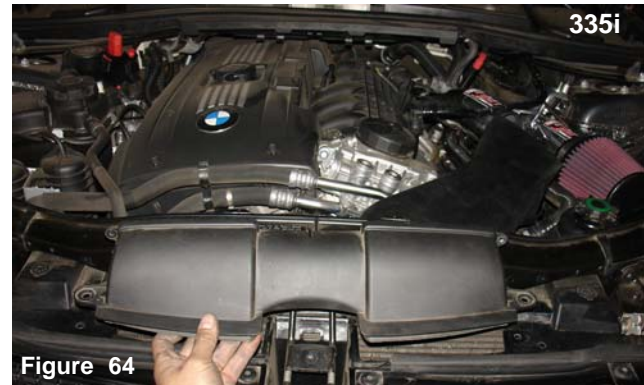
Figure 64

The front air scoop is lowered in front of the cross member.

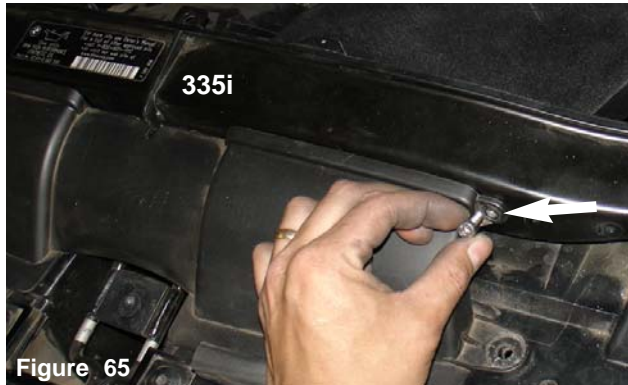
Figure 65

Attaching the air scoop to the 335i: The front scoop is re-attached to the cross member and the stock bolt is used to fasten the front scoop to the new engine air scoop. The plastic clips are also used on the scoop.

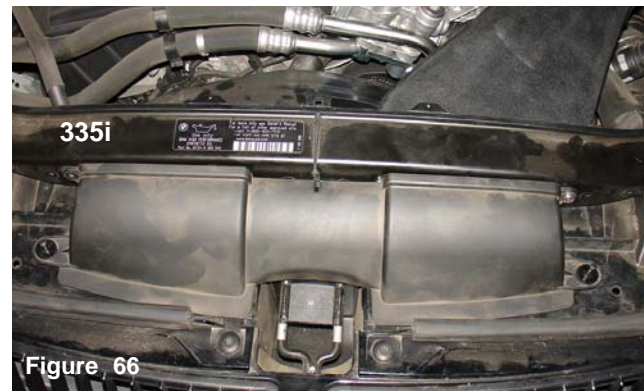
Figure 66

The front air scoop is now installed in the 335i.

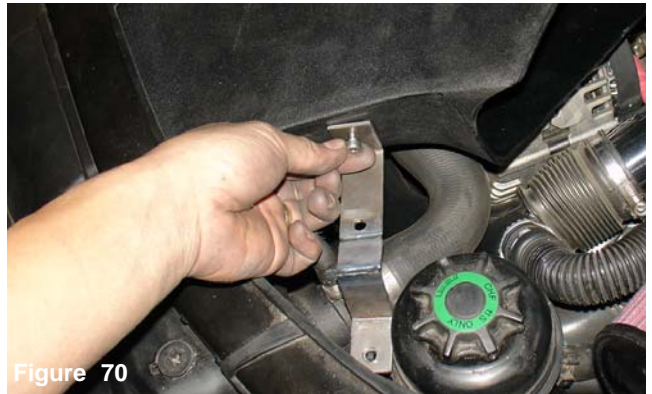
Figure 70

An m6 x 10mm bolt is used to attach the upper bracket to the second nut insert located on the air scoop.

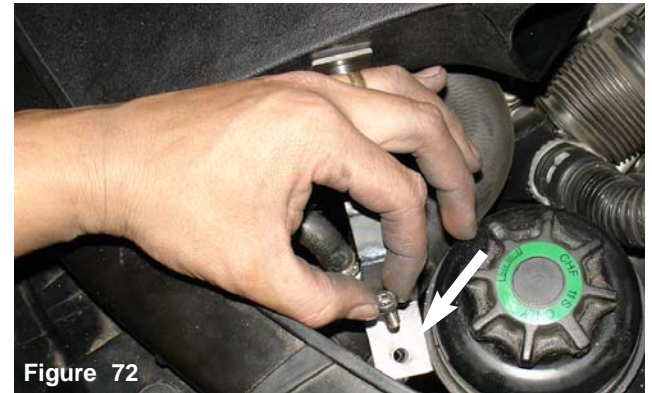
Figure 72

The second m6 x 10mm bolt is used to secure the lower bracket to the upper power steering reservoir bracket.

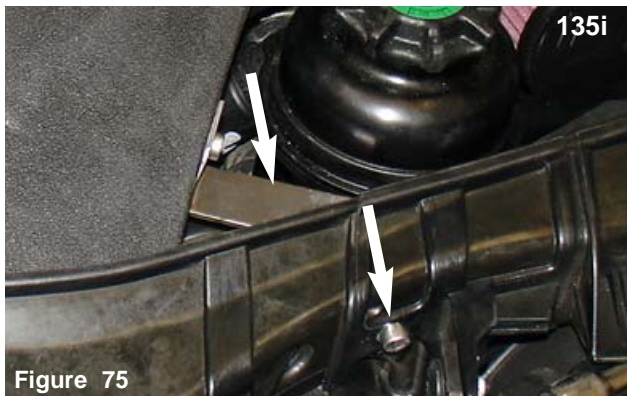
Figure 75

The bracket on the 135i is installed for those that choose to cut and use the bracket provided.

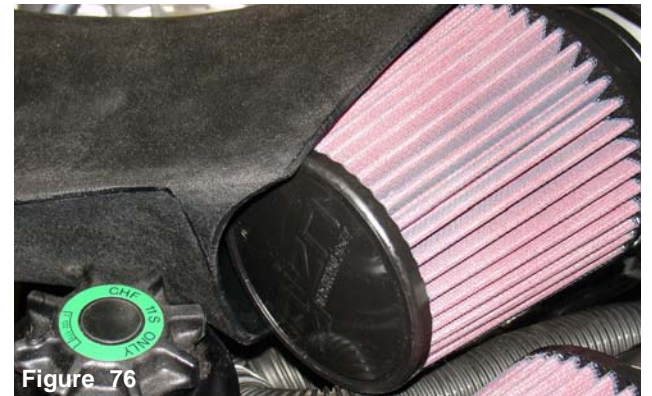
Figure 76

The second filter is now pressed over the secondary intake and adjusted in the air scoop. Once you have adjusted the filter, the intake clamp and filter clamps are tightened.

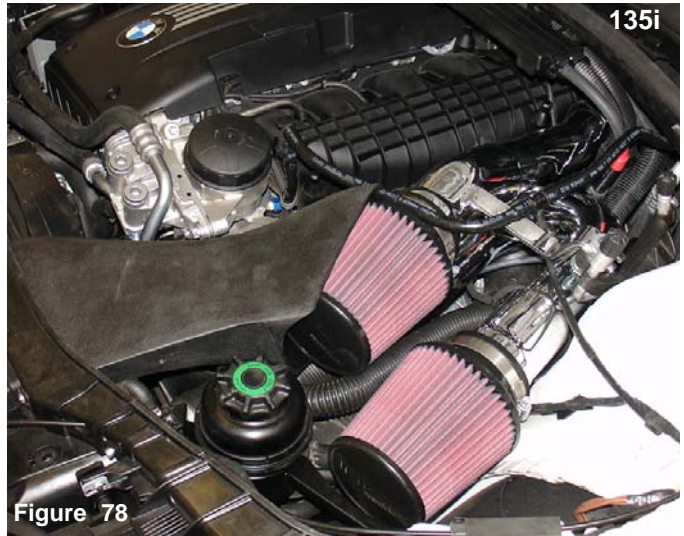
Figure 78

Note: The secondary filter on the 135i will fit snug inside of the air scoop as shown above. The secondary filter will have space around the filter when installed in the 335i.

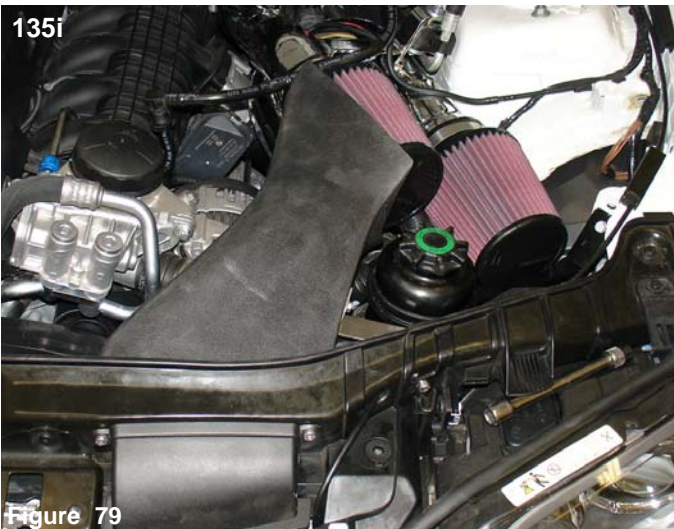
Figure 79

Align the entire intake for best possible fit. Once you have aligned and made sure that the length of the intake is free from any moving parts, continue to tighten all nuts, bolts and clamps.

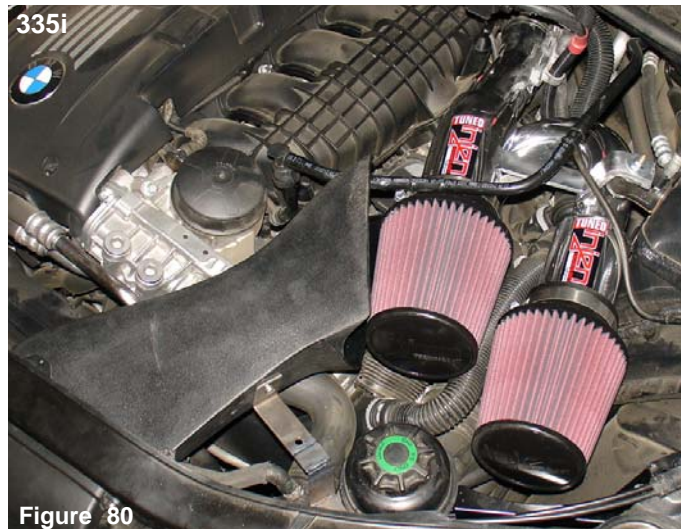
Figure 80

Congratulations! You have just completed the installation of this intake system. Periodically, check the alignment of the intake, normal wear and tear can cause nuts and bolts to come loose. Failure to check the alignment and adjust the intake can cause damage that will void the warranty.
