GM8427

2011-2013 CHEVROLET/GMC, SILVERADO/ SIERRA,
HD2500-3500, DURAMAX, DOWN PIPE

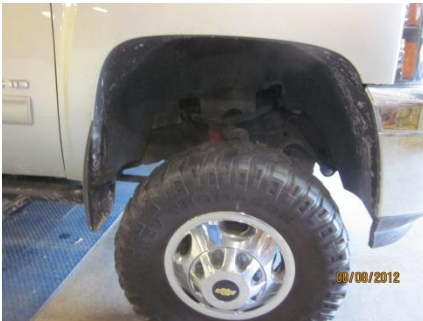
Figure 1

1. Remove the passenger side inner fender. **See Figure 1.**
Note: we also removed the Grille Assembly to prevent damage to it during the removal or installation of the down pipe.
2. Remove the hex bolt securing the down pipe to the exhaust manifold. Remove the sensor located just above the hex bolt. The V-Band clamp connecting the front pipe to the down pipe can also be removed. Save the hex bolt, sensor and V-band clamp for the installation. **See Figure 2.**
3. The front pipe needs to be temporarily removed. Carefully disconnect all sensors and loosen the four flange nuts on the rearward part of the front pipe. The transmission cross-member will need to be temporarily dropped to remove the front pipe. Remember to support the transmission with a block or jack stand while doing the transmission cross member is removal. **See Figure 3.**

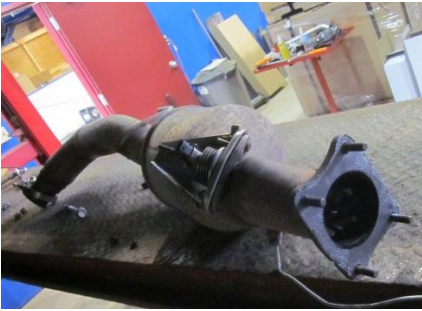
Figure 4

4. The front pipe also has a hanger mounted to the transmission that will also have to be removed. **Figure 4** shows the front pipe assembly removed.
5. The heat shield on top of the turbo will need to be removed. There is also a shield on the back of the down pipe. It runs along the firewall that needs to be removed. The 2 stock sensors on the top of the down pipe need to be carefully removed. Set the sensors aside and save for the installation. The stock V-Band clamp can be removed save for the installation. From the underside of the vehicle carefully slide the stock down pipe out between the frame and transmission.

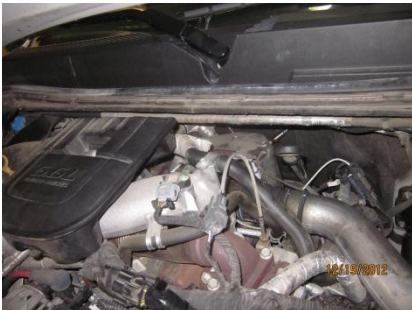
Figure 10

5. Reinstall the exhaust hanger to the transmission cross member. Reinstall the transmission cross member. Reconnect all the sensors to the front pipe.
6. Reinstall the passenger side inner fender.
7. Reinstall the turbo heat shield. **Refer to Figure 10.** Check along the exhaust to make sure all connections are tightened. Check along the whole length of the exhaust system to ensure that there is adequate clearance around the spare tire, fuel and brake lines or any wiring. If any interference is detected relocate or adjust.
