# PROBLEM SOLVER™ BULLETIN

## Inaccessible Idler Arm Grease Fittings

1993-2007 Full Size  
GM Pickup Trucks & SUVs

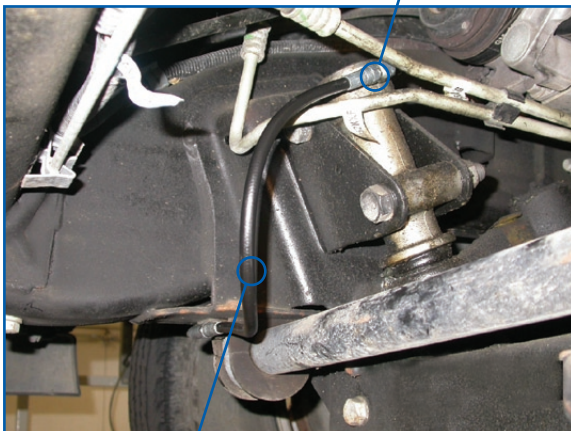
GREASE HOSE KIT ATTACHES TO BOTH OE AND MOOG IDLER ARM BRACKET ASSEMBLIES.

- MOOG grease hose kit K6714 relocates the idler arm grease fitting to the sway bar frame bracket. Routine service is easy as the zerk is now accessible through the wheel well.
- Installation is quick and simple, taking less than 20 minutes (approximately 0.3 labor hours).
- K6714 can be installed on MOOG and original equipment idler arms.
- The grease hose kit can be used on all K6659 and K6532 vehicle applications.

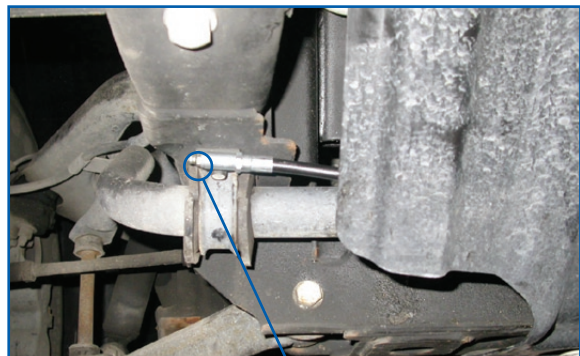
MOOG K6714 GREASE HOSE KIT WITH SKID PLATE REMOVED

IDLER ARM BRACKET GREASE FITTING IS EASILY ACCESSIBLE THROUGH RIGHT FRONT WHEEL WELL WITH THE USE OF THE MOOG K6714 GREASE HOSE KIT.
