PROBLEM *Solver* BULLETIN

Rear Suspension Pivot Bushing Failure

**GM Crossovers
and Minivans**

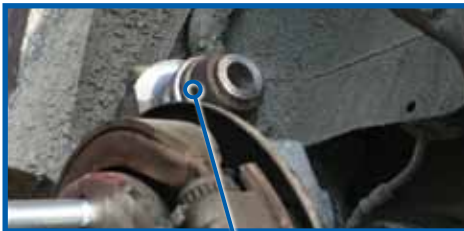
PIVOT BUSHING

GM crossover and minivan rear aluminum suspensions use a "cross-axis" pivot bushing which is pressed into the upper axle/hub carrier (or knuckle). This pivot bushing takes the place of an upper ball joint. The OE part may experience early failure, creating rear alignment change which can lead to excessive tire wear. In addition, this part is not available separately from the dealer. If the bushing is worn or failed, the entire axle/hub carrier must be replaced.

Cross axis pivot bushing unassembled

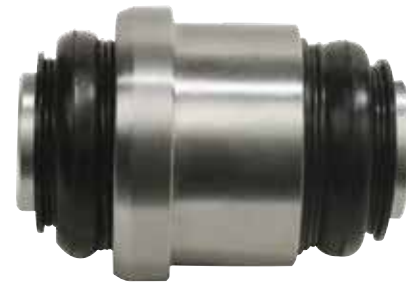
MOOG K200174 upper pivot bushing

The MOOG K200174 and MOOG K200175 pivot bushings correct the looseness and restore alignment integrity. The lower pivot bushing K200175 is a companion part suggested to be changed when the upper pivot bushing is replaced. Since these parts are available separately, the OE axle/hub carrier (knuckle) can be retained.

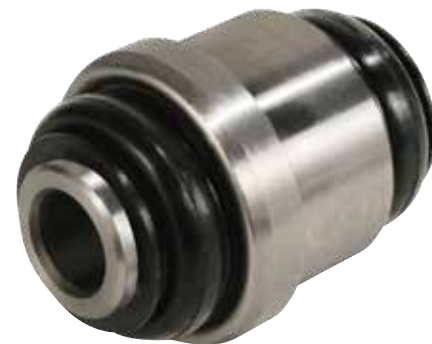
MOOG K200175 lower pivot bushing
