FRONT UPPER BALL JOINT

1989-1997 MAZDA MX-5 MIATA

THE PROBLEM SOLVER®

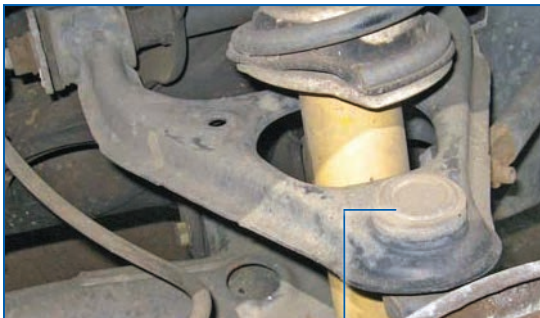
OE dealers do not offer a replacement front upper ball joint by itself. So to replace the upper ball joint, installers must purchase the entire control arm.

REPLACEABLE PART. REPLACE WITH MOOG® PROBLEM SOLVER® K500210 UPPER BALL JOINT.

MOOG® Problem Solver® ball joint K500210 is the perfect replacement for the failed control arm ball joint. Its knurled housing enables it to fit securely into the control arm. Its design, which incorporates an all-metal gusher bearing and full ball stud, is both smooth and durable.

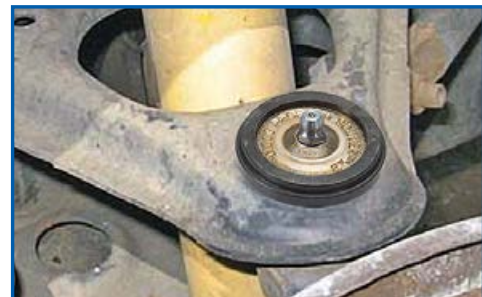
- All-metal “gusher” bearing design provides strength and allows lubricant to penetrate bearing surfaces for longer life.
- Greaseable design flushes contamination and keeps part lubricated.
- MOOG patented domed cover plate and Belleville washer ensure proper preload and consistent socket torque for the life of the part.
- Metal stud with full-ball configuration provides smooth, even rotational movement.
- MOOG “grease relief” polychloroprene boot lasts longer and directs contaminants out of the socket and away from brake components during lubrication.
