THE PROBLEM SOLVER®

FRONT LOWER BALL JOINT
2007-2012 NISSAN SENTRA

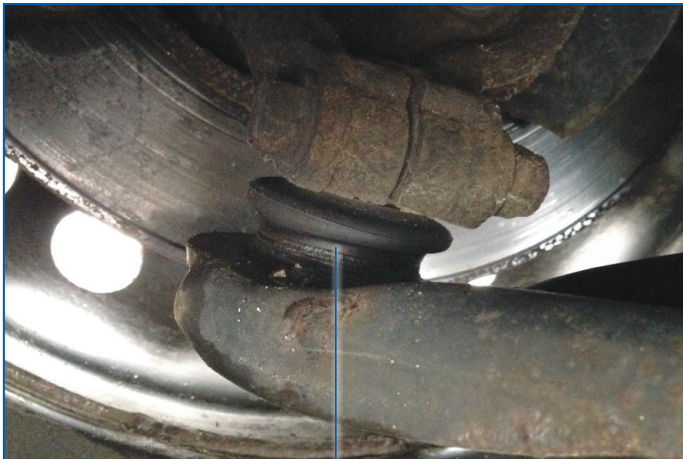
OE dealers do not offer a replacement front lower ball joint by itself. So to replace the lower ball joint, installers must purchase the entire control arm.

REPLACEABLE PART.
REPLACE WITH MOOG® PROBLEM SOLVER® K500223 LOWER BALL JOINT.

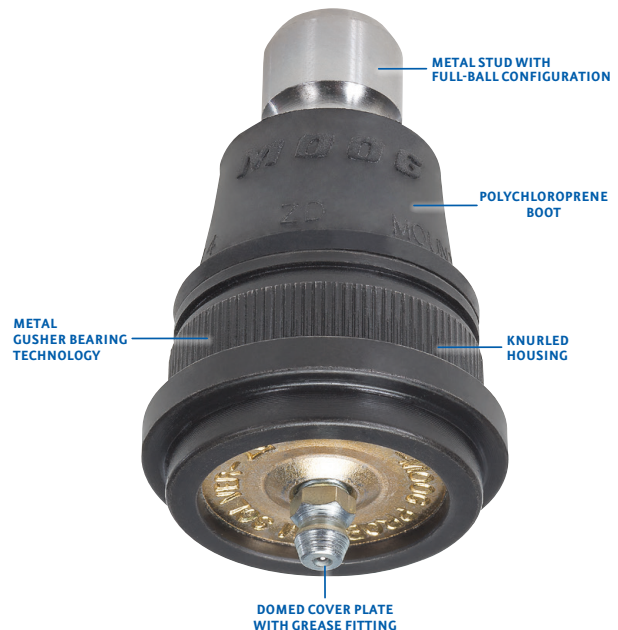
MOOG® Problem Solver® ball joint K500223 is the perfect replacement for the failed control arm ball joint. The knurled housing enables it to fit securely into the control arm. The K500223 design, which incorporates an all-metal gusher bearing and full-ball stud, is both smooth and durable.

- All-metal “gusher” bearing design provides strength and allows lubricant to penetrate bearing surfaces for longer life.
- Greaseable design flushes contamination and keeps part lubricated.
- MOOG patented domed cover plate and Belleville washer ensure proper preload and consistent socket torque for the life of the part.
- Metal stud with full-ball configuration provides smooth, even rotational movement.
- MOOG “grease relief” polychloroprene boot lasts longer and directs contaminants out of the socket and away from brake components during lubrication.
