BULLETIN: 27028.R

Ball Joint Failure Due to Improper Installation

Press-in ball joint applications

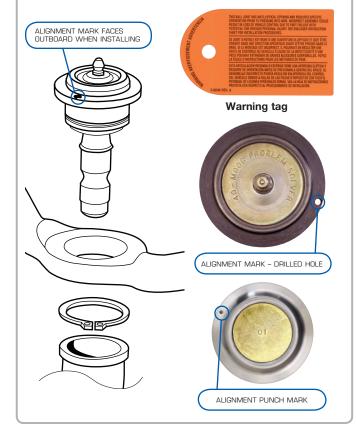
Always look at press-in ball joints for alignment marks such as drilled holes, arrows, punch marks, etc., and follow instructions regarding orientation when installing the joint in the arm. MOOG instruction sheets contain specific information about ball joint orientation where applicable. In addition, MOOG-manufactured ball joints with elliptical openings have a warning tag on the stud.
