Fabricated Aluminum Valve covers – Gen III Hemi Engines

68501G Mr. Gasket (silver finish)
68501BG Mr. Gasket (black finish)

Instruction/Installation Sheet P/N # 199R11689

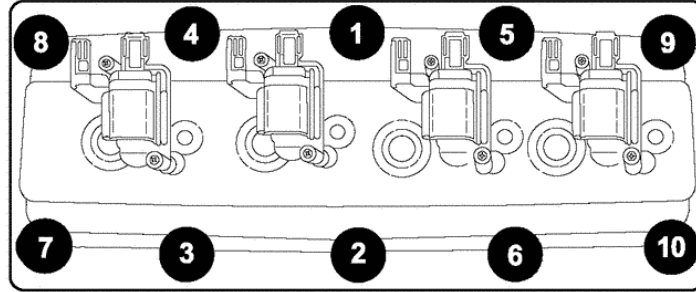
6. Using the sequence shown, tighten the valve cover bolts to (71 in./lbs.).
