Toyota Camry Hybrid:

Remove plastic fascia covering the Driver's side frame rail of the vehicle. Return plastic fascia covering and screws to vehicle owner. Newer model Hybrids will also require removing of plastic fin attached to bottom of trunk pan on Passenger's side.

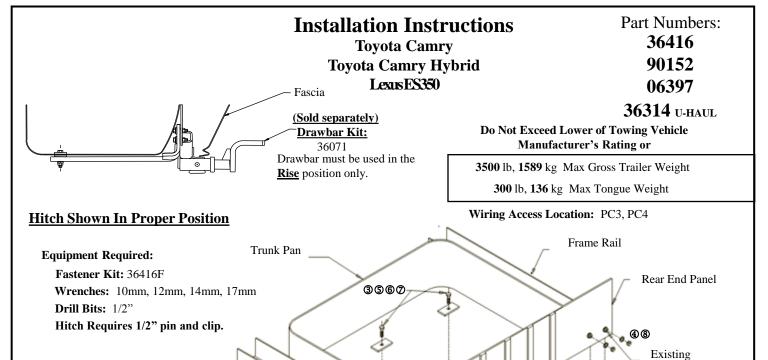
Figure 2

Fastener and bracket location see Figure 2.

Weldnuts

Bracket Removed in

installation step 4.

- 4. Remove the existing bracket shown in <u>Figure 2</u> from the driver's side vehicle frame rail and the rear end panel and return to vehicle owner.

- 5. Raise hitch into position and install the M10 Hex bolts and the 3/8" conical toothed washers into the existing weldnuts in the vehicle. If no weldnuts are present on the passenger side, then use the nuts and washers provided. (②, ③)
