Installation Instructions

Volvo V-70
Volvo XC-70
Volvo S60
Volvo V60

Part Numbers:

75916, 87674, 44999
75178 (U-Haul)

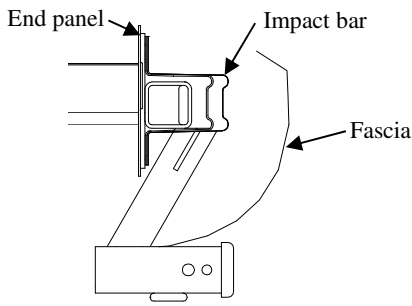
Hitch Shown In Proper Position

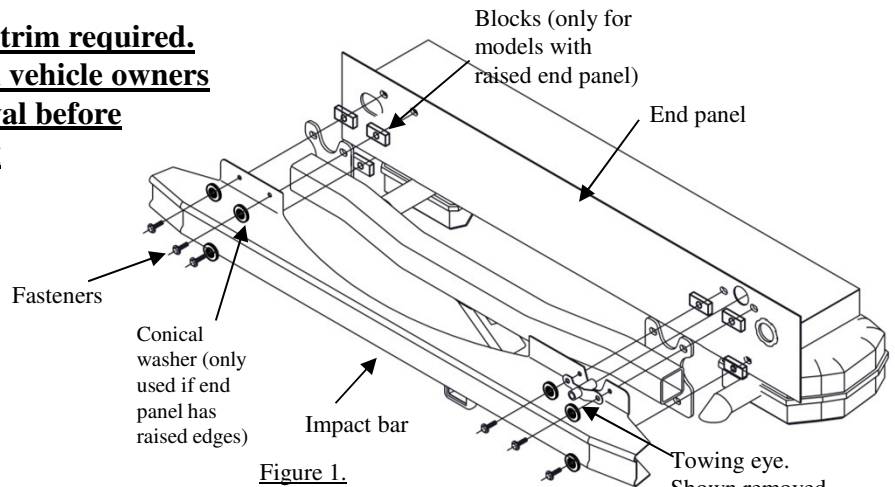
Figure 1.

Towing eye. Shown removed

①	Qty. (6)	Hex Bolt, M10 x 1.5 x 45 CL 10.9	③	Qty. (6)	Conical Washer, 7/16"
②	Qty. (6)	Block, 3/8"

8. Re-install towing eye (sandwich hitch, impact bar and towing eye). Hand tighten (6) bolts. See Figure 1 (Towing eye shown removed for clarity)
9. Tighten fasteners to specification.

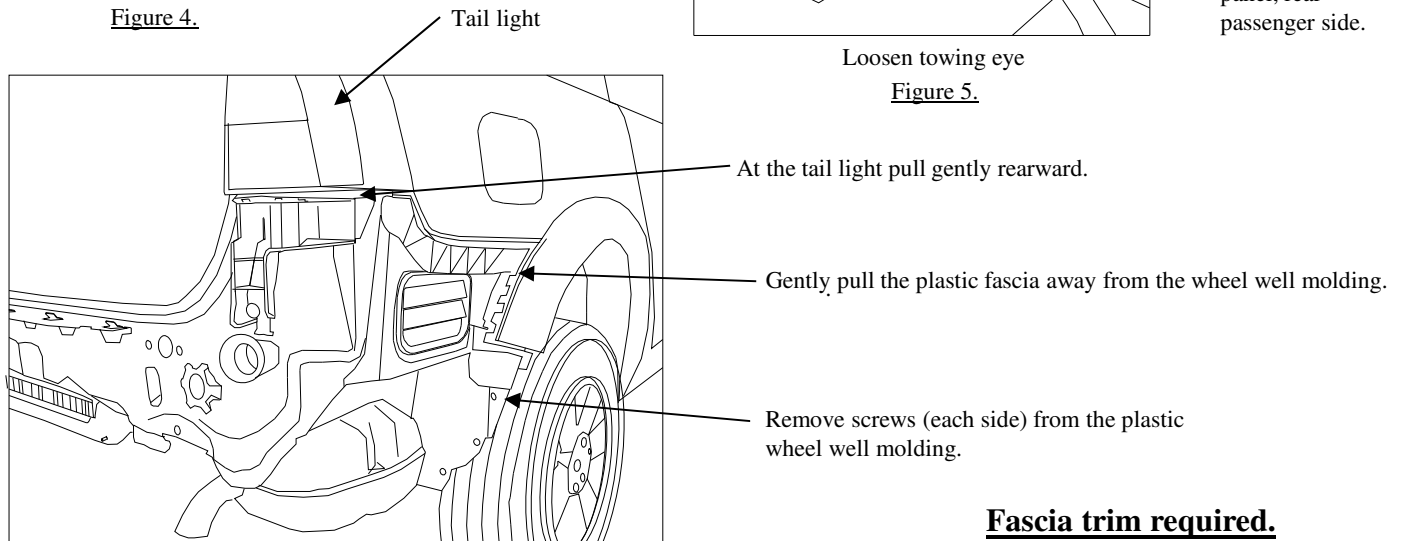
Fascia shown removed

- d. Gently pull the plastic fascia away from the wheel well molding. See Figure 6.
 - e. Gently continue to remove fascia. At the tail light pull gently rearward.
